# HIGHWAY-RAIL GRADE CROSSING COLLISION TEST OF A FUEL TENDER

## SUMMARY

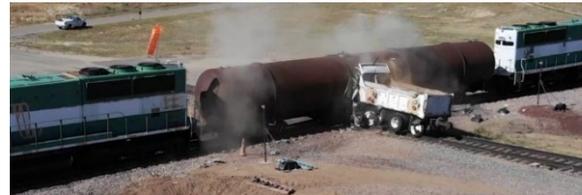
The tender resisted the impact without tearing either the inner or the outer tank. The tender and locomotives derailed but remained upright. No leaks were observed in any of the piping following the impact, and the locomotive fuel supply valve functioned as intended during the test. Figure 2 shows the post-impact positions of the dump truck, tender, and locomotives.

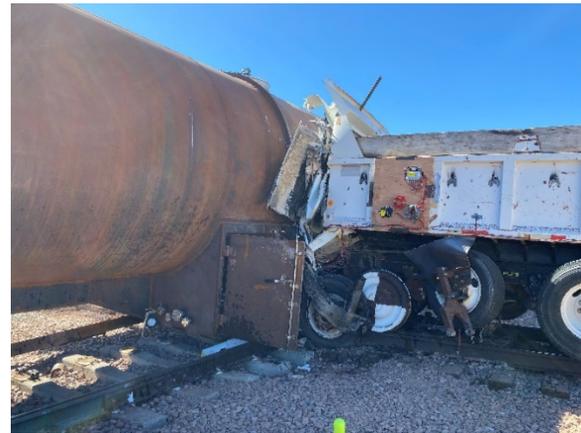
Figure 4. Post-impact Dump Truck and Cabinet

The impact occurred at approximately 43 mph. The track structure supporting the tender and locomotives experienced both tie shift and rail rollover, resulting in derailment of both tender trucks and the B-end trucks of each locomotive. The tender engaged with the rollover inhibitors on both ends and remained upright. The dump truck cab was destroyed, reducing in length from 10.5 feet pre-test to approximately 2 feet post-test. The welds attaching the dump bed's hinges to the truck frame failed, allowing the dump bed to displace forward approximately 20 and 11 inches relative to its original hinge points (i.e., right and left, respectively). Figure 4 shows the post-impact dump truck and cabinet. Note that the cabinet door opened as a result of the impact, however, no piping damage occurred as a result of this behavior.

During the test, the hose supplying compressed air to the locomotive fuel supply valve was severed. This caused the fuel supply valve to automatically actuate from its open to closed positions. The valve successfully closed completely on its own, demonstrating the ability to shut-off fuel supply to the locomotives even after a grade-crossing impact to the tender. Post-impact examination of both the mechanical gauges and the test instrumentation confirmed that the tank was still holding pressure following the impact. Before the test, the internal pressure was 26 psig. The internal pressure dropped to 22 psig during the test, likely because cold liquid nitrogen splashed into the vapor space and caused it to condense. The inner tank maintained its integrity and no leaks of LN<sub>2</sub> were found in any piping. The outer tank maintained its vacuum after the impact.

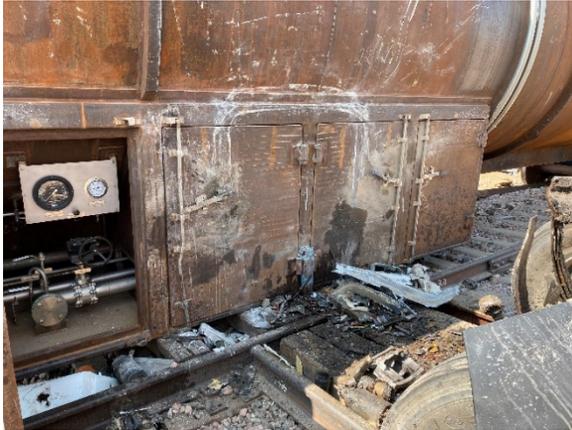
**Figure 5. Post-impact Cabinet Following Separation from Dump Truck**

Following documentation of the post-impact positions of the test vehicles, the tender and dump truck were separated. The dump truck was pulled back from the cabinet. The post-impact cabinet is shown in Figure 5. Note the visible outline of the dump truck on the outer surface of the cabinet doors. Only minor areas of permanent deformation were observed on the cabinet and its doors.
