1997 Railroad Employee Fatalities: A Comprehensive Study

Date: June 18, 2001

Subject: **1997 Railroad Employee Fatalities: A Comprehensive Study**

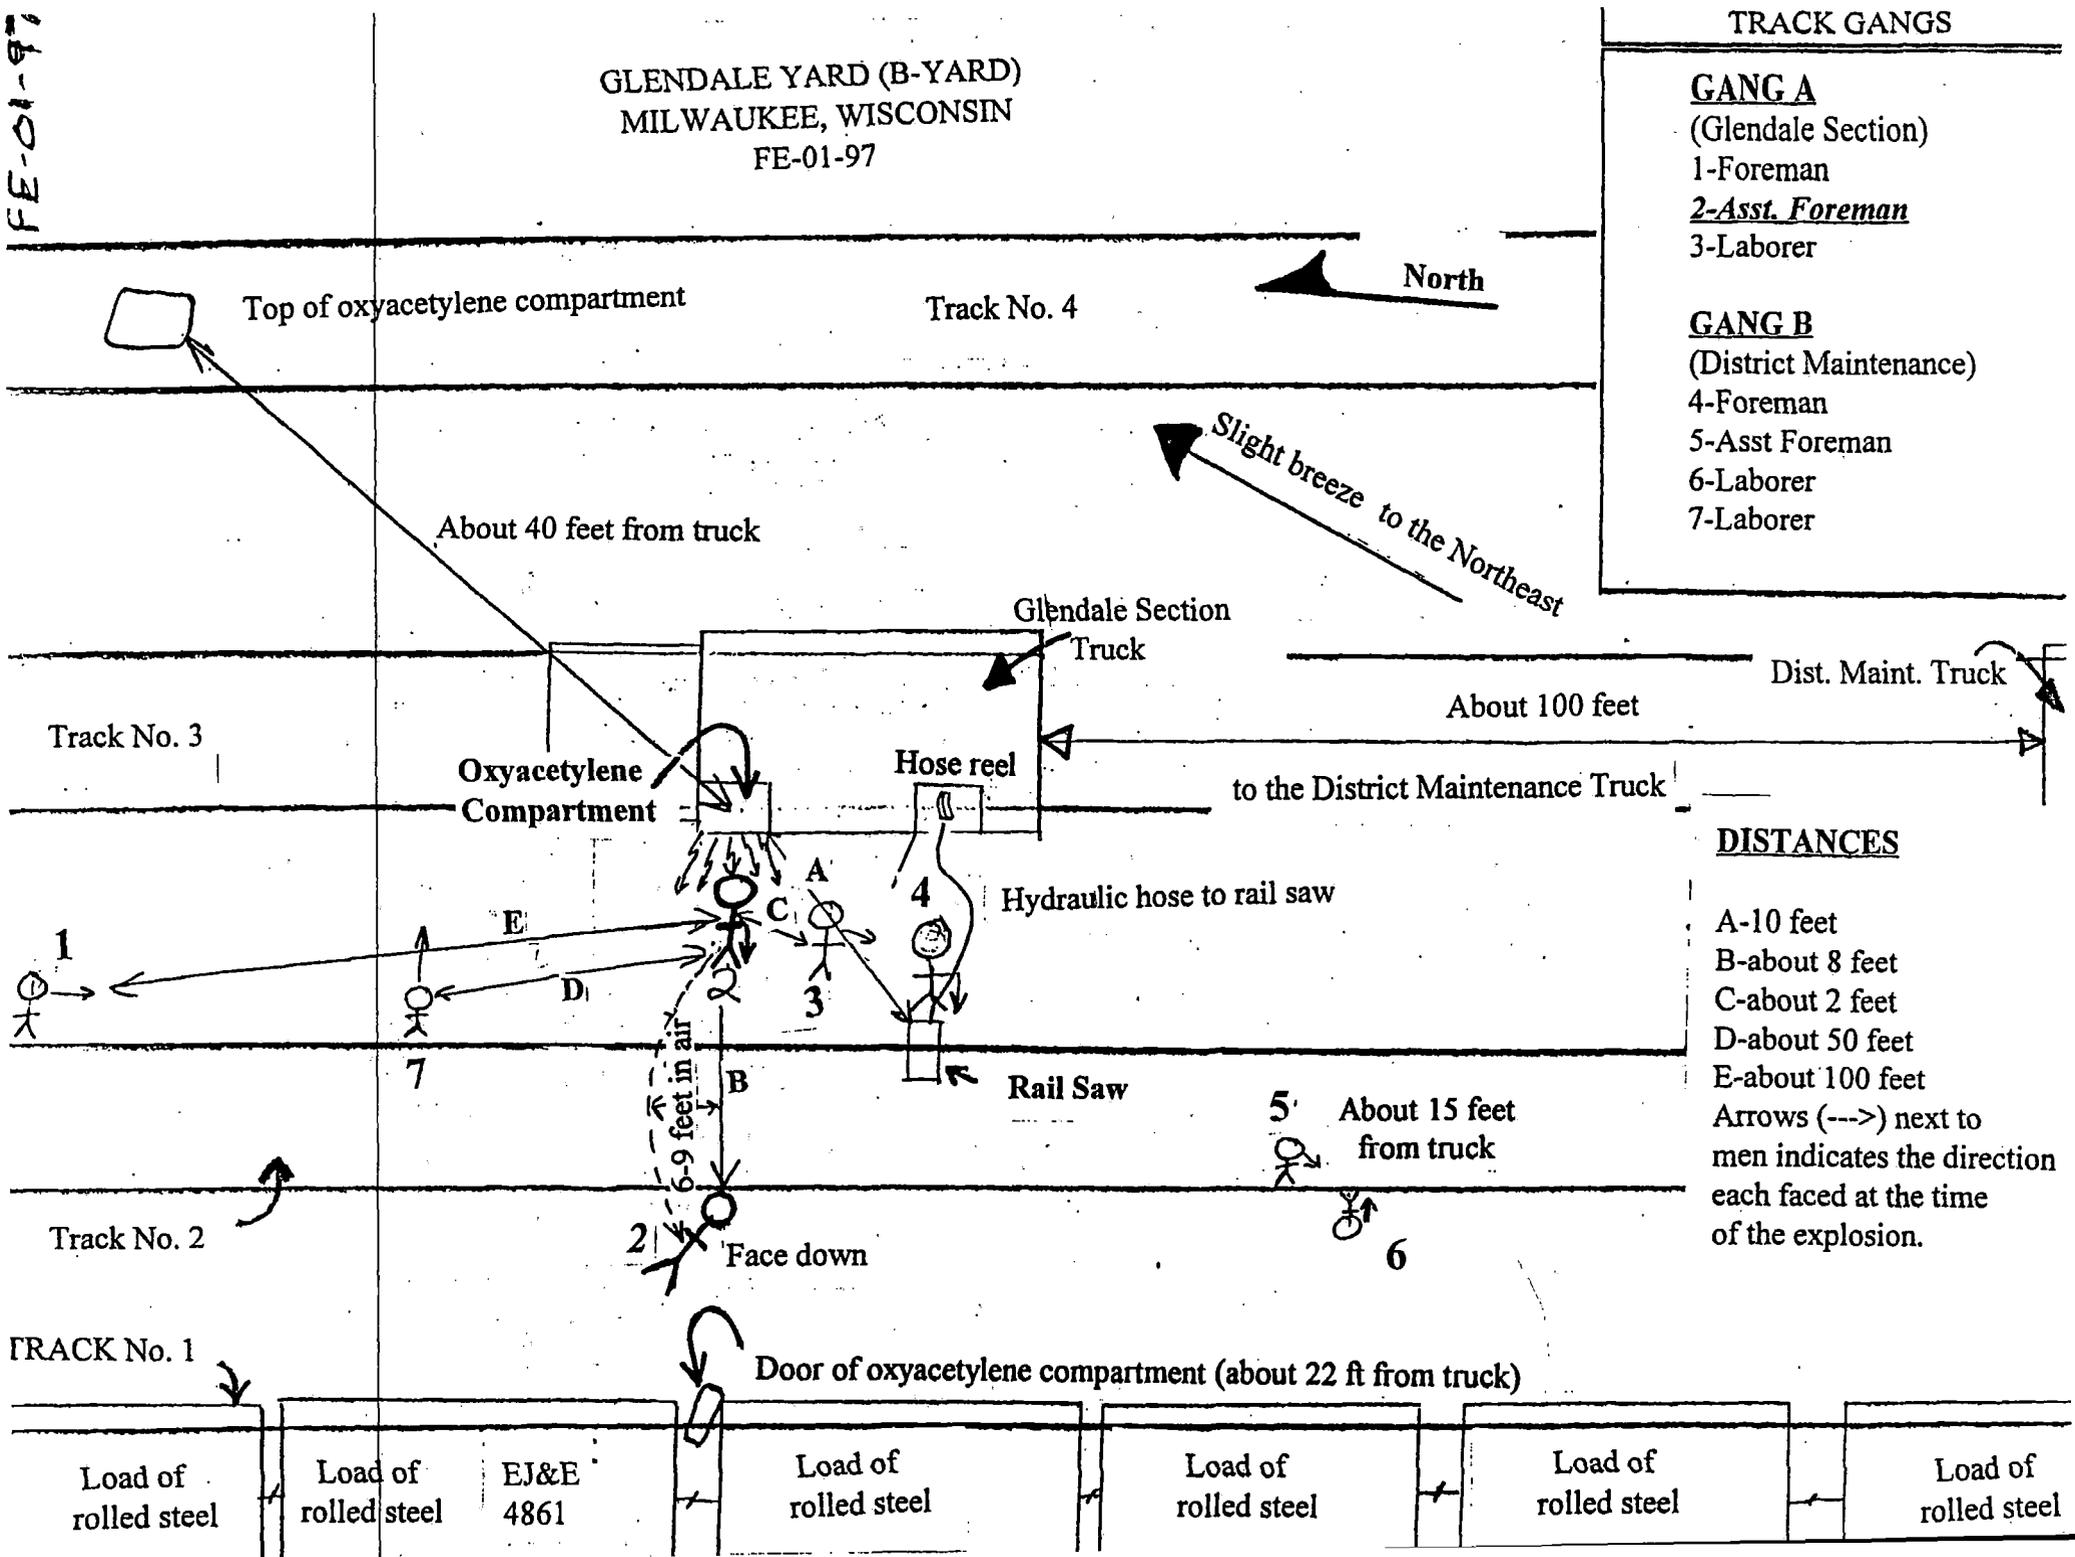
REPORT: FE-01-97
RAILROAD: Soo Line Railroad (SOO)
LOCATION: Milwaukee, Wisconsin
DATE, TIME: Jan. 8, 1997, 11:25 a.m., CST
PROBABLE CAUSE: Vapors from an oxygen/acetylene gas tank set in an enclosed area were ignited by flying sparks from a rail saw which caused an explosion within the compartment. This resulted in debris striking the nearby employee.

The Gang A Assistant Foreman was going to saw off about three inches of rail to eliminate a broken rail end. The Gang B Foreman told the Assistant Foreman he would saw this rail end, as the Assistant Foreman had sawed the previous ones. The saw, hydraulic-powered from the F-800 truck, was operated from the same side of the truck as the gas compartment. The hydraulic hose reel was in a rear compartment on the left side of the truck. The rail was being cut ten feet away from the gas compartment.

- A-10 feet
- B-about 8 feet
- C-about 2 feet
- D-about 50 feet
- E-about 100 feet
- Arrows (--->) next to men indicates the direction each faced at the time of the explosion.

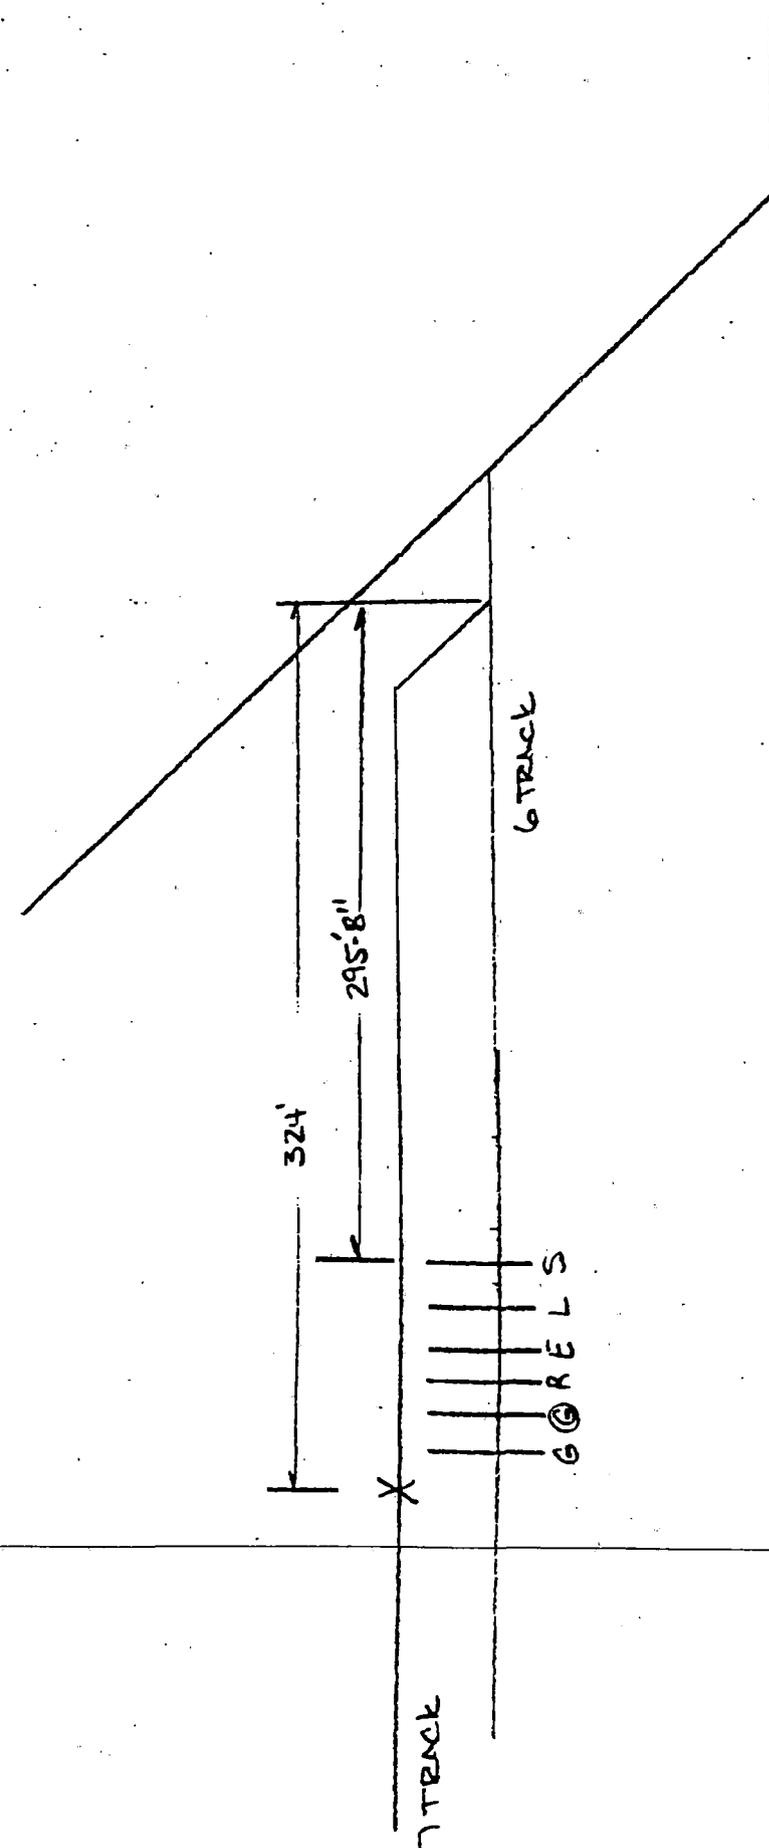
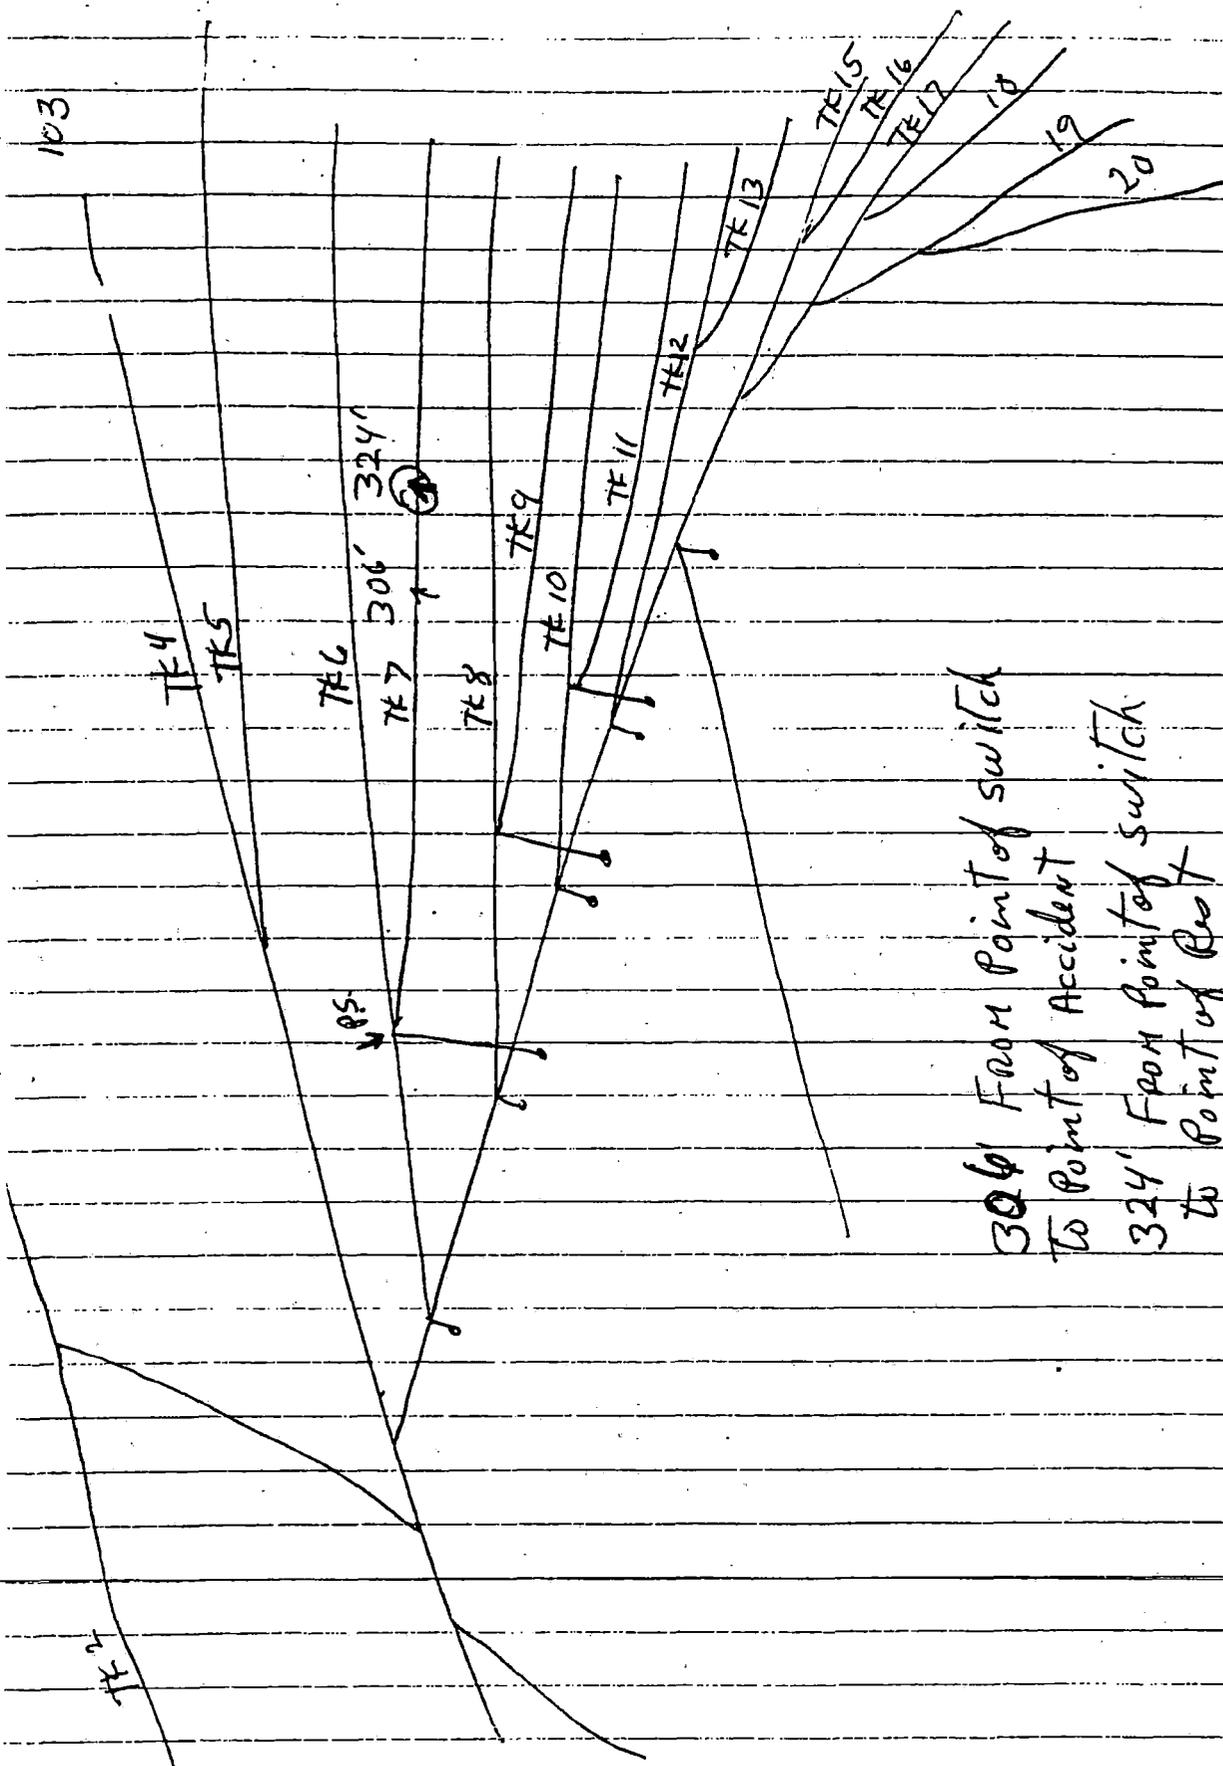
2/2/97

- G = GLOVE - 141" FROM REST - 141" FROM BASE OF NR EDGE OF TIE
- G @ = GLASSES - 151" FROM REST - 141" FROM BASE OF NR
- R = RADIO - 159" FROM REST - 29" FROM BASE OF NR
- E = EYE LENSE - 217" FROM REST - 5" FROM BASE OF NR
- ... - 341" FROM BASE OF NR

306' From Point of switch
 To Point of Accident
 324' From Point of switch
 To Point of Rest

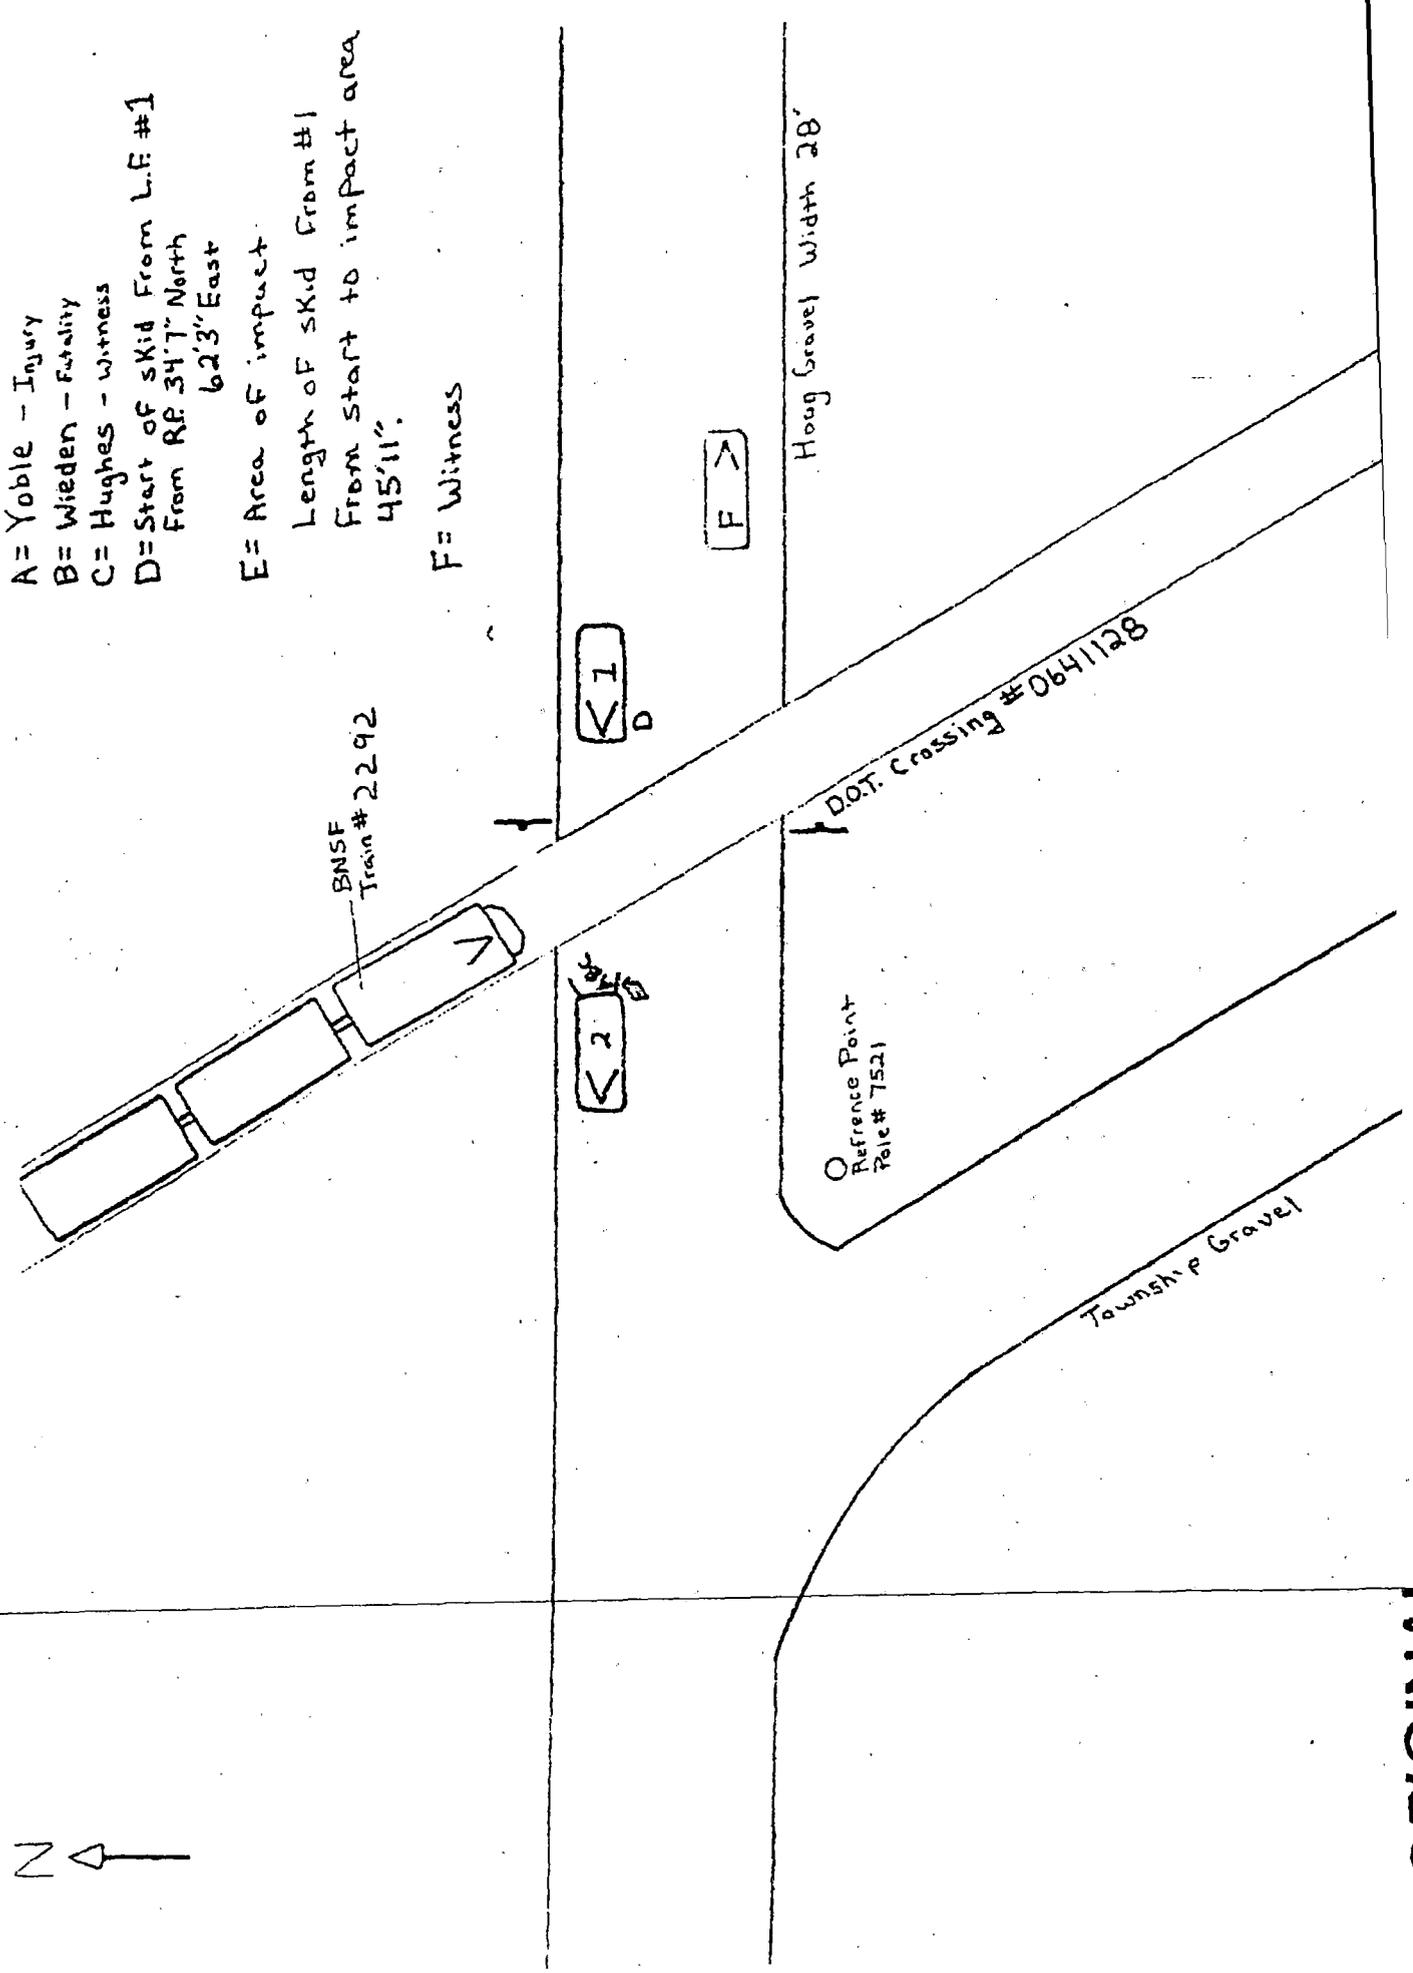
A = Area of impact
39' North 16'3" East

A =	42'7"	North	30'8"	West
B =	39'1"	North	20'7"	West
C =	30'4"	North	8'10"	East
D =	34'7"	North	18'9"	East
E =	Area of Body - Wieden			
	39'4"	North	4'7"	West

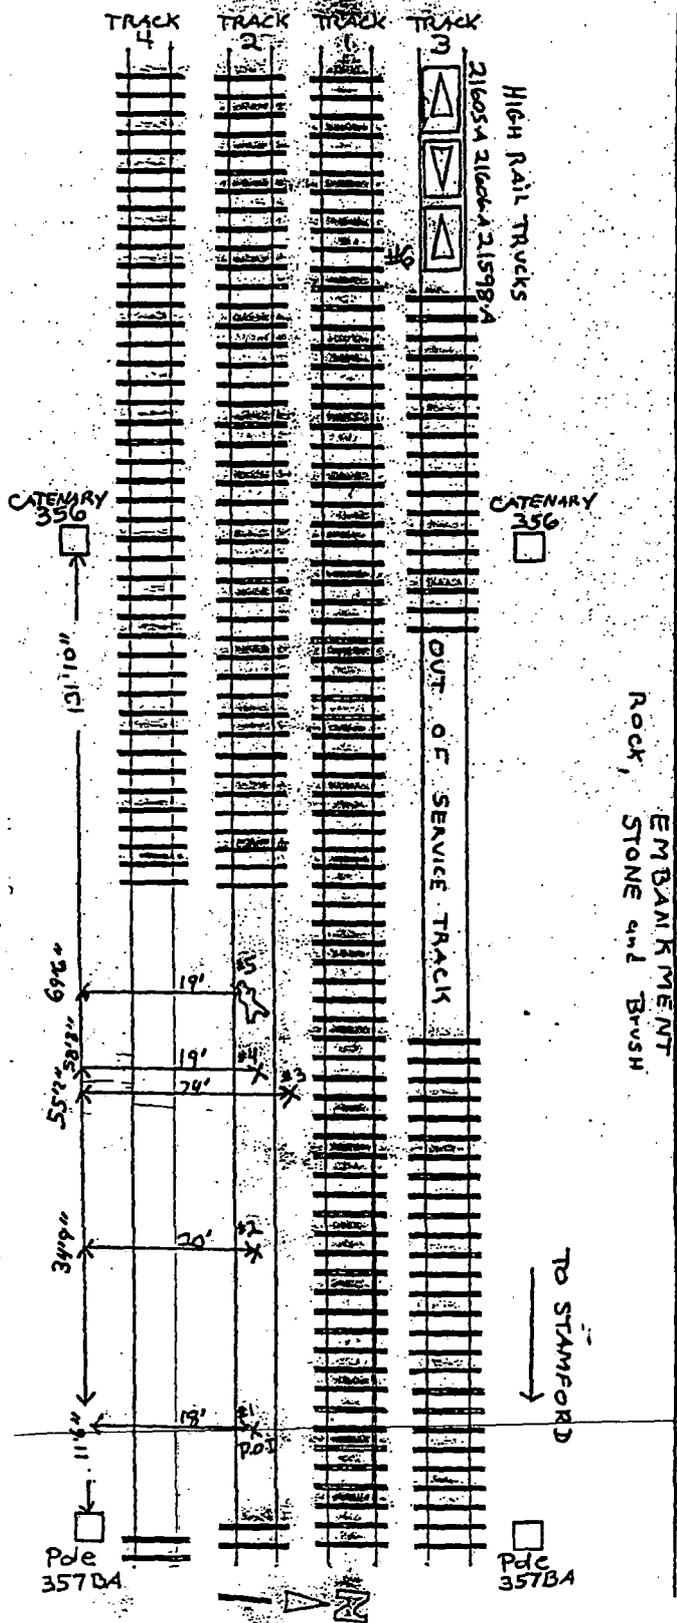
- #1- Point of Impact. Approx. 11'6" WEST of Pole 357BA and approx. approx. 18 feet North of the track #4 SOUTH TIE end. Within the gauge of track #2.
- #2- Radio battery pack within the gauge of track #2 and approx. 34'9" WEST of Pole 357BA and approx 20' NORTH of the track #4 SOUTH TIE end.
- #3- Victims RIGHT arm between the track #1 and #2, approx. 55'2" WEST of Pole 357BA, and approx. 24' NORTH of the track #4 SOUTH TIE end.
- #4- Upper portion of a RKPCO radio approx. 58'8" WEST of Pole 357BA and approx 19 feet North of the Track #4 SOUTH TIE end, and within the gauge of track #2
- #5- Body of the victim within the Gauge of track #2, and approx. 69'6" from Pole 357BA and approx. 19' NORTH of the TRACK #4 SOUTH TIE end.
- #6- A RED baseball style cap located between track #1 and 3 approx 200 feet WEST of the point of impact.

A cross-over is present between tracks #2 and #1 in this area and has been deleted from this diagram.

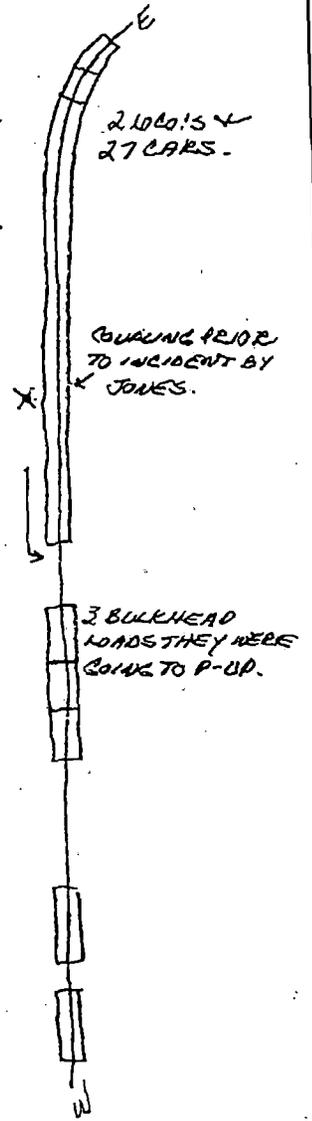
POSSIBLE CAUSE AT THIS TIME IS THAT AFTER MAKING
FIRST COUPLING, JONES WALKED BACK TO REAR OF CUT &
STEPPED INSIDE RAIL TO ADJUST COUPLERS. THE
ASSUMPTION IS THAT WHEN MAKING THE FIRST COUPLING
THE 3 BULKHEAD FLATS WERE KNOCKED WEST ABOUT 3
CARS ON A SLIGHT GRADE & WHEN JONES STEPPED
BETWEEN RAIL THE BULKHEAD CARS ROLLED BACK
EAST COUPLING JONES UP.

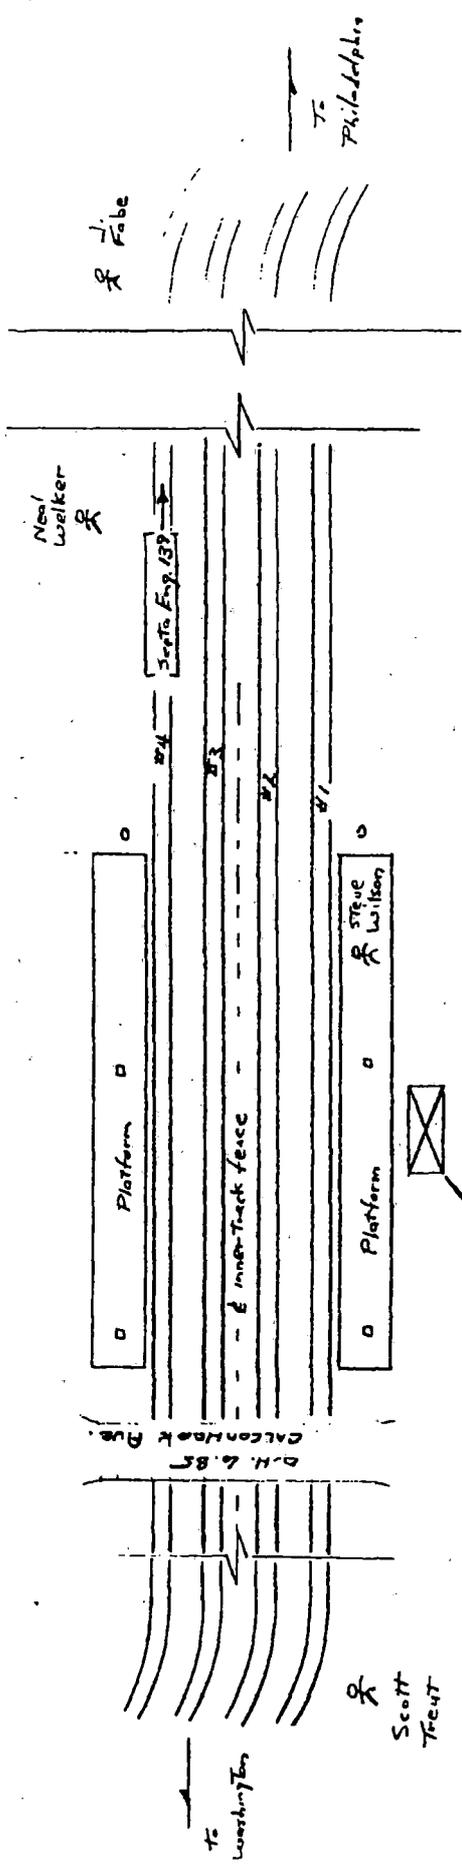
FRA has determined the failure of the northernmost Watchman to remain clear of the right-of-way as the probable cause of death; however, alcohol consumption may have caused him to be inattentive to imminent danger and contributed to his failure to remain clear of the right-of-way.

- Dimensions Approximate
 - Locations of Watchmen as stated themselves.

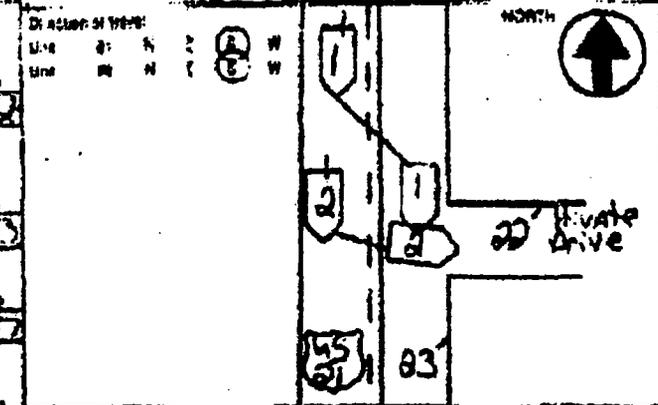
Unit #1 was making a legal pass. The driver of Unit #2 made an improper left turn into the path of Unit #1. Unit #1 struck Unit #2 in the left side.
