***Federal Railroad Administration
Office of Railroad Safety
Accident and Analysis Branch***

***Accident Investigation Report
HQ-2015-1024***

***BNSF Railway Company (BNSF)
Galena, IL
March 5, 2015***

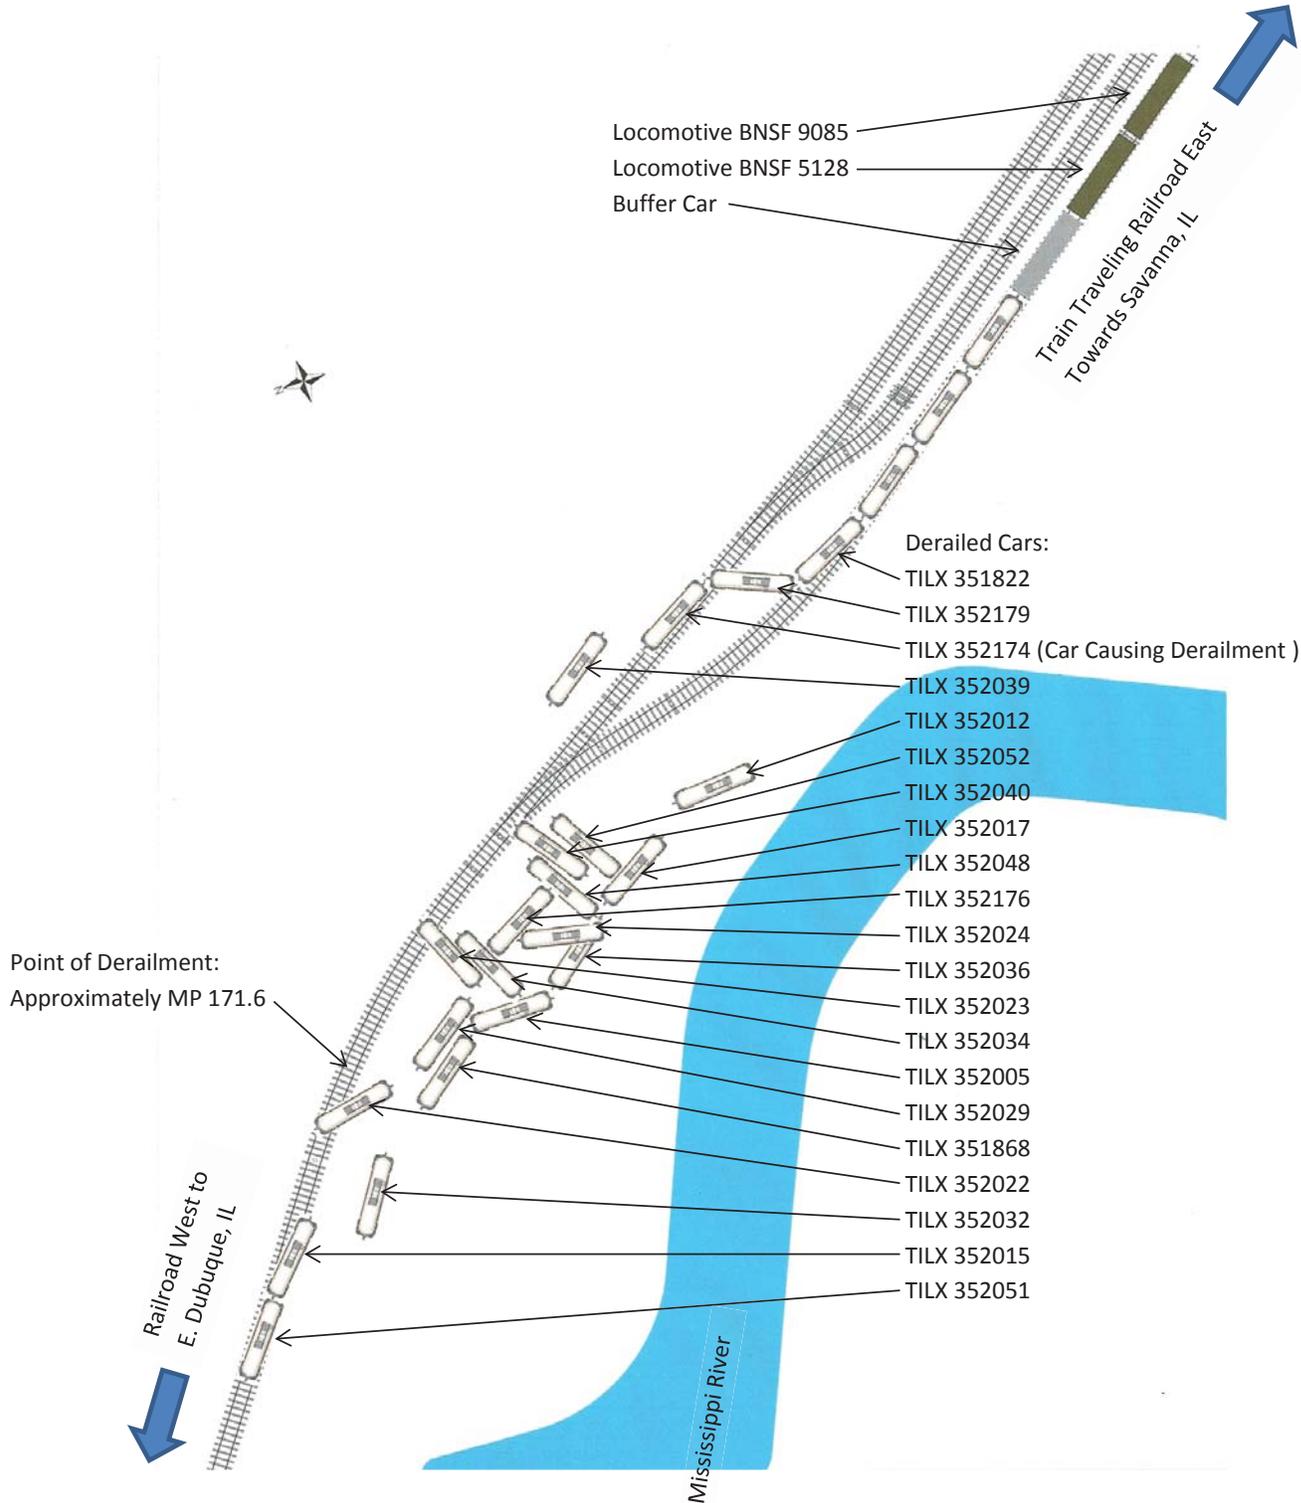
Derailment sketch Showing Car Numbers

A total of 21 cars derailed, positions 5-25, all of which were loaded crude oil tank cars. Fourteen of the cars were derailed accordion style. Thirteen of the tank cars lost product. Ten of the cars were breached (three cars lost lading on account of being consumed by fire and 7 cars developed heat tears).

A large enough portion of the wheel tread was broken off to allow the L1 wheel to fall to the inside of the south rail at the POD. This is consistent with the facts, as tank car TILX 352174 was found upright, east of the Galena Junction CP, with its wheels to the north side of their corresponding rails. After the L1 wheel of the tank car TILX 352174 fell into the gage of the single main track, it failed to negotiate the turnout which was lined for Main Track 2 at Galena Junction. It continued on the ground for approximately 150 feet past the turnout towards Main Track 1 and, due to the shelf style couplers, pulled the two cars to the east of it off the track. When tank car TILX 352174 failed to negotiate the turnout, it destroyed the turnout which made the track to the west of it impassable for the trailing cars.
