***Federal Railroad Administration
Office of Railroad Safety
Accident and Analysis Branch***

***Accident Investigation Report
HQ-2017-1193***

***CSX Transportation (CSX)
Newburgh, NY
March 7, 2017***

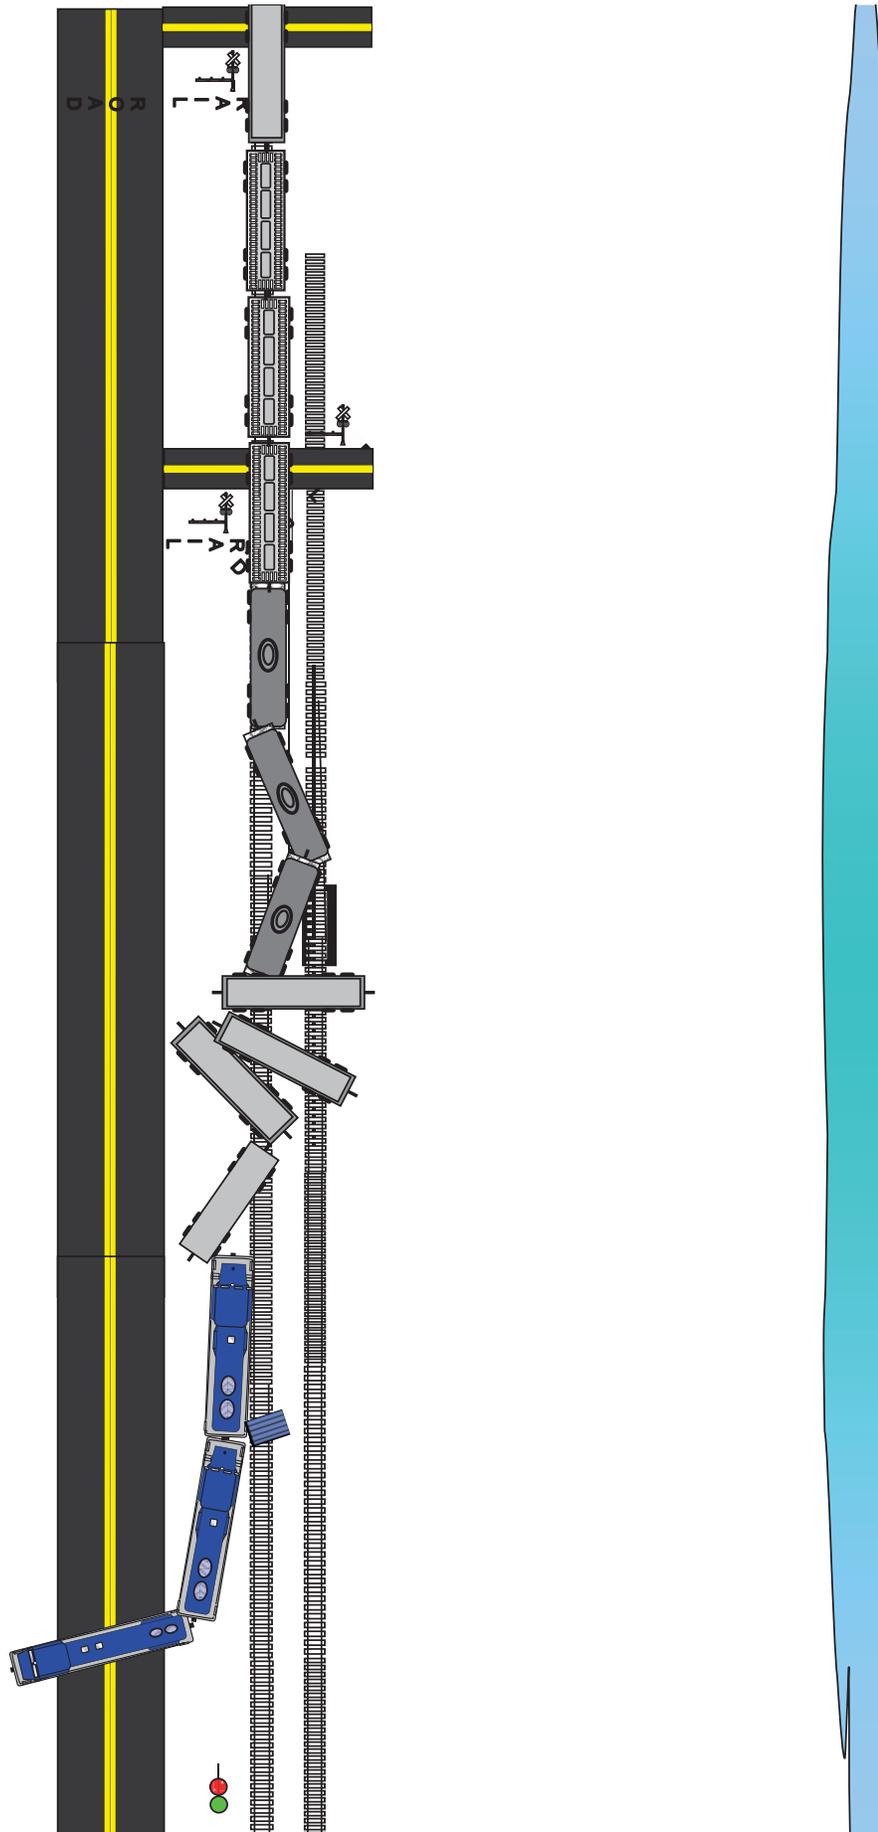
Sketch

The train struck the midpoint of the man lift just to the right of the front wheel. The man lift was carried south along the track for about 1,050 feet before bursting into flames from the propane tank strike by the lead locomotive. The man lift came to rest on the west side of the track. The train came to a stop about 200 feet southwest of this point. The man lift was a total loss and damage is estimated at approximately \$120,000.

As a result, the 20 head cars in the train derailed, 7 of which were placarded hazardous material. The seven hazardous material placarded cars remained upright and no release of hazardous materials occurred.

MOW Equipment: Equipment from the derailed CSX train struck stationary MOW equipment located on an adjacent siding. The track crew was waiting to receive track authority at the time of the derailment. CSX tamper MT5410 and CSX ballast regulator BR201318 were totally destroyed as a result of the train derailment. Two of the three MOW employees, one occupying the tamper and one occupying the ballast regulator, received non-life-threatening injuries and were taken to a local hospital for treatment. The third track employee was a Forman sitting in a truck beside the track equipment. After the train stopped, the Conductor and Locomotive Engineer exited the locomotive and awaited the arrival of emergency response personnel. The Engineer stated that local police arrived within minutes, and that, shortly after, he was asked to shut down the locomotives by emergency responders. Approximately 1 hour after the accident, a CSX Trainmaster arrived and took the crew to the hospital for evaluation. The train crew was treated and later released from the hospital and driven by the Trainmaster back to Selkirk, their home terminal.
