***Federal Railroad Administration
Office of Railroad Safety
Accident and Analysis Branch***

***Accident Investigation Report
HQ-2017-1228***

***Kansas City Southern Railway Company (KCS)
Laredo, TX
September 14, 2017***

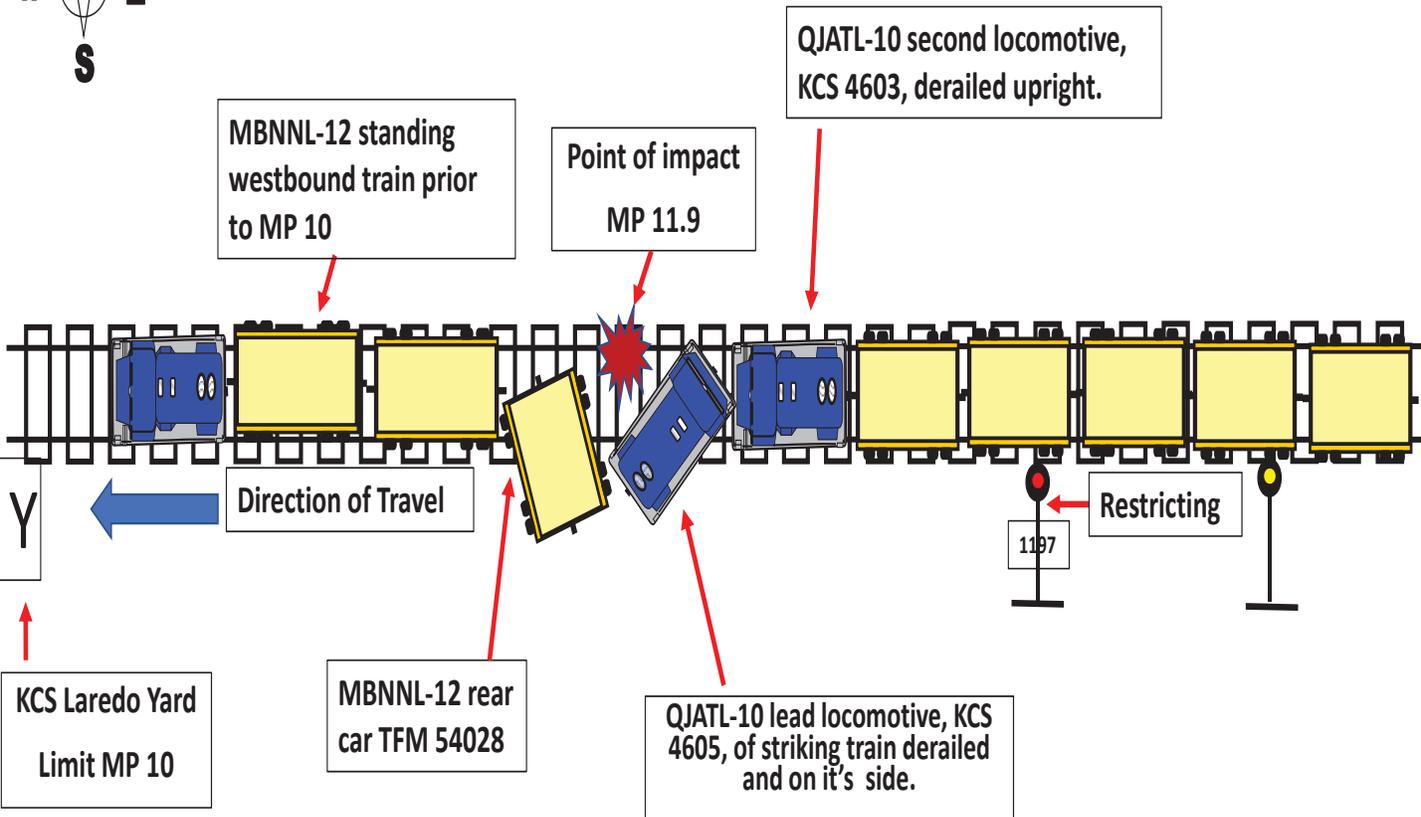
HQ-2017-1228 KCS Rear End Collision Laredo, TX

The struck train had stopped at or near Milepost 11.9 (East of Laredo Yard @ Milepost 10) awaiting yarding instructions from the manager on duty when they were struck on the rear by the striking train at a recorded speed of 14 mph. This resulted in the rear car of the struck train (TFM 54028 – empty gondola) to derail, along with the locomotive consist of the striking train. The lead locomotive, KCS 4605 turned

over onto the conductor side, and the rear locomotive, KCS 4603 derailed but remained upright. The method of operation is Centralized Traffic Control (CTC) with a maximum authorized speed of 50 MPH.
