**Federal Railroad
Administration**

Blunt Impact Tests of Retired Passenger Locomotive Fuel Tanks

1. AGENCY USE ONLY (Leave blank)		2. REPORT DATE August 2017	3. REPORT TYPE AND DATES COVERED Technical Report	
4. TITLE AND SUBTITLE Blunt Impact Tests of Retired Passenger Locomotive Fuel Tanks			5. FUNDING NUMBERS DTFR53-10-X-00061, RR28A3/NLL72

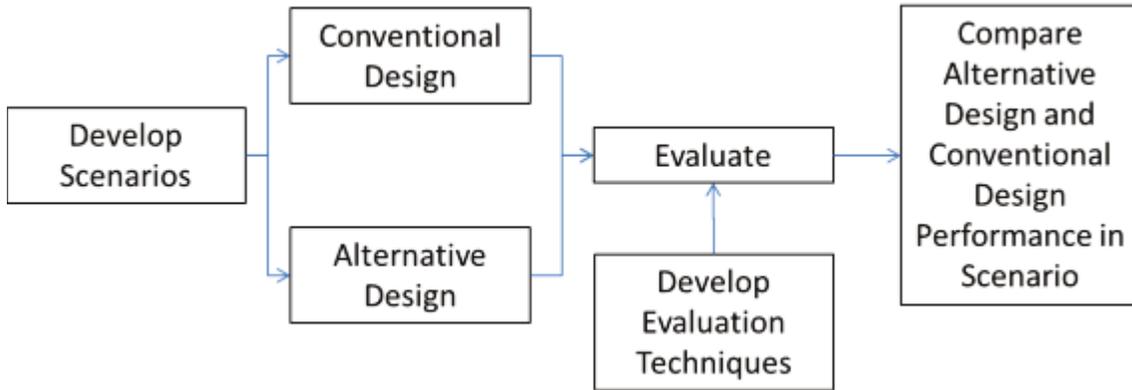
Figure 1. Flowchart Diagram of Fuel Tank Research Methodology

This research program included a combination of physical testing and computer simulations of a variety of fuel tank designs. Testing is planned to include fuel tanks of conventional, existing designs as well as tests of alternative designs. Testing on existing designs is intended to establish the baseline level of performance that would be expected to be met by an alternative fuel tank design. Figure 1 shows the overall flow of the passenger fuel tank crashworthiness research.

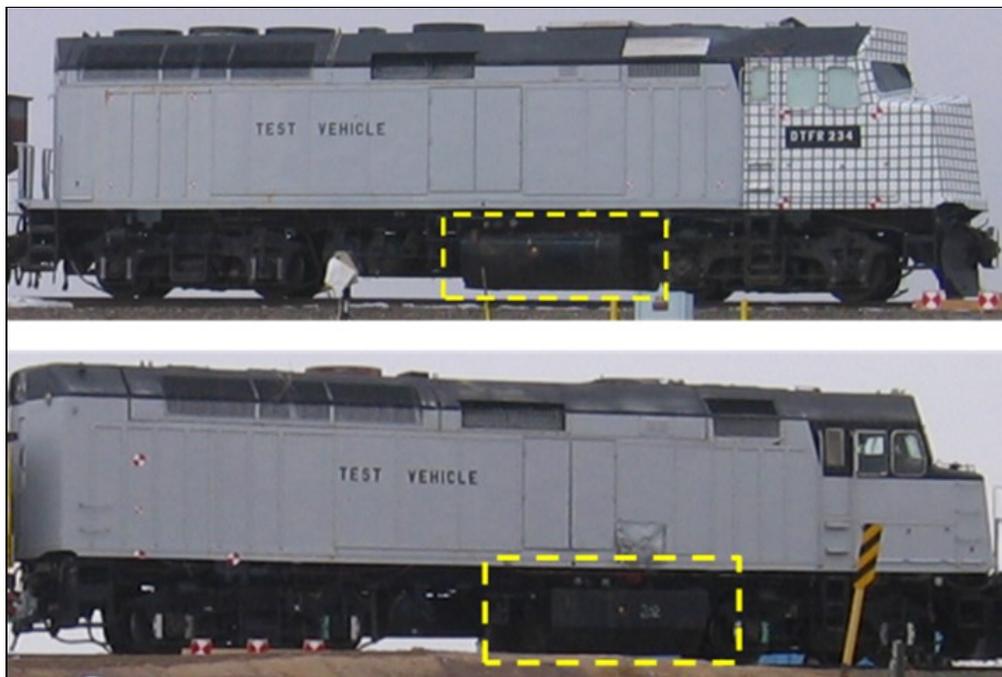
Figure 2. Typical Fuel Tank Placement on Two Conventional Passenger Locomotives

An additional issue related to the capacity of the fuel tank and its proximity to more people is the actual location of the fuel tank on the vehicle. On a typical passenger locomotive, the fuel tank is suspended beneath the underframe of the locomotive, and it is adjacent to a truck and/or other pieces of underframe equipment. Two passenger locomotives are shown in Figure 2, with the fuel tanks indicated beneath the underframes. This placement renders the fuel tank exposed to loading both from a side impact (e.g., a highway vehicle at a grade crossing, or a raking impact), or from a detached piece of underframe equipment (e.g., a detached truck) for a sufficiently severe accident.

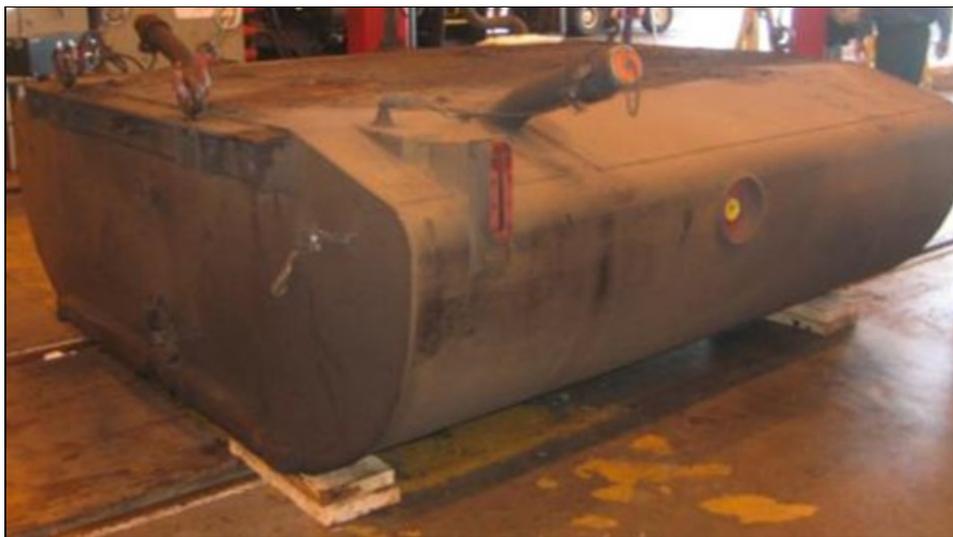
Figure 3. Concord, MA, Locomotive Fuel Tank

On Sunday, September 5, 2010, a Massachusetts Bay Transportation Authority (MBTA) locomotive struck debris on the track, and the bottom sheet of the locomotive’s fuel tank was punctured [9]. FRA Region I personnel and Volpe staff conducted an examination of this locomotive fuel tank at MBTA’s Somerville, MA, locomotive shop. The locomotive involved in this incident was an F-40 type locomotive with a fuel tank of similar construction to tanks 232 and 234 in the impact testing program. This locomotive was constructed in the late 1970s, including this fuel tank. The fuel tank involved in the puncture is shown in Figure 3.

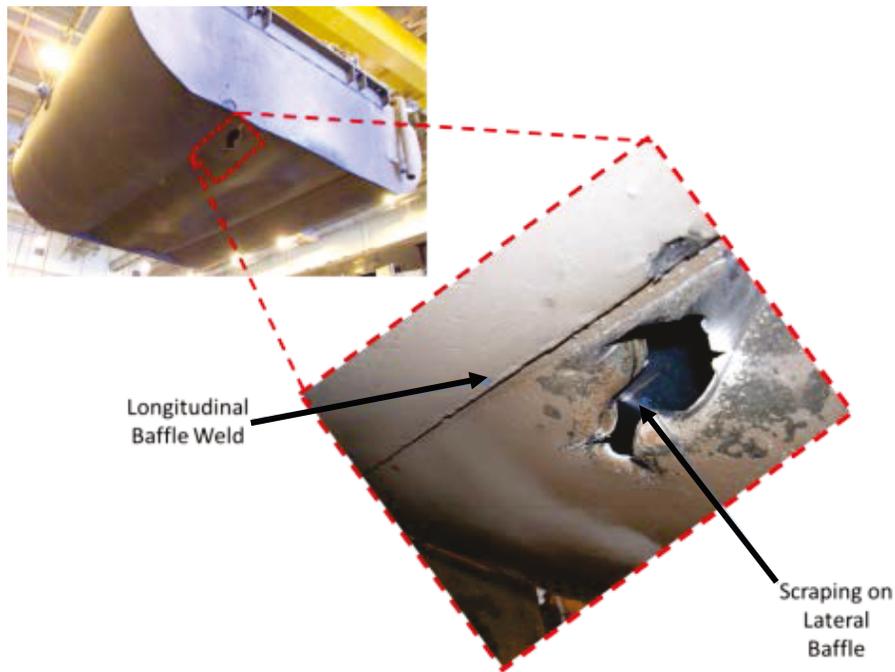
adjacent to both a longitudinal and a lateral baffle, as Figure 4 shows. The damaged area also includes scuff marks on the bottom of the lateral baffle, which indicated apparent contact either between the struck object or the punctured bottom sheet and this baffle.

Figure 4. Puncture on Bottom Sheet (Concord, MA)

Examination of the fuel tank revealed a single puncture to its bottom sheet in the center lobe toward the leading end of the fuel tank. Judging from the marks on the bottom of the tank, it appeared that the struck debris scraped along the bottom surface of the tank until encountering the change-in-stiffness adjacent to the baffles, when it caused a puncture. This puncture occurred

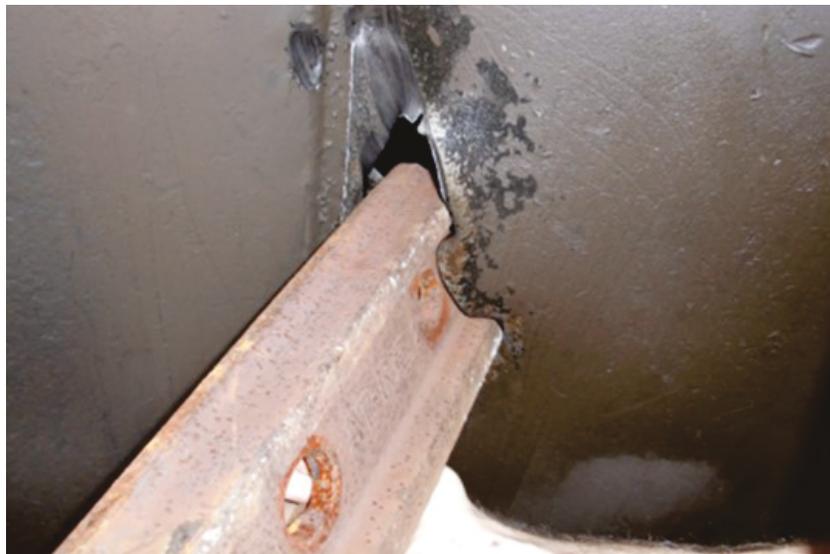
From examining the size and the shape of the punctured bottom sheet as well as discussions with MBTA personnel, it appeared that the puncture was caused by a joint bar which had been placed upon the track by vandals. Figure 5 shows an exemplar joint bar compared with the puncture. Unfortunately, it is not known at what speed the locomotive was traveling when this incident occurred.

Figure 5. Joint Bar and Puncture (Concord, MA)

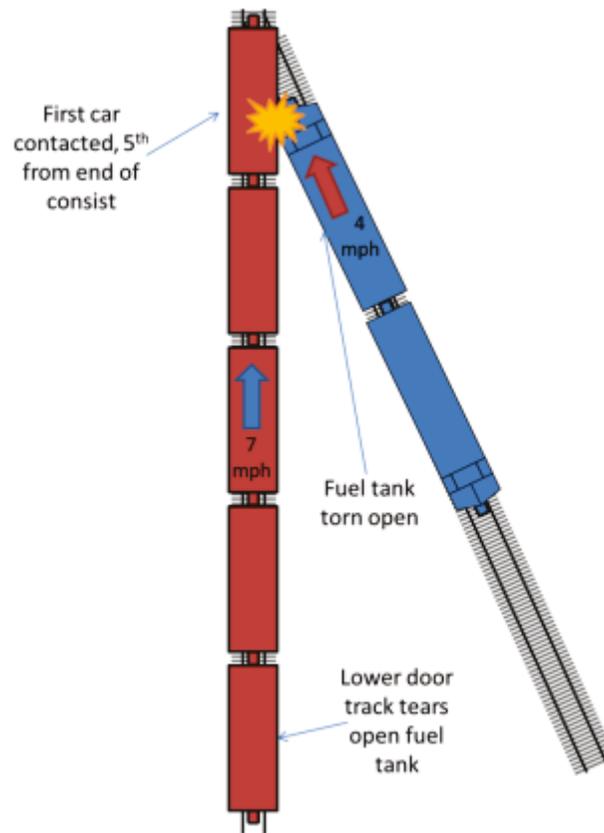
Figure 6. Schematic View of Oak Island Raking Collision

On April 28, 2012, a raking impact collision occurred at Oak Island Yard in Newark, NJ. In this incident, two locomotives rolled into a switch while the trailing end of another freight consist was still passing through. Figure 6 shows a diagram of the accident. The freight consist that was traveling through the switch was moving at approximately 7 mph and the rolling locomotives were moving at approximately 4 mph at the time of collision. As a result of this collision, the lead locomotive's fuel tank (manufactured in 1977) was ruptured and the spilled diesel fuel ignited, resulting in a fire and damage to the leading locomotive.

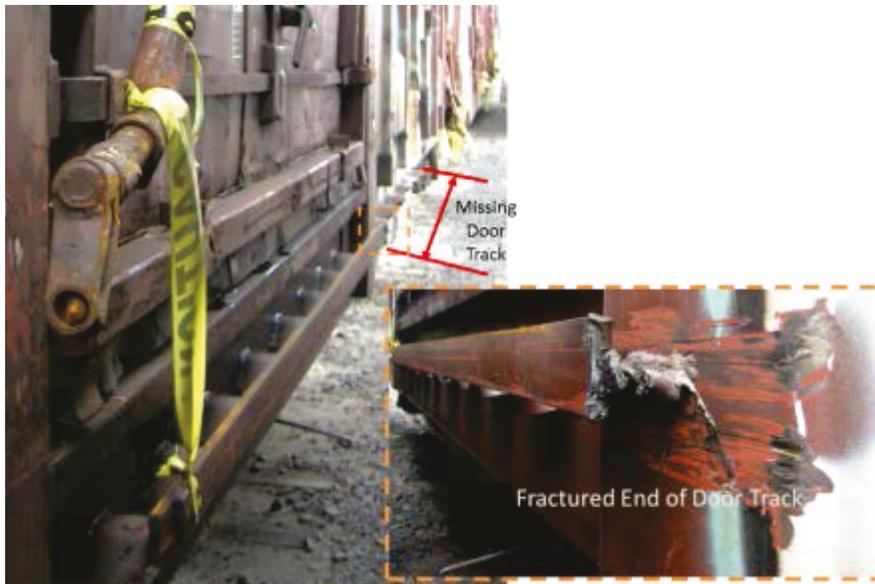
The last five cars of the moving consist struck the locomotives, and the door track on the last boxcar tore a gash into the locomotive fuel tank along nearly its entire length. Figure 7 shows this boxcar after the collision, with the missing length of door track indicated. The inset image shows the fractured end of the door track, which remained attached to the boxcar.

Figure 7. Fractured Door Track on Trailing Boxcar (Oak Island)

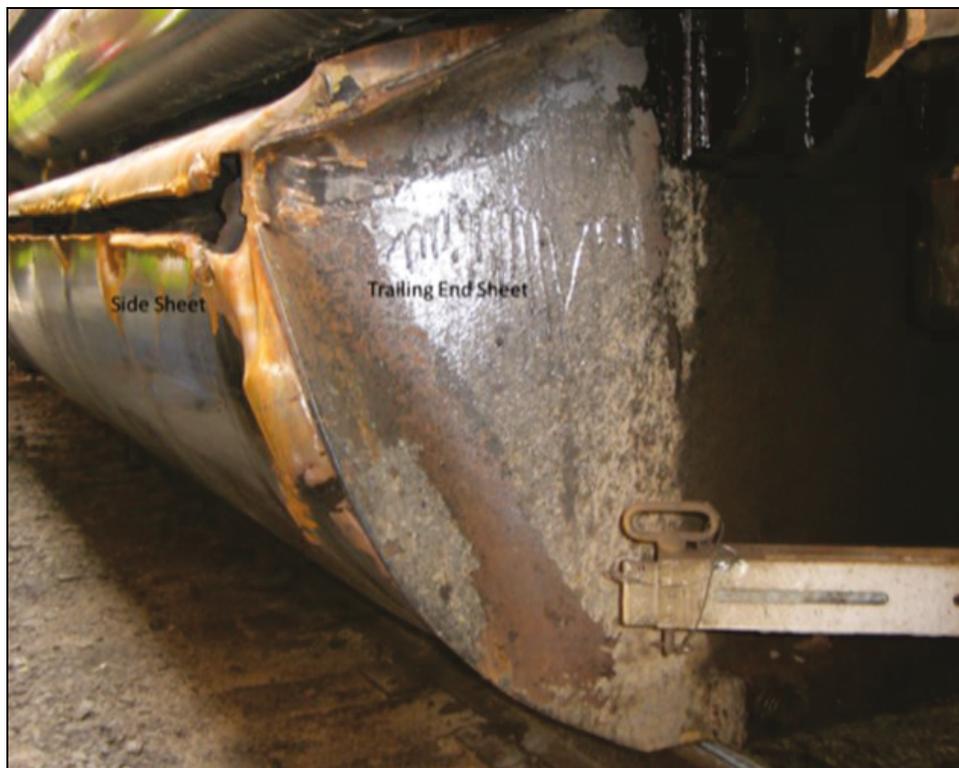
The door track struck the trailing end sheet of the lead freight locomotive, but did not puncture this sheet. The end sheet deformed, and the force on the end sheet appears to have buckled the side sheet, causing it to bulge outward. The door track then punctured the buckled portion of the side sheet as the boxcar continued to move past the locomotive. Figure 8 shows the trailing end of the punctured fuel tank.

Figure 8. Damage to Trailing End Sheet and Side Sheet (Oak Island)

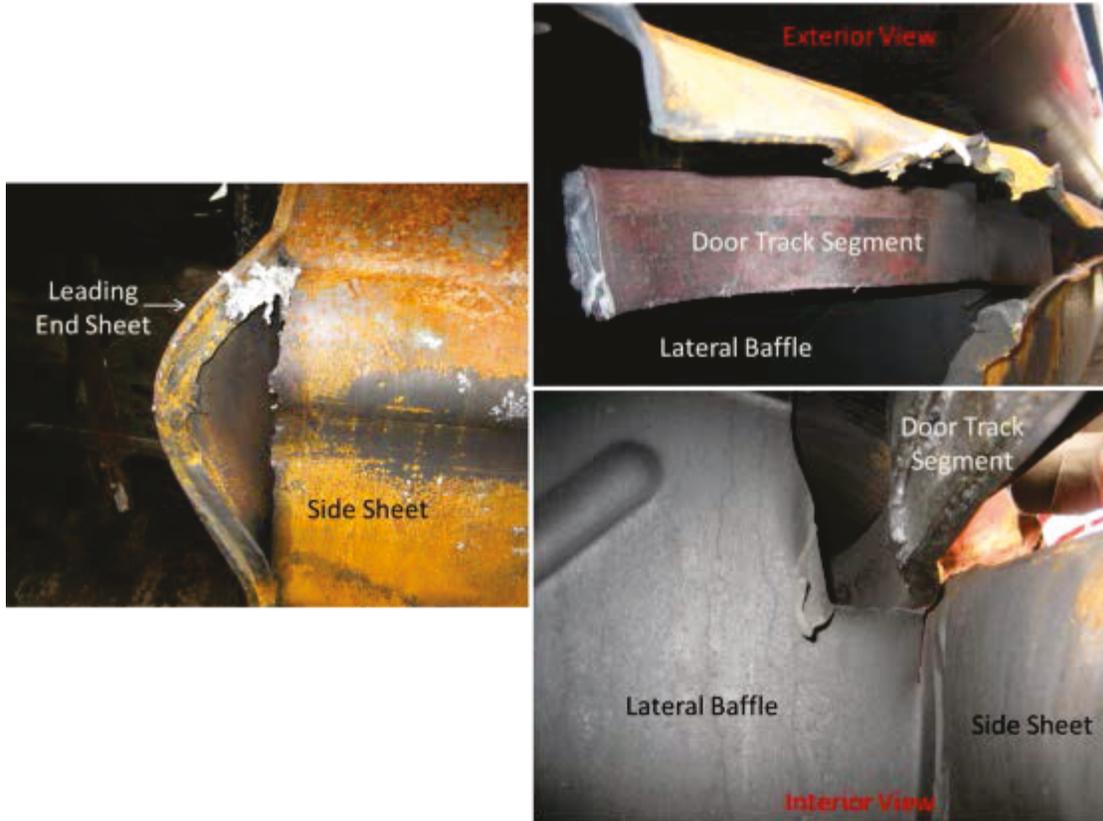
The door track tore through several baffles and tore the lead end sheet away from the side sheet of the fuel tank. The portion of door track that had been torn away from the boxcar was found inside the lead locomotive's fuel tank. Figure 9 shows the torn side sheet and the lead end sheet. As can be seen in this image, the lead sheet itself did not tear. The separation occurred either through tearing of the side sheet or the weld between the side sheet and the leading end sheet.

Figure 9. Damage to Leading End of Fuel Tank, Side Sheet, and Baffles (Oak Island)

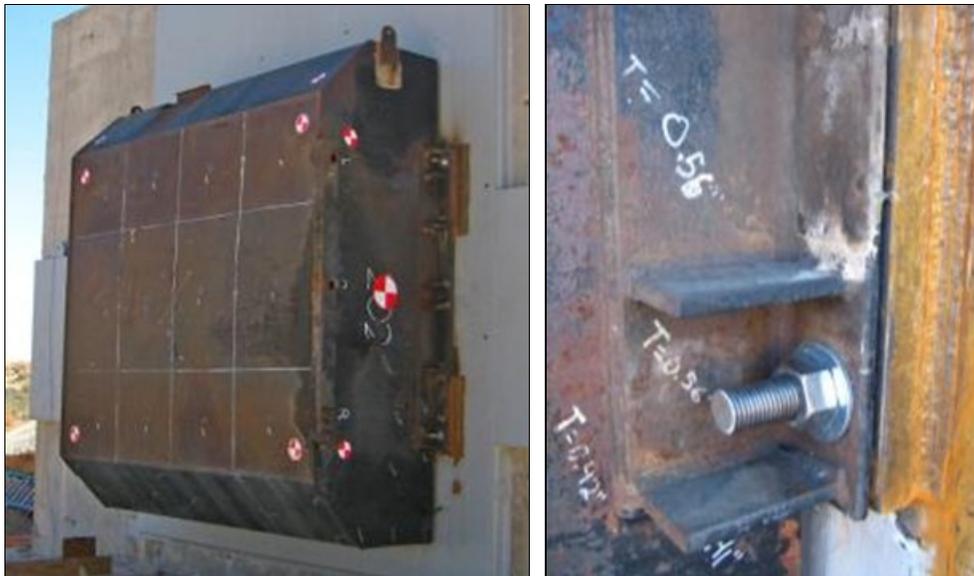
All fuel impact tests were conducted on the impact wall at the Transportation Technology Center (TTC). Mounting brackets were built by TTCI to support the fuel tanks on the impact barrier face. The brackets were aligned with the existing connections on each fuel tank, and the mounting method created a support condition similar to what would occur for a fuel tank installed under a locomotive. Figure 10 shows a test fuel tank that had been mounted on the impact wall.

Figure 10. Test Fuel Tank Mounted on the Impact Wall

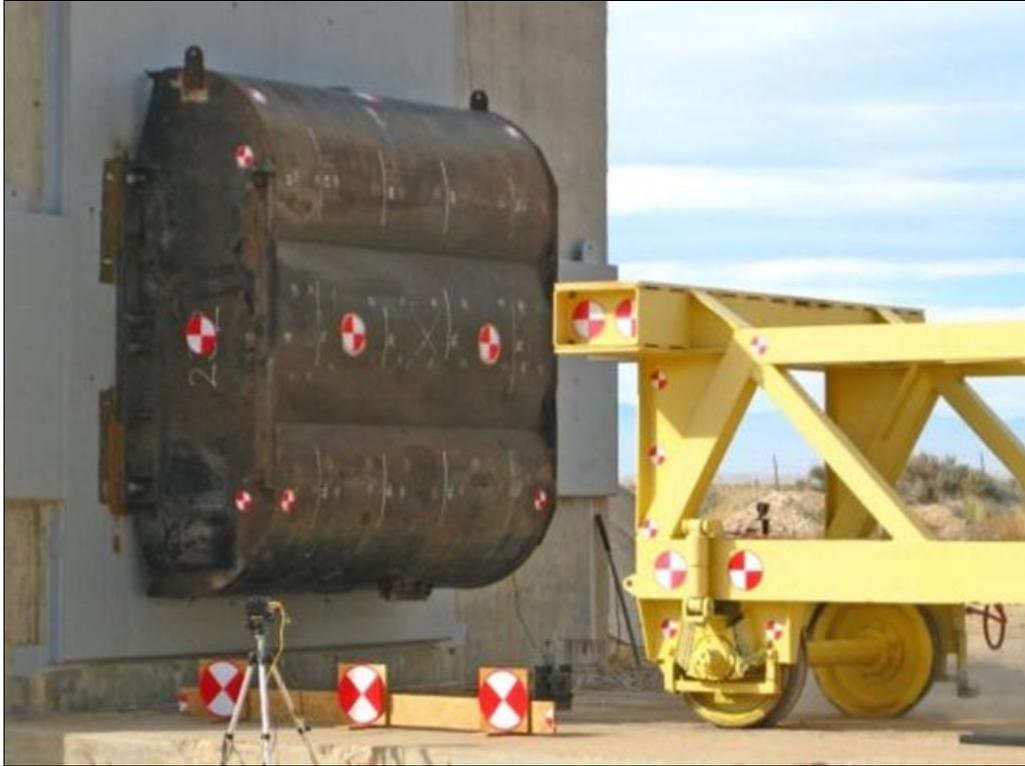
FRA, Volpe, and TTCI collectively developed the test requirements contained in this report. Three fuel tanks were set up for individual impact tests. The fuel tanks were supported directly on the impact wall as described in Section 3.1. Two of the fuel tanks (202 and 232) were positioned to align with a 12-inch by 12-inch indenter for the center impact. Fuel tank 234 was offset from the center in the horizontal direction. Figure 11 illustrates the test setup and fuel tank mounted to the impact wall.

Figure 11. Test Setup

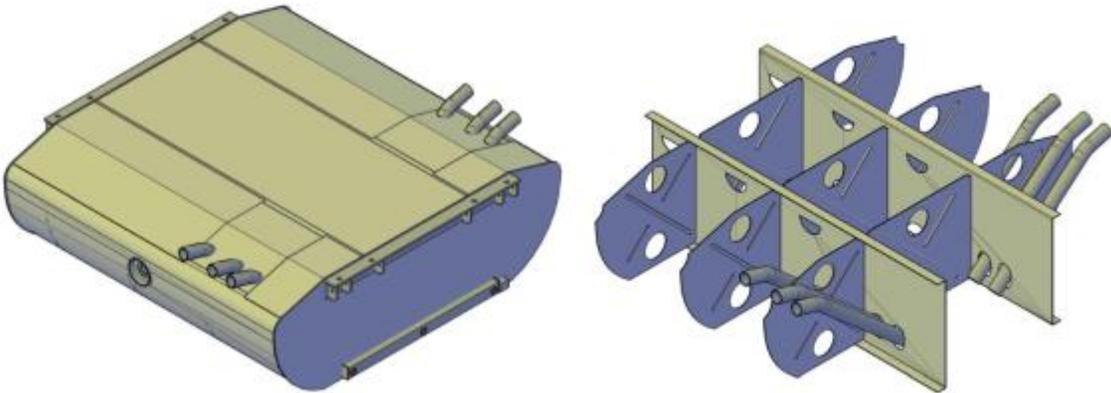
Figure 14. Fuel Tank 234

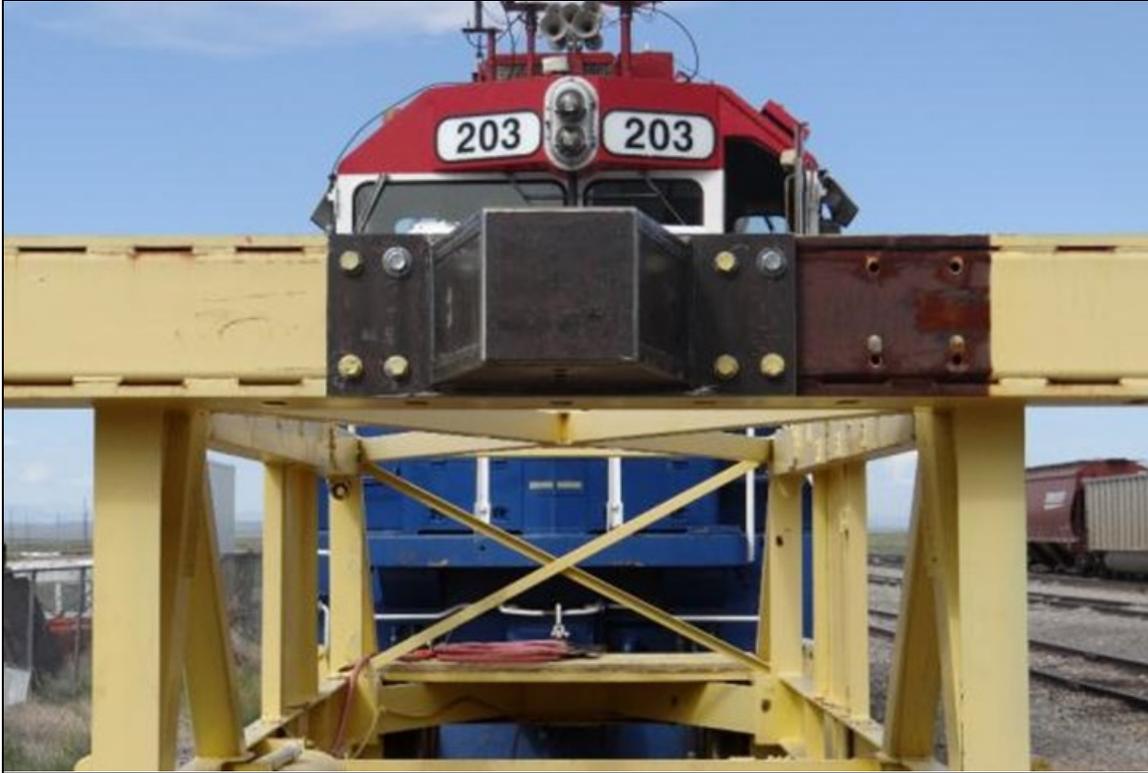
Figure 15. Impact Cart with Indenter Attached

calibration runs carried out beforehand on the adjacent Precision Test Track at TTC and adjusted on the basis of the wind speed and the wind direction before the start of the test. During these speed calibration runs, a radar speed measuring system was used to precisely measure the speed of the impact cart.

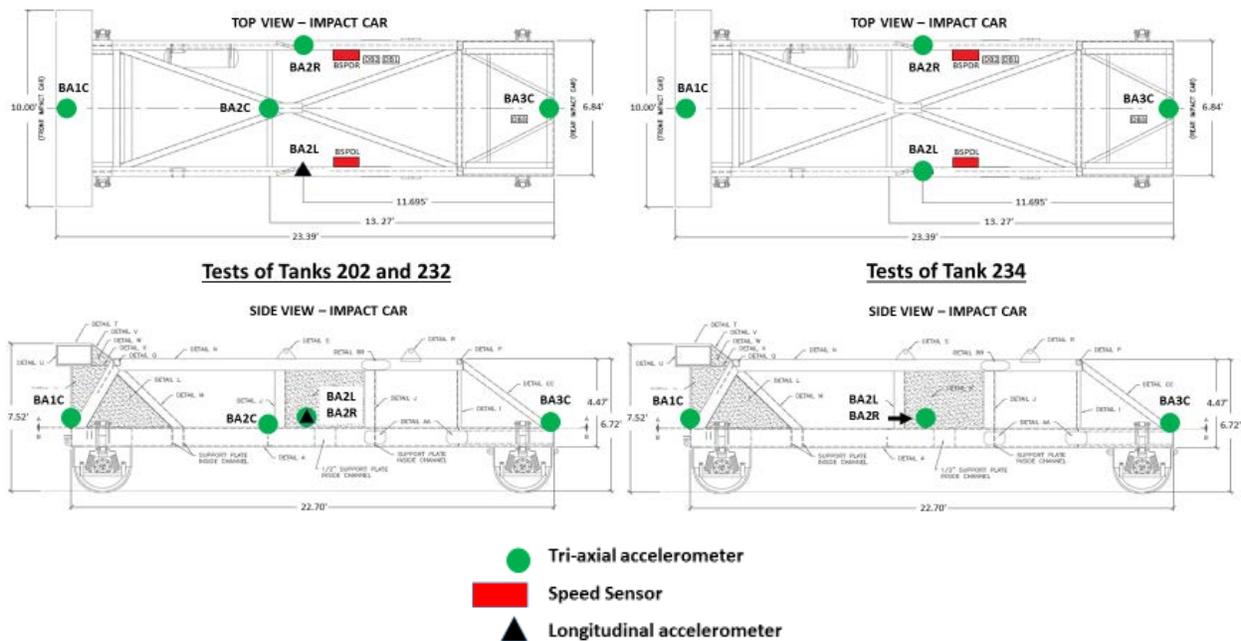
Figure 16. Accelerometer Locations on Impact Cart for Tests of Tanks 202 and 232 (left) and Tank 234 (right)

Type of Instrumentation	Channel Count
Accelerometers	13 (12 for 3rd test)
Speed Sensors	2 (all tests)
Total Data Channels	13 (14 for 3rd test)

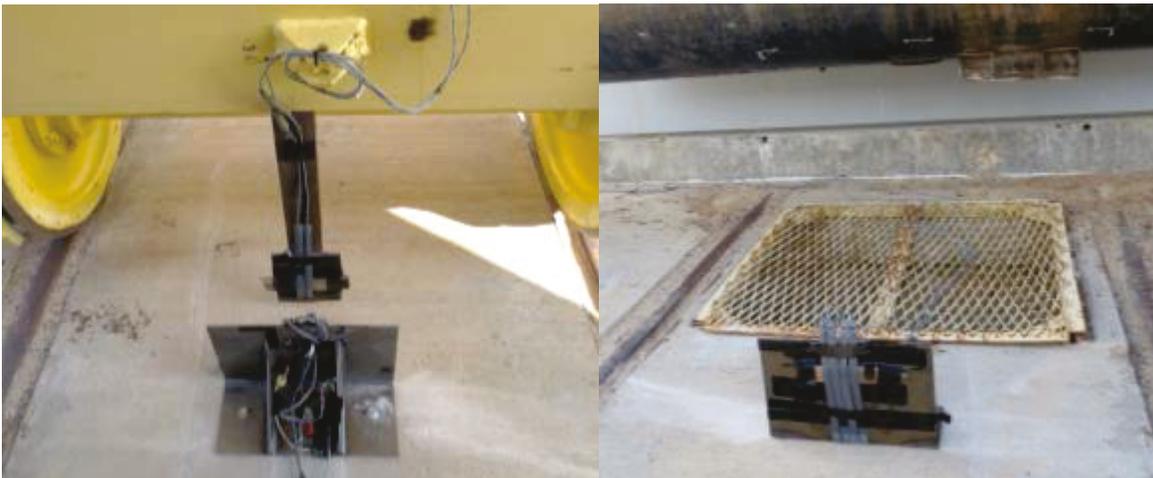
During the test of fuel tank 232, the tape switches onboard the impact cart and on the ground were arranged as shown in Figure 17. Tape switches on the impact cart, which were used to activate data storage and indicate $t=0$ for the onboard instrumentation, were installed below the cart on an arm that was designed to break away from the cart at a fairly low level of force, thereby reducing the kinetic energy of the impact cart by a negligible amount. A separate plate was attached securely to the ground, with tape switches used to trigger high-speed cameras. On each plate, the tape switches were offset from the plate by a 0.5-inch thick piece of plywood. The wood was arranged to result in shear of the tape switches when the switches on the impact cart made contact with the switches on the ground.

Figure 17. Trigger Switch Arrangement for Tank 232 on Cart (left) and Ground (right)

the mechanism for activating the switches in the test of tank 232 was shear resulting from an offset between the plywood on the cart and on the ground. However, the mechanism for triggering in subsequent tests relied on the sharp peak formed by the steel section pinching the switches against the wooden block.

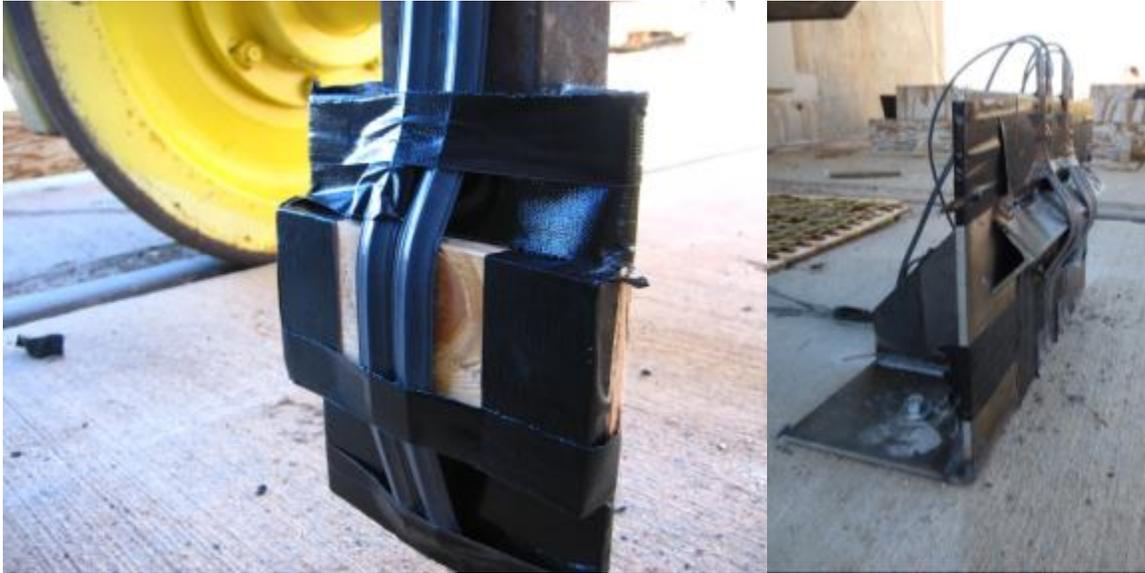
The trigger arrangement was modified for the subsequent tests of tanks 202 and 234. In order to increase the certainty that all switches would trigger and that triggering would occur at the same time for all switches, the wooden block on the ground plate was replaced with a steel L-section, which was arranged (Figure 18) to form a peak behind the switches. The plywood behind the switches on the cart was replaced with a piece of solid wood that spans a larger area. Originally,

Figure 18. Trigger Switch Arrangement for Tank 202 on Cart (left) and Ground (right)

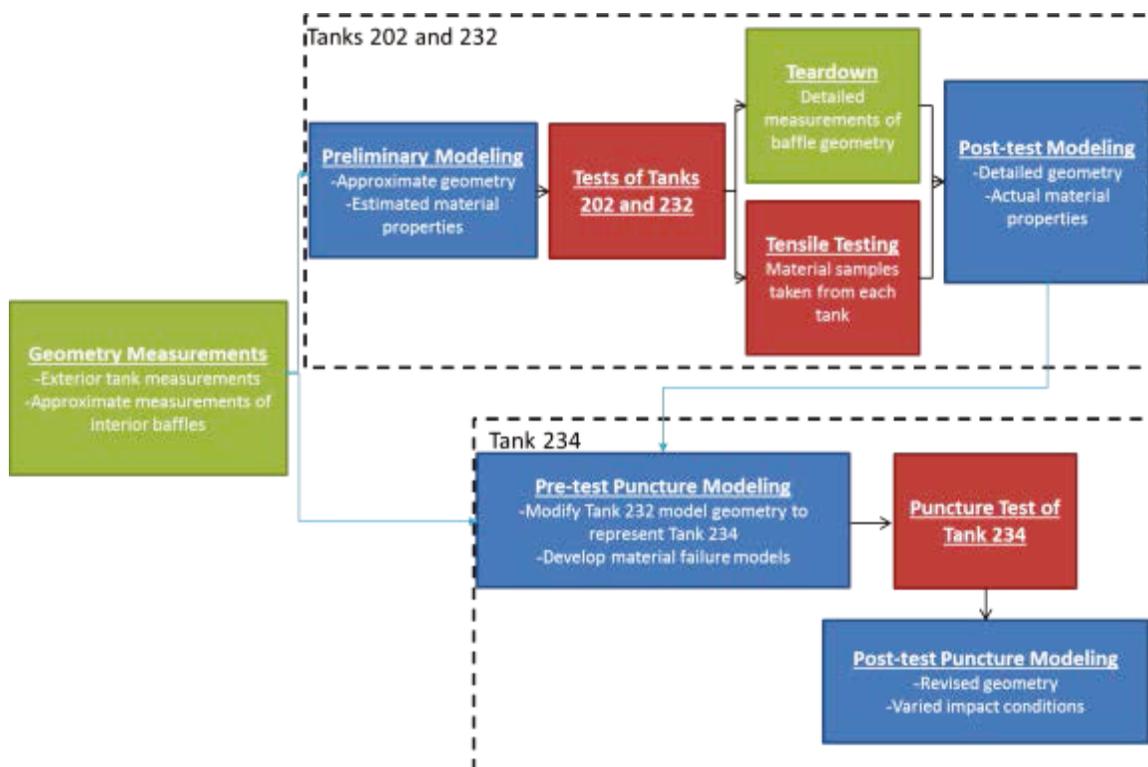
Following each test, post-test modeling was performed to include newly discovered information about each tank. The new data was generated from post-test teardown of the test article such as internal geometry details and material properties. Because a major goal of this program was to evaluate the test setup and test conditions, the testing program was conducted in two phases. This allowed the team to take lessons learned in the first phase of testing and implement them in the second phase. Figure 19 contains a flowchart of the overall process of generating model input through measurements, pre- and post-test modeling, and impact testing.

Figure 19. Flowchart of Modeling and Testing Process

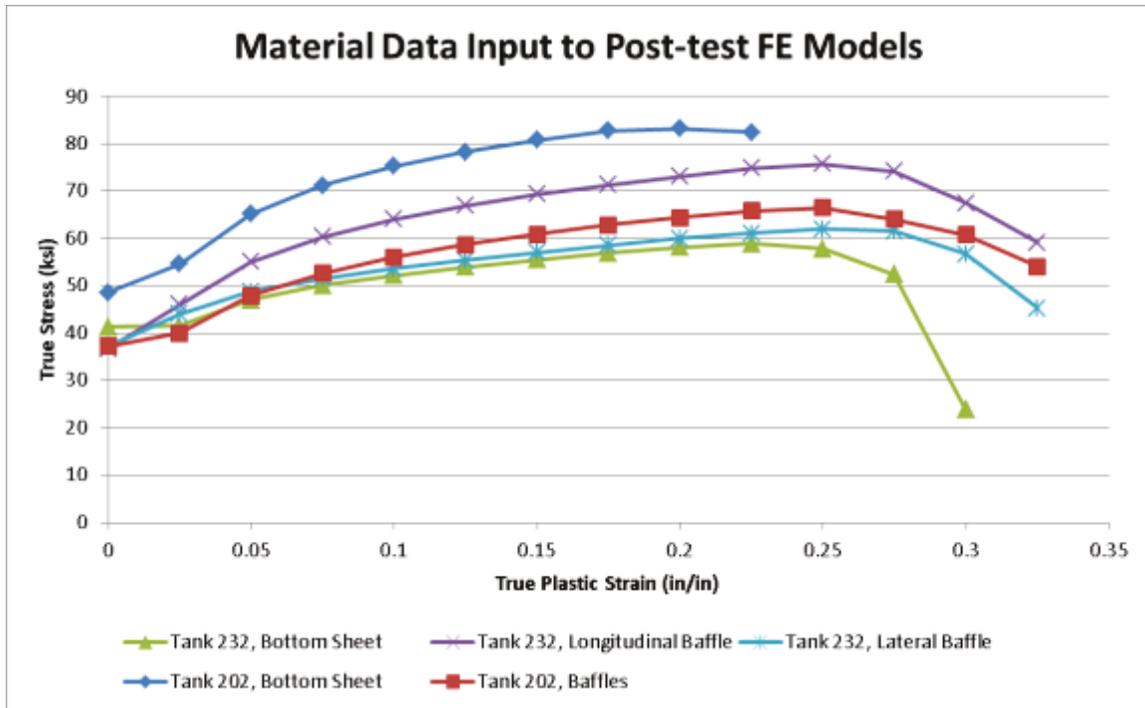
The material properties obtained through tensile testing were used to update the post-test models of the respective tanks. A complete description of the tensile test results and the implementation of the material behaviors within the FE models can be found in Appendix B. Figure 20 shows the true stress-true plastic strain behaviors that were input into the post-test models of tanks 202 and 232.

Figure 20. True Stress-True Plastic Strain Characteristics for Tanks 202 and 232, Post-test FE Models

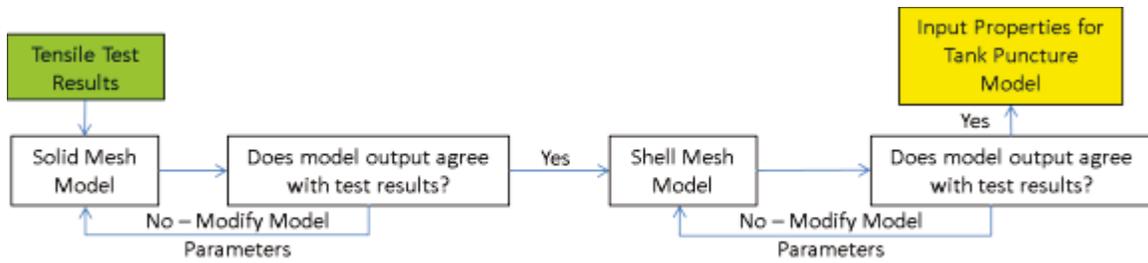
Previous FRA-sponsored impact testing and analysis programs in the field of tank car puncture [14] and end frame integrity [15] included FE modeling of material failure. In both efforts, the failure model chosen uses a combination of PEEQ strain and triaxiality to determine when material fracture has initiated. This approach is referred to as the Bao and Wierzbicki (B-W) method. [16] Figure 21 diagrams the overall approach to material modeling used by Volpe in this research program. This technique involved tensile testing, FE modeling of the tensile testing using solid and shell elements, and refinement of the material parameters used in the FE model of the tensile tests until a suitable agreement was reached between the model and the actual tests.

Figure 21. Process for Derivation of Material Properties for Tank 234 Puncture Model

with respect to PEEQ), following a similar process as shown in Figure 21. Figure 23 shows the post-test B-W envelopes used for tank 234. The best agreement resulted from a PEEQ shift of 0.1.

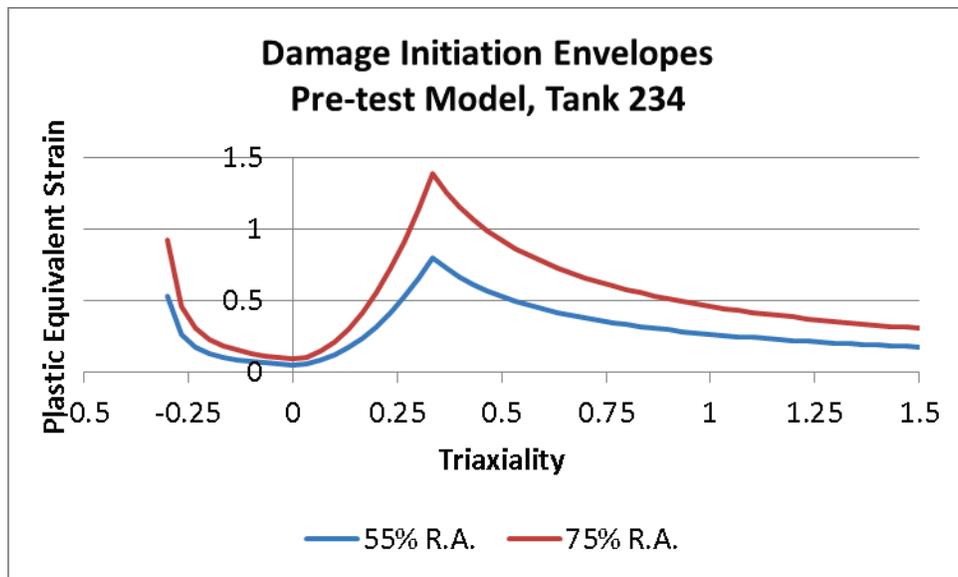
The pre-test material modeling for tank 234 used an approach derived from the B-W method that had been previously employed in tank car research that utilized a “quick calibration” method of deriving the baseline B-W envelope using the results of a uniaxial tensile test. [17] Several adjustments were made to the baseline failure initiation envelope that resulted from the modified quick-calibration method. As had been done with previous B-W envelopes developed during tank car research performed by Volpe, the cusp shown on Figure 22 was manually adjusted to occur at a triaxiality of one-third [18]. A second adjustment to the curve was made to enable use of this failure initiation technique with shell elements in the FE model. The baseline B-W characteristic was derived using the average measured reduction in area of the tested material coupons, which was approximately 75 percent. In order to use the B-W envelope with shell elements, the effective reduction in area was varied until the results of the simulation of the tensile test were in good agreement with the results of the tensile tests themselves. Figure 22 shows the initial 75 percent reduction in area envelope as compared with the 55 percent reduction in area envelope, which was found to give the best agreement in a shell element model.

Figure 22. Pre-test Damage Initiation Envelopes for Tank 234

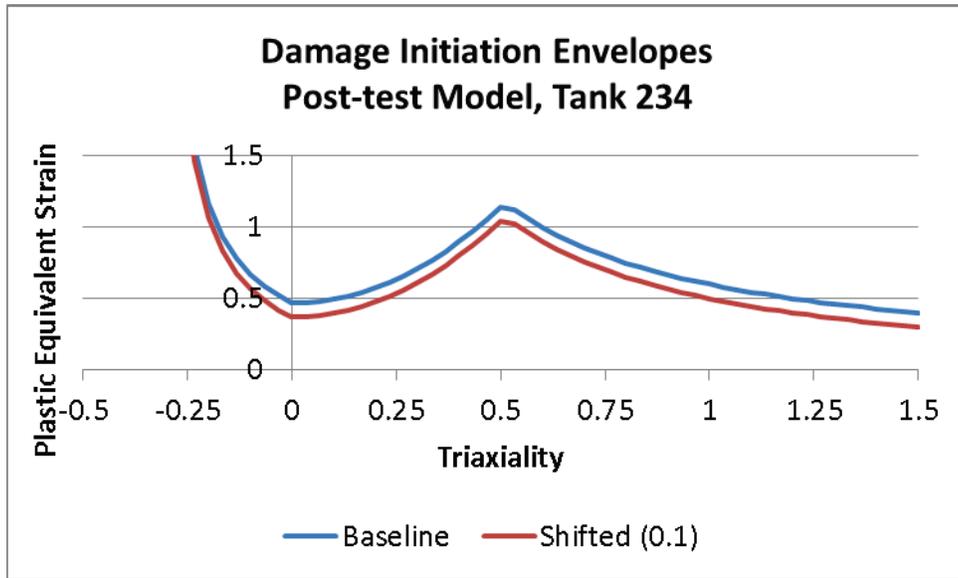
Figure 23. Post-test Damage Initiation Envelopes for Tank 234

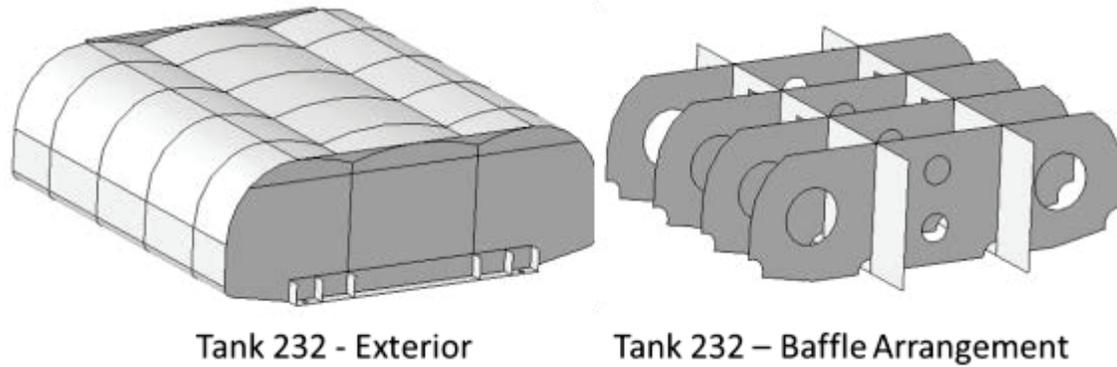
The exterior geometry of tank 232 and its internal baffle arrangement, as implemented in the pre-test model, are shown in Figure 24. In this image, the fuel tank has been inverted from its normal operating position when attached to a locomotive. This tank featured three distinct lobes on its bottom sheet. Internally, a longitudinal (parallel to the rails) baffle ran the length of the tank at the intersection of each side lobe with the center lobe. Tank 232 featured four lateral baffles with approximately equal spacing along the length of the tank. These baffles featured cutouts to permit fuel to flow from one compartment to the next. Additionally, there was a gap between the lowest point of each bottom sheet lobe and the lowest point of each lateral baffle, presumably to permit fuel to flow beneath each baffle.

Figure 24. Exterior and Baffle Arrangement for Tank 232 Pre-test Model

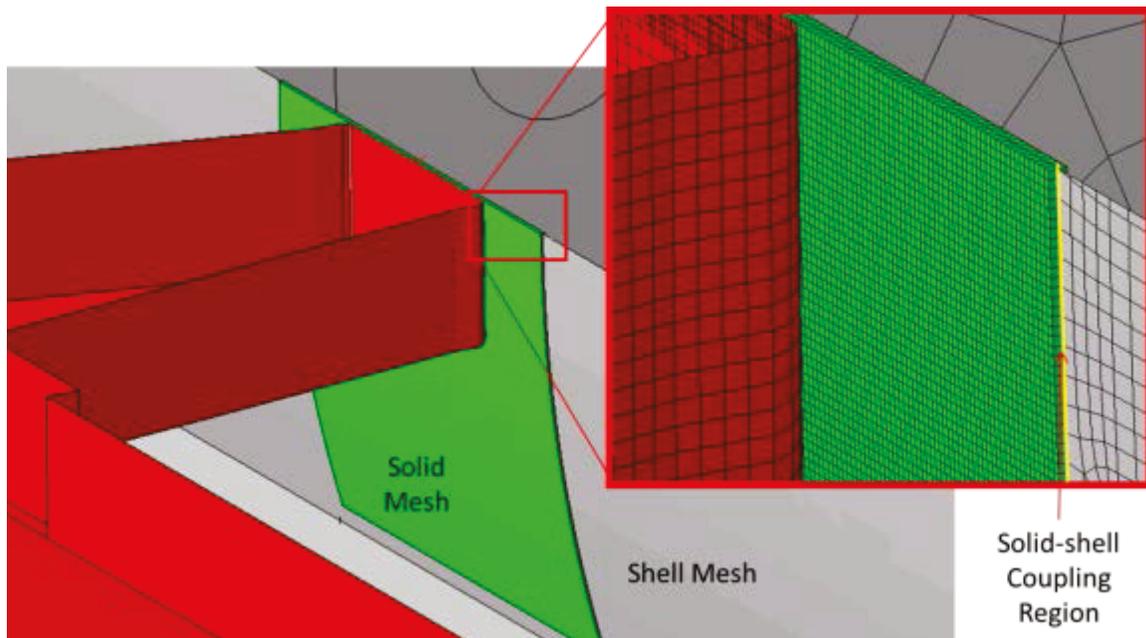
In the pre-test model of tank 232, a simple shear failure criterion was used to allow element removal to occur, simulating puncture of the tank. Solid (hexahedral) elements were used to model the impact zone on the bottom sheet of the tank, where puncture could potentially occur. Two solid elements were meshed through the thickness of the tank. Outside of the impact zone, shell elements were used to model the remainder of the tank. At the interface between the solid mesh and the shell mesh, a technique known as shell-to-solid coupling was employed to attach the two different mesh types to one another. The impact zone of tank 232 is shown in Figure 25. This figure also shows the rigid 14-kip 12-inch by 12-inch impactor used to strike the tank.

Figure 25. Solid Mesh on Tank 232 Pre-test Model

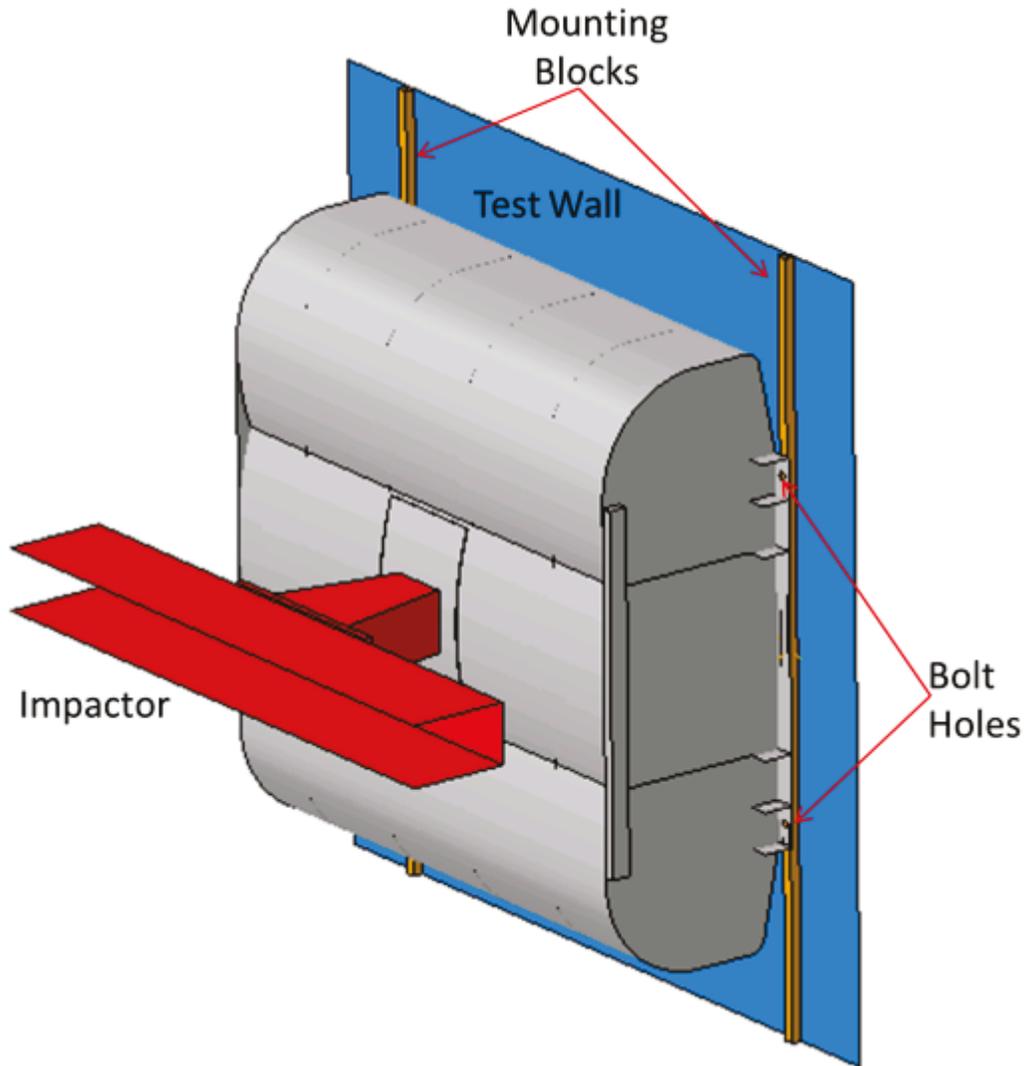
sides of the tank, effectively pinning the tank against its mounting blocks. A rigid representation of a 12-inch by 12-inch impactor, which had a weight of 14 kips, was given an initial velocity and allowed to contact the bottom surface of the tank. The rigid impactor was only permitted longitudinal motion, with boundary conditions preventing vertical or lateral motion. The impactor did not have any rotational DOF. The test setup used in the pre-test simulation of tank 232 is shown in Figure 26.

Figure 26. Model Setup in Pre-test Models of Tanks 202 and 232 (Tank 232 Shown)

In the pre-test model, the fuel tank was separated from a rigid test wall with a 2-inch by 2-inch rigid rectangular member. The test wall and the mounting blocks were rigid bodies with no degrees of freedom (DOF). This modeling condition was intended to represent the use of a similar arrangement on the test wall at TTC, which itself was intended to simulate the support condition of a fuel tank suspended beneath a locomotive. In the FE model, zero-displacement boundary conditions were applied to the translational DOF each of the four bolt holes on the

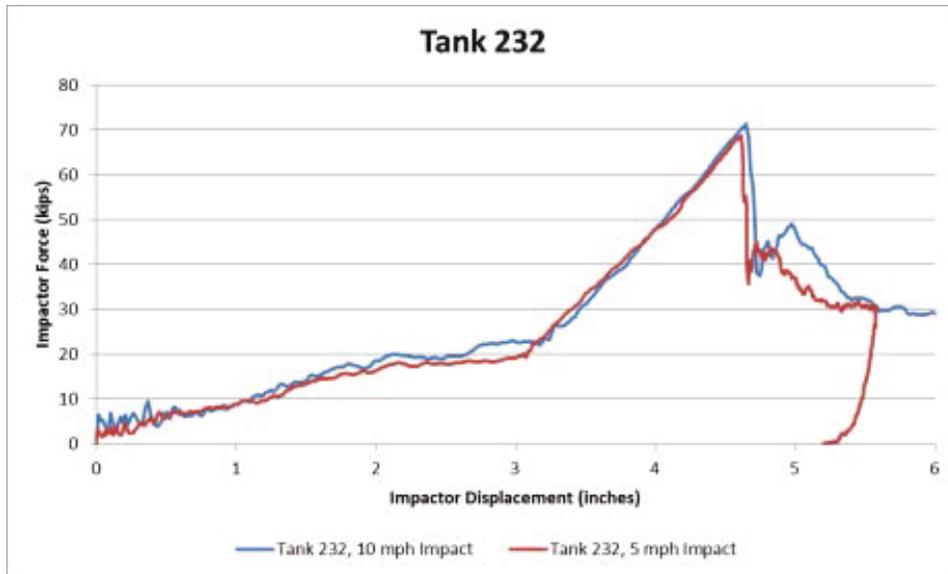
The impact simulation was first run with an initial velocity of 10 mph on the rigid impactor. This resulted in the puncture of the tank, according to the simplified puncture characterization employed in this model. The simulation was repeated with an initial velocity of 5 mph. In the 5 mph impact case, the bottom sheet of the tank has a tear in it, but the impactor rebounded from the tank. The force versus displacement responses of the tank under both impact speeds are shown in Figure 27.

Figure 27. Force-displacement Behavior from Tank 232 Pre-test Model

In both models, the resulting force-displacement responses are both qualitatively and quantitatively similar. The initial response is fairly soft, as only the bottom sheet is being deformed. After approximately 3 inches of displacement, the inside of the bottom sheet makes contact with the bottom of the lateral baffles and results in a stiffening of the force-displacement response. The response continues up a fairly constant slope until failure of the bottom sheet occurs. In the 5 mph case, the tear does not extend around the full perimeter of the impactor. The impactor is reflected after approximately 5.5 inches of indentation. However, in the 10 mph case, the impactor fully punctures the bottom sheet and continues moving in the same direction. The deformed shape of the 5 mph model is shown in Figure 28, with contours of displacement in inches illustrating the indentation. This image is taken just after the puncture has begun to occur in the model.

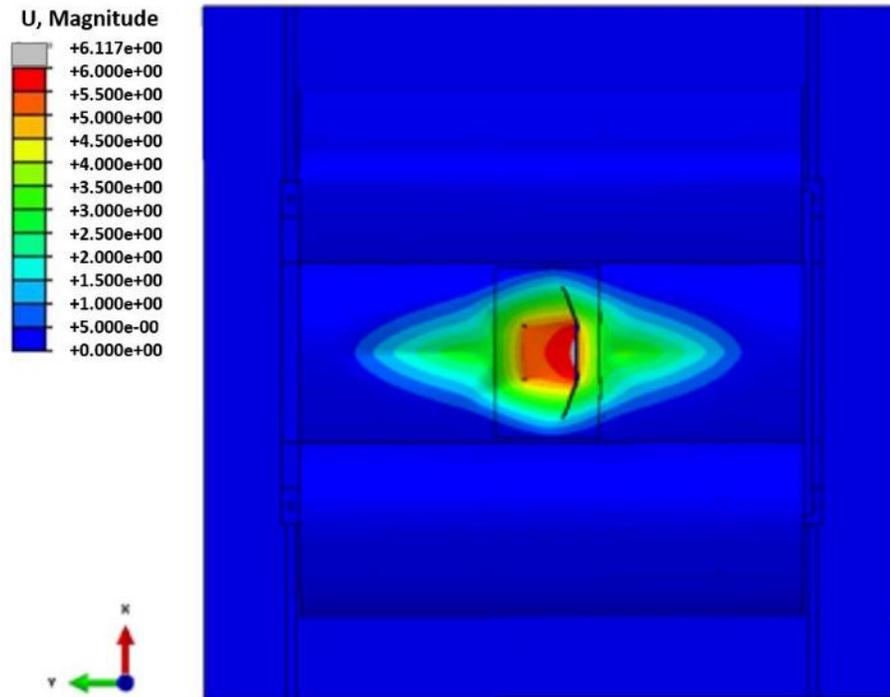
Figure 28. Deformed Shape of Tank 232 after 5 mph Impact, Pre-test Model (Contours of Displacement in inches)

The pre-test model of tank 232 demonstrated that the baffles could play a key role in the impact response of the tank. For impacts of sufficient energy to close the gap between the bottom sheet and the bottom surface of the baffles, the loading conditions on the bottom sheet will change. Initially, the bottom sheet is loaded like a plate that is supported at its edges, far from the impacted zone. However, once contact is made with the baffles, the load is being transferred through the bottom sheet directly into the baffles. These baffles are able to deform and dissipate some portion of the impactor's kinetic energy.

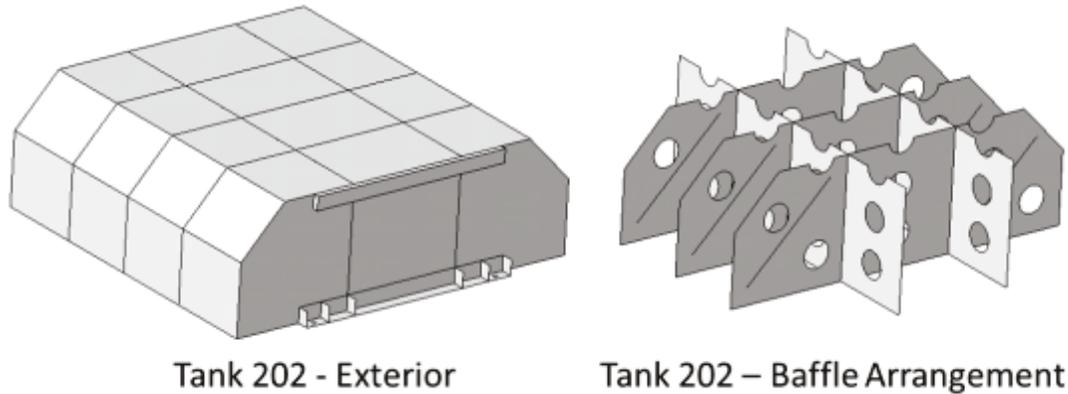
Figure 29. Exterior and Baffle Arrangement for Tank 202 Pre-test Model

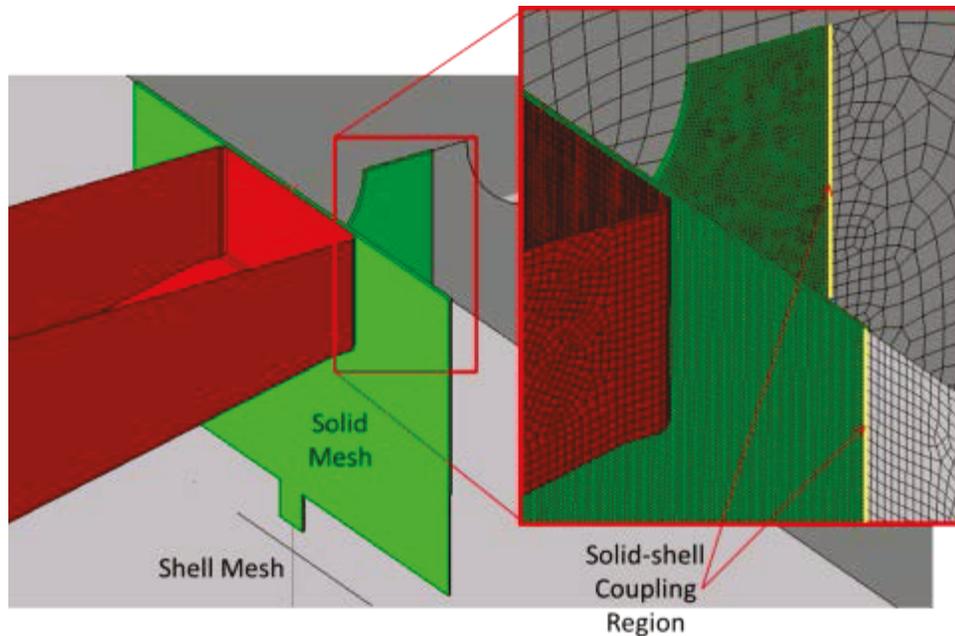
Similar to the pre-test model of tank 232, a simple shear failure criterion was used to permit elements to be removed from the analysis. A mesh of solid elements was used in the region directly below the impactor. Because of this particular baffle arrangement at this impacted location, it was necessary to employ solid elements both in the bottom sheet of the tank and in the baffle directly beneath the impactor. Shell-to-solid coupling was used to attach the solid region to the shell mesh used to model the remainder of the tank, as seen in Figure 30.

Figure 30. Tank 202 Pre-test Model Solid Mesh
