**Federal Railroad
Administration**

Blunt Impact Tests of Retired Passenger Locomotive Fuel Tanks

1. AGENCY USE ONLY (Leave blank)		2. REPORT DATE August 2017	3. REPORT TYPE AND DATES COVERED Technical Report	
4. TITLE AND SUBTITLE Blunt Impact Tests of Retired Passenger Locomotive Fuel Tanks			5. FUNDING NUMBERS DTFR53-10-X-00061, RR28A3/NLL72

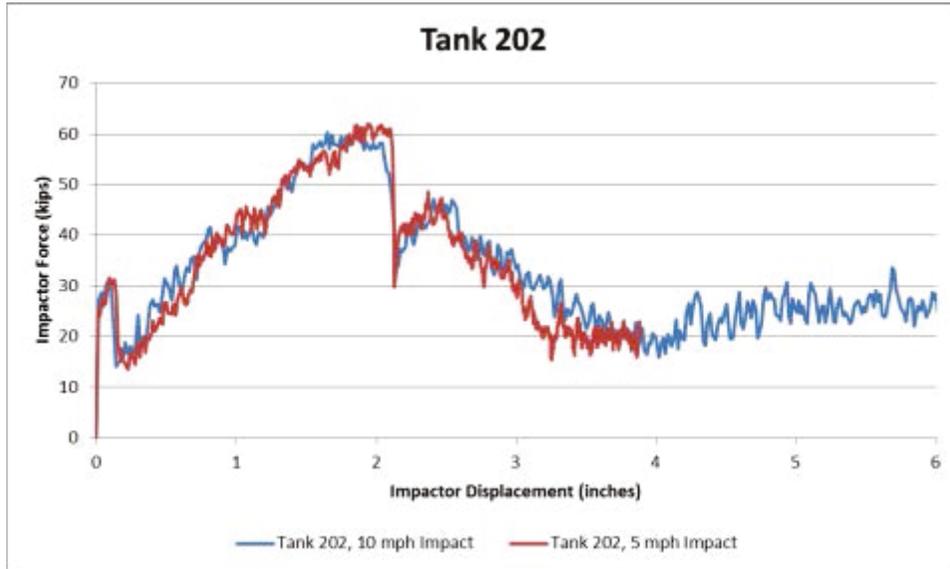
Figure 31. Tank 202 Pre-test Model Force-displacement Behavior

The force-versus-displacement results from tank 202 pre-test model are distinctly different from those obtained using the pre-test model of tank 232. Results show the response of tank 202 is initially stiff; the force quickly reaches 30 kips with very little impactor displacement. This is followed by a decrease in load, likely caused by folding of the baffle directly beneath the impacted location. As the baffle folds and contact is made between the bottom sheet of the tank and the folded portion of the baffle, the force resumes increasing. After a load of approximately 60 kips is reached, tearing of the bottom sheet begins, and it results in a drop in load. However, because the tear is limited to the vicinity of the attachment between the baffle and the bottom sheet, the force level does not drop to zero. Rather, the impactor continues to move forward while the baffle is in contact with the bottom sheet, keeping the resistance force above 20 kips.

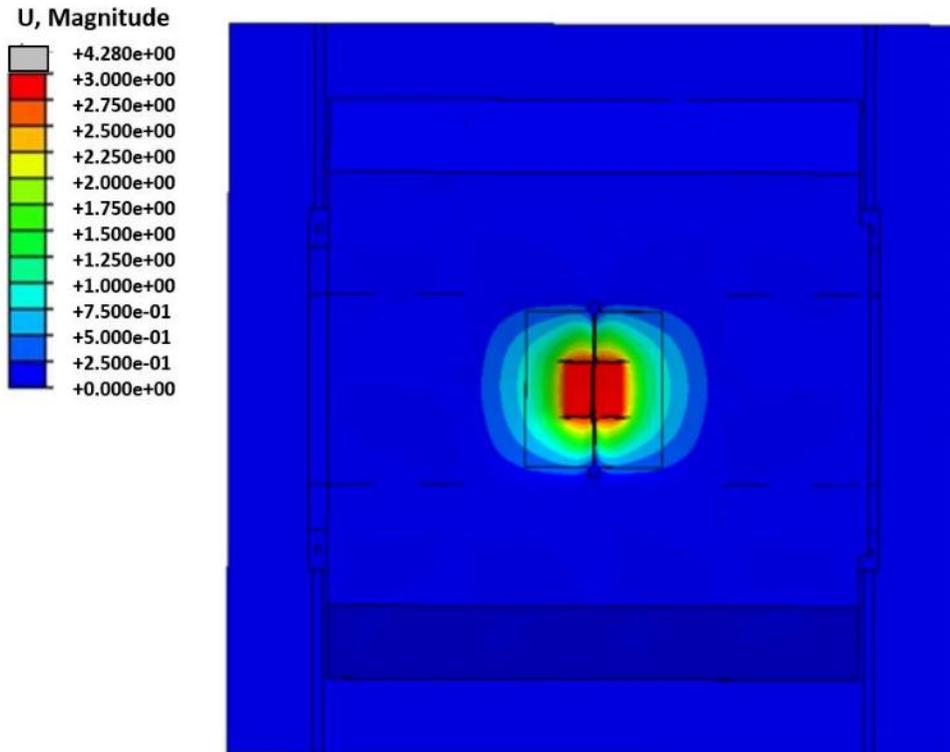
Figure 32. Deformed Shape of Tank 202 after 5 mph Impact, Pre-test Model (Contours of Displacement, in inches)

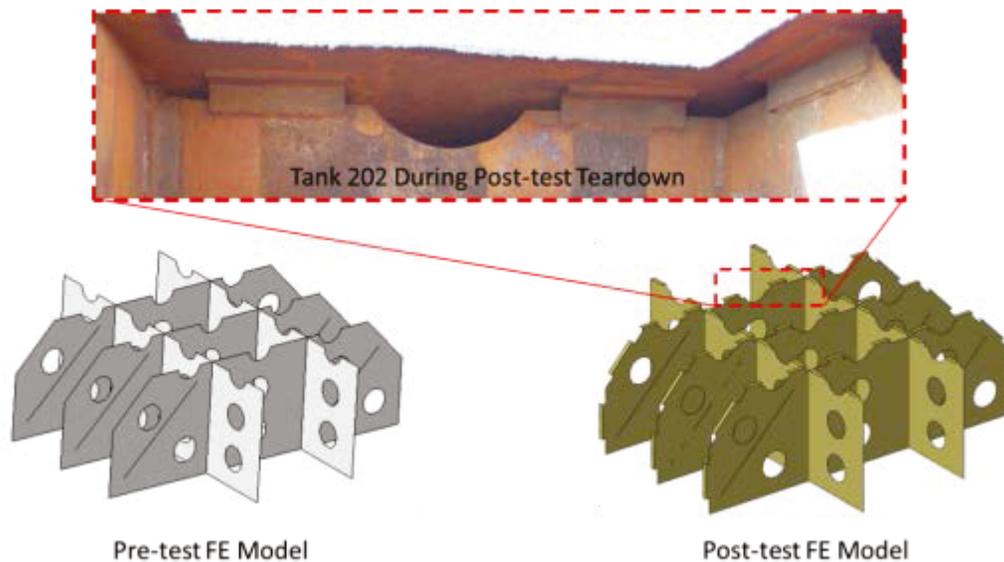
Figure 33. Tank 202 Baffle Arrangement during Teardown (top) Pre-test Model (bottom left), and Post-test Model (bottom right)

During the post-test teardown of tanks 202 and 232, several geometric differences were noted between the pre-test measurements and the actual structures of the tank. Specifically, the baffle arrangements and their attachments within each tank were slightly different from what had been included in the pre-test FE models. Correspondingly, the baffle structures in each model had to be updated to reflect the actual baffle geometry found within each tank.

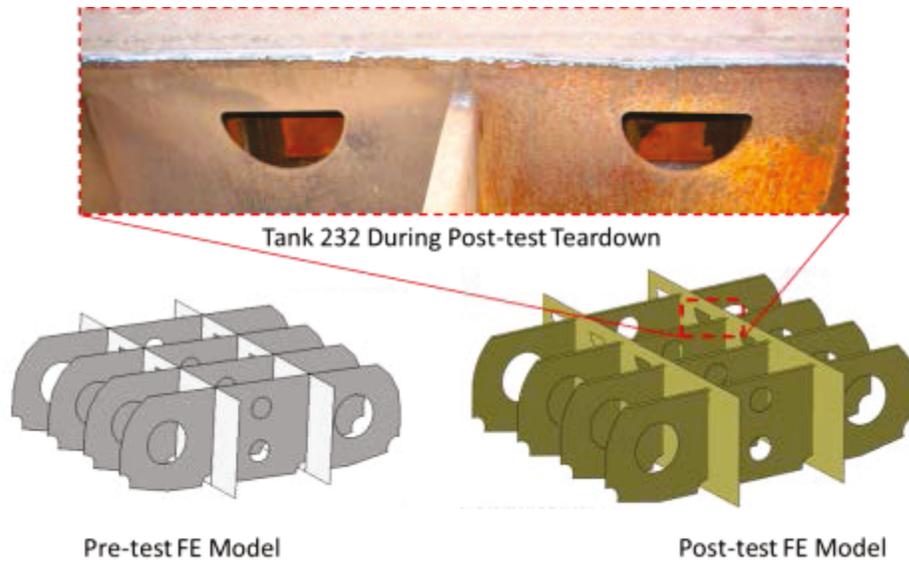
Figure 34. Tank 232 Baffle Arrangement during Teardown (top) Pre-test Model (bottom left), and Post-test Model (bottom right)

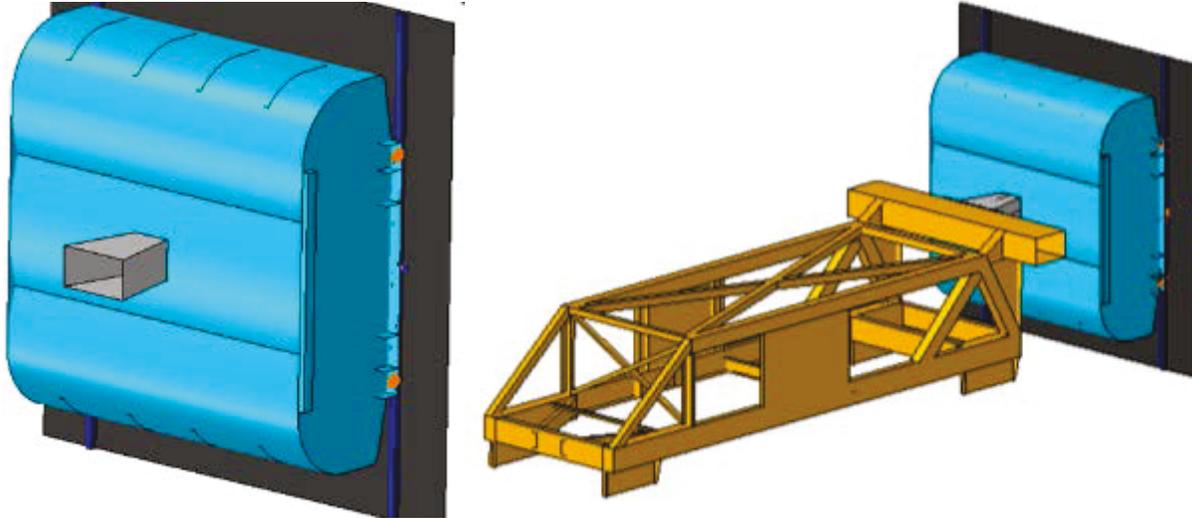
Figure 35. Pre-test Rigid Impactor (left) and Post-test Deformable Impact Cart (right) Used in Models of Tanks 202 and 232

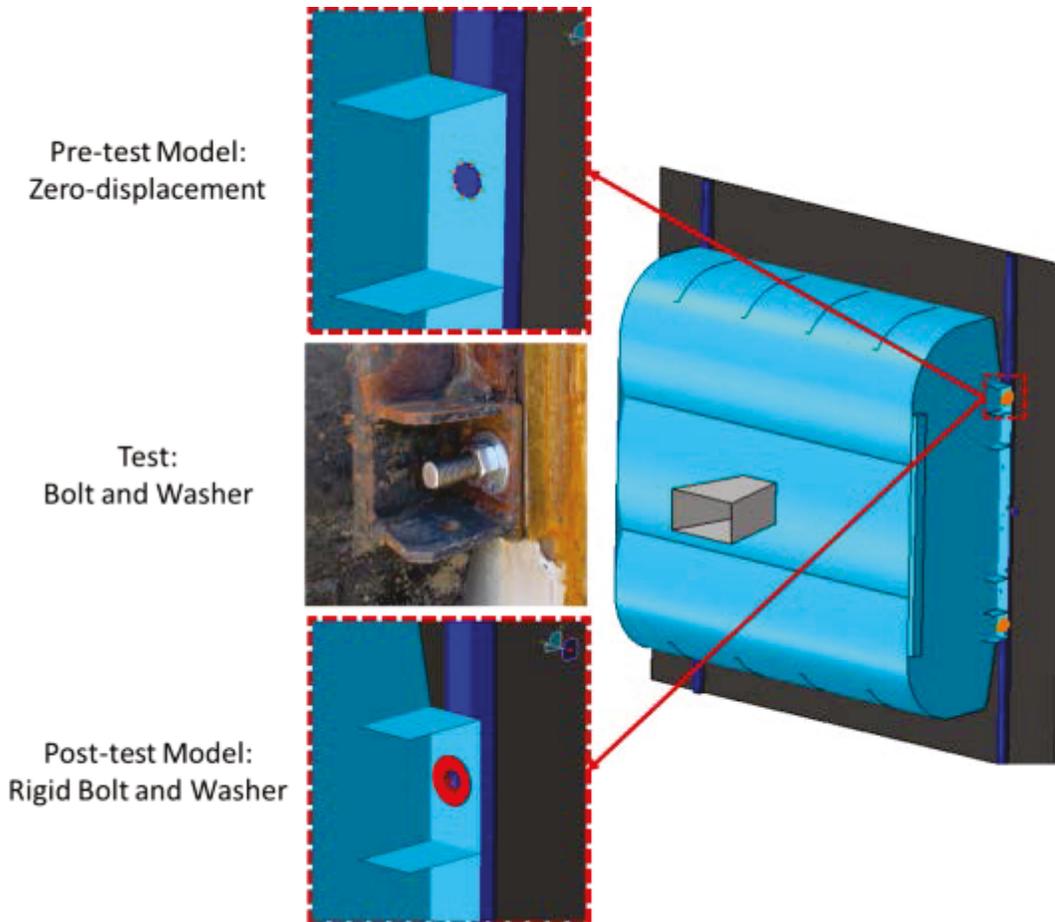
Figure 36. Tank-to-wall Attachment in Pre-test Model (top), Test (center), and Post-test Model (bottom)

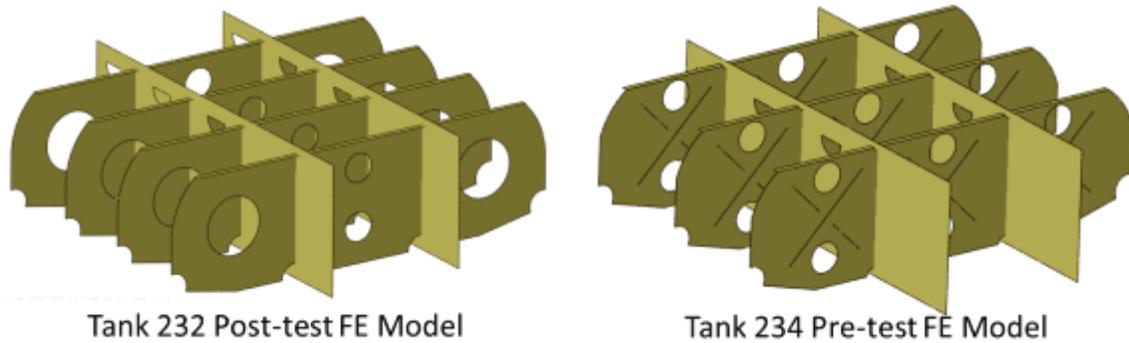
Figure 37. Comparison between Baffle Arrangement in Tank 232 Post-test FE Model (left) and Tank 234 Pre-test FE Model (right)

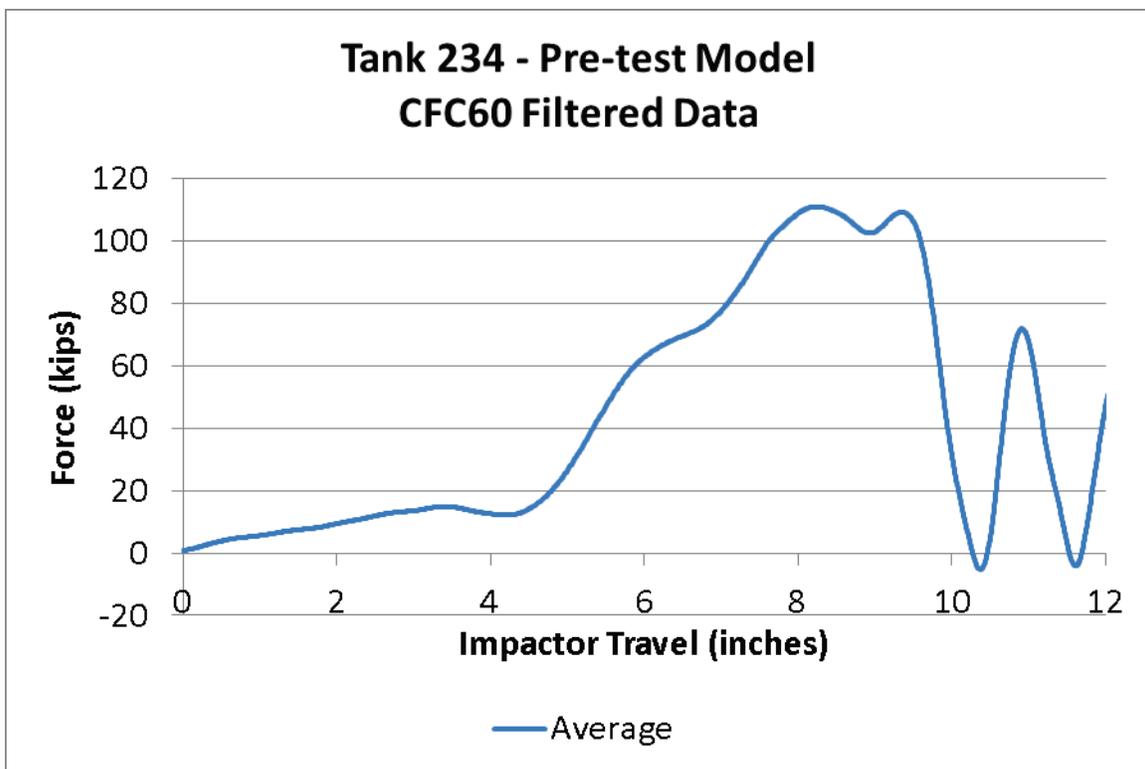
Figure 38. Force-displacement Response from Tank 234 Pre-test Model, 11.2 mph Impact

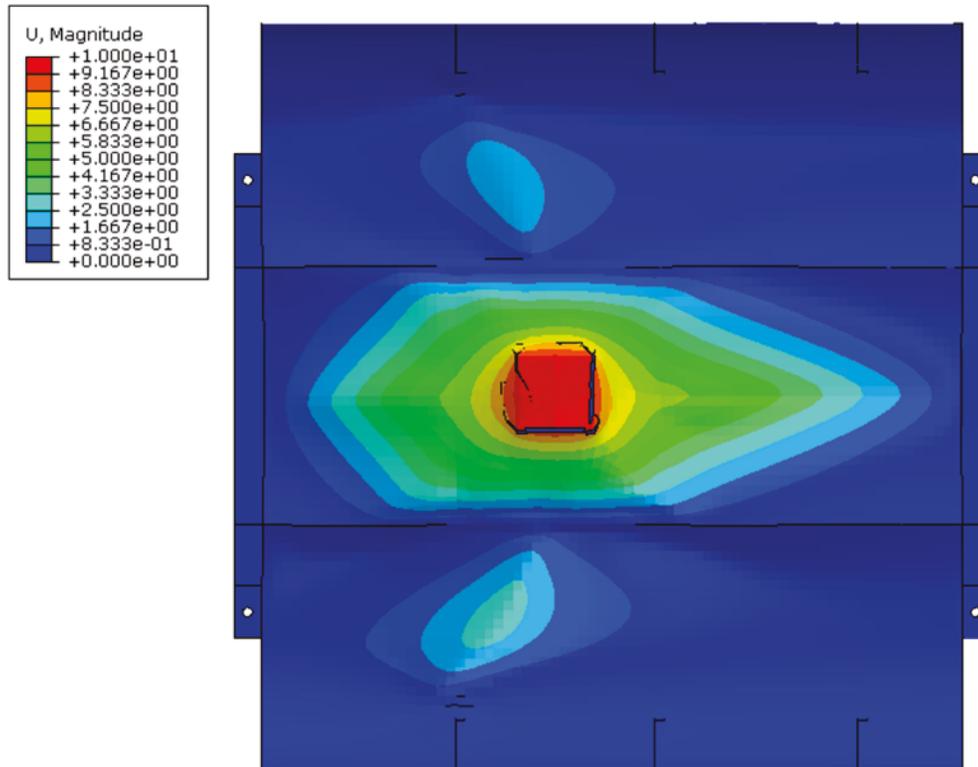
Figure 39. Deformed Shape of Tank 234 after 11.2 mph Impact, Pre-test Model (Contours of Displacement, in inches)

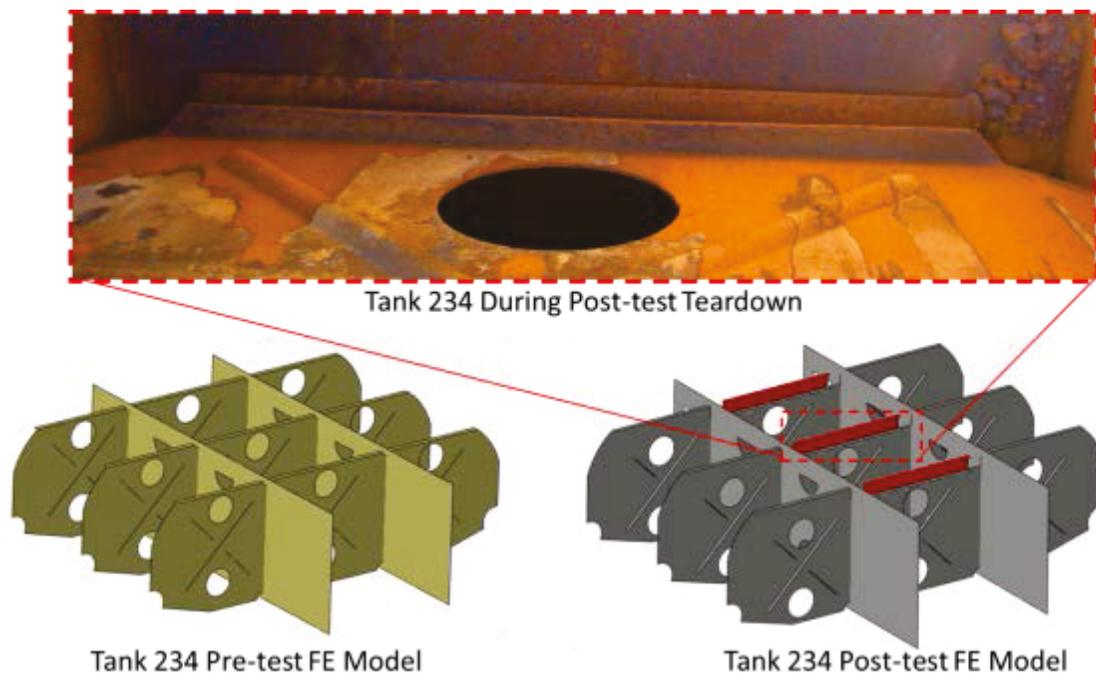
Figure 40. Tank 234 Baffle Arrangement during Teardown (top) Pre-test Model (bottom left), and Post-test Model (bottom right)

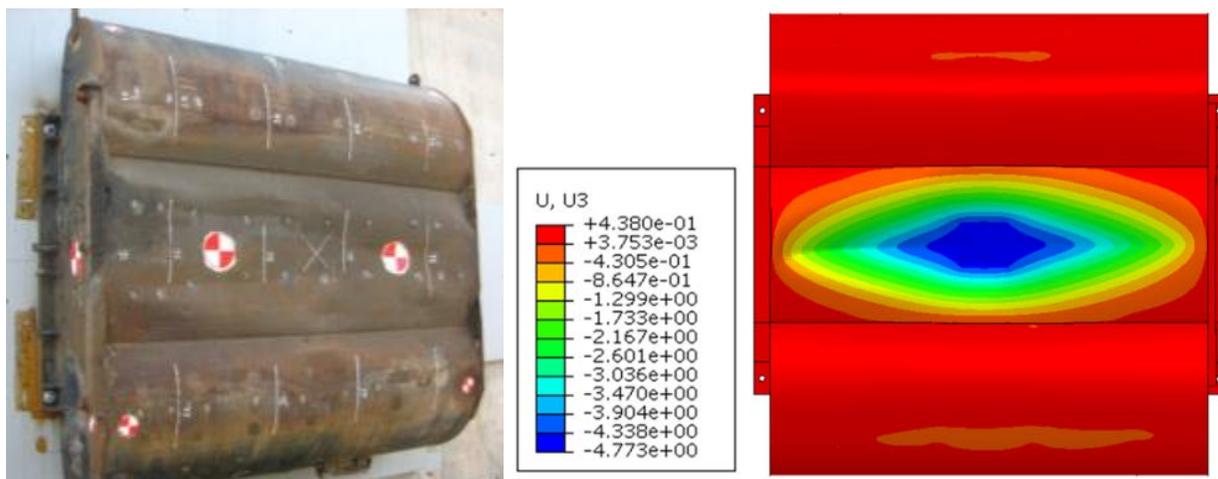
Figure 41. Post-test View of Tank 232 from Test (left) and FE Model (right)

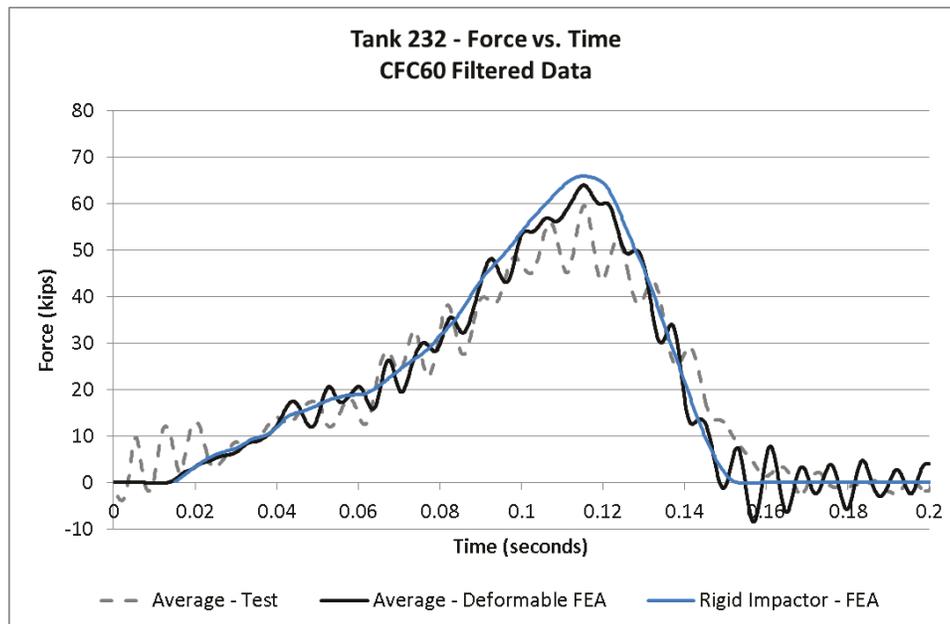
Figure 42. Tank 232 Force-time History from Test and Post-test FEA

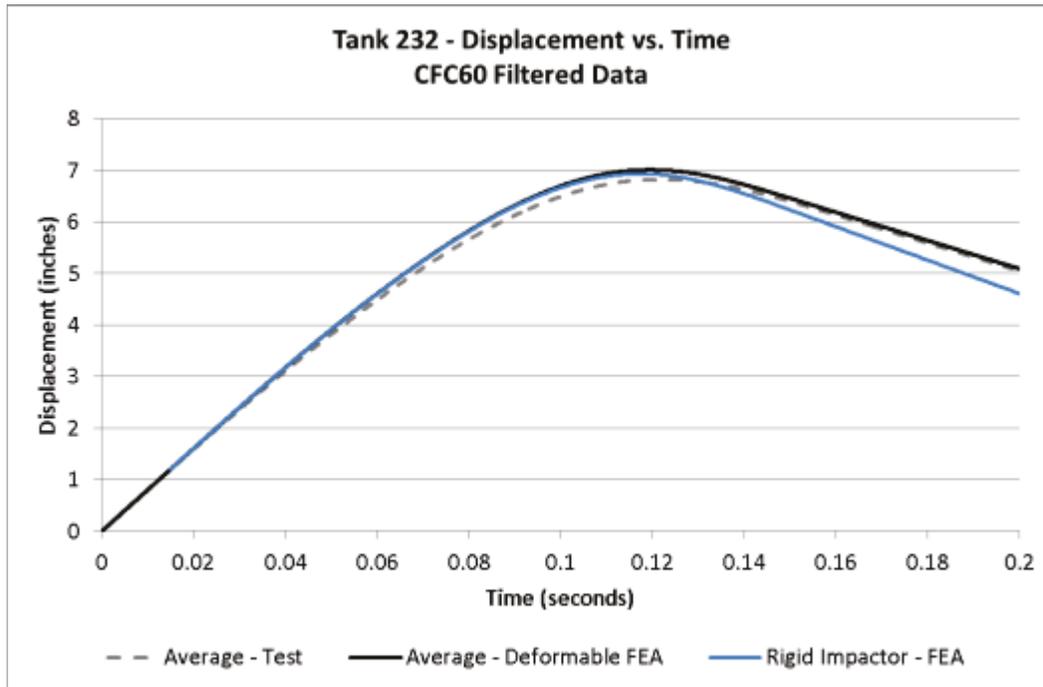
Figure 43. Tank 232 Displacement-time History from Test and Post-test FEA

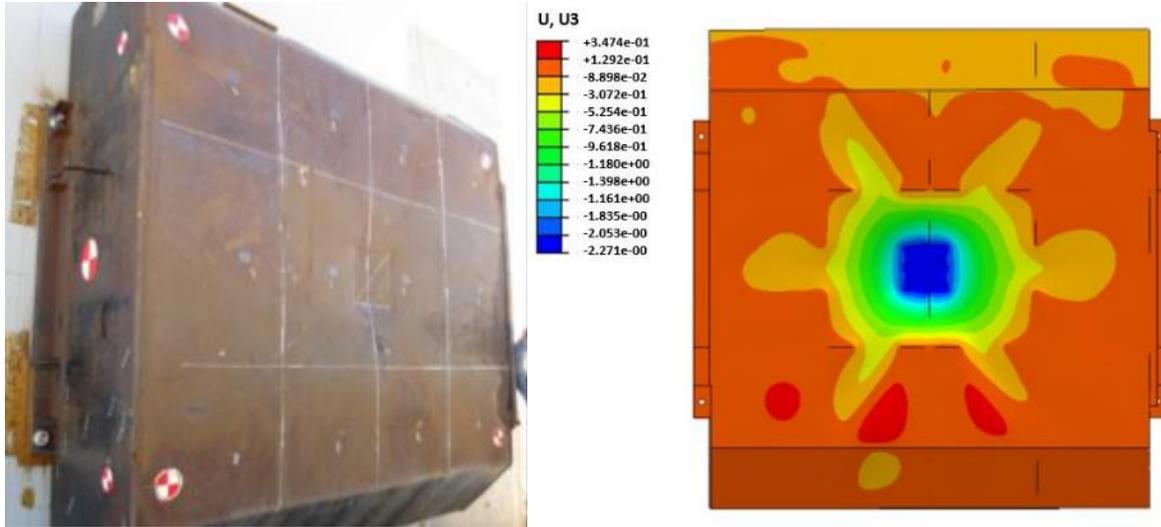
Figure 44. Post-test View of Tank 202 from Test (left) and FE Model (right)

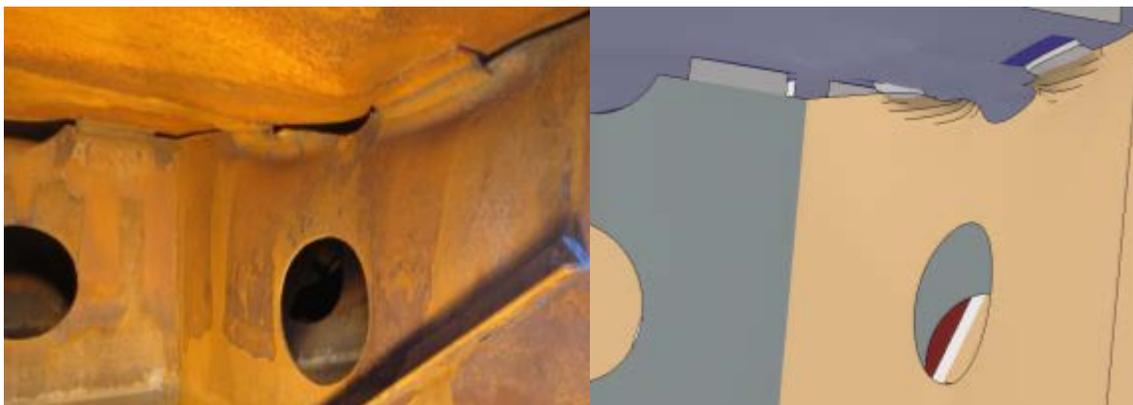
Figure 45. Post-test View of Tank 202 Baffles from Test (left) and FE Model (right)

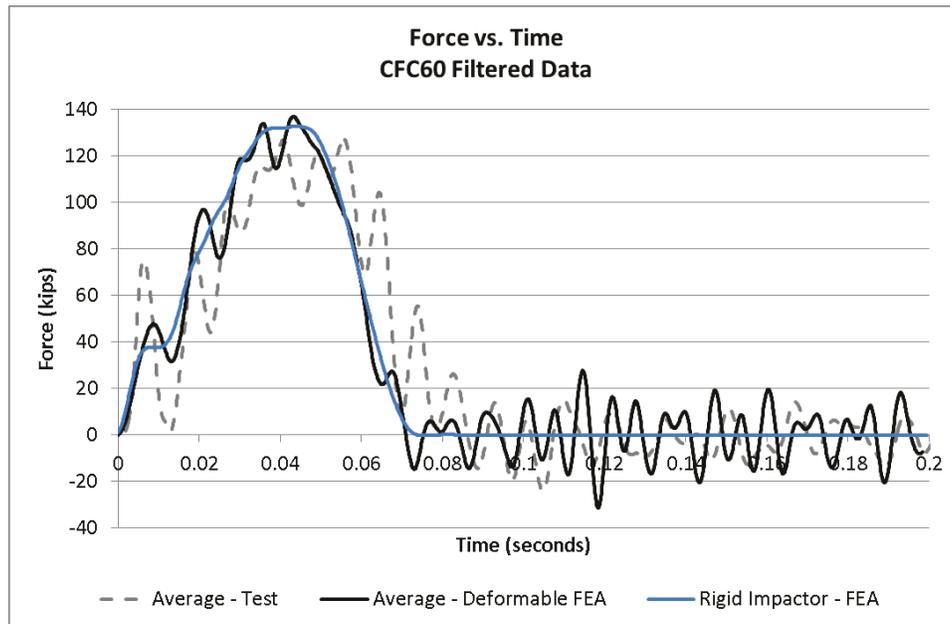
Figure 46. Tank 202 Force-time History from Test and Post-test FEA

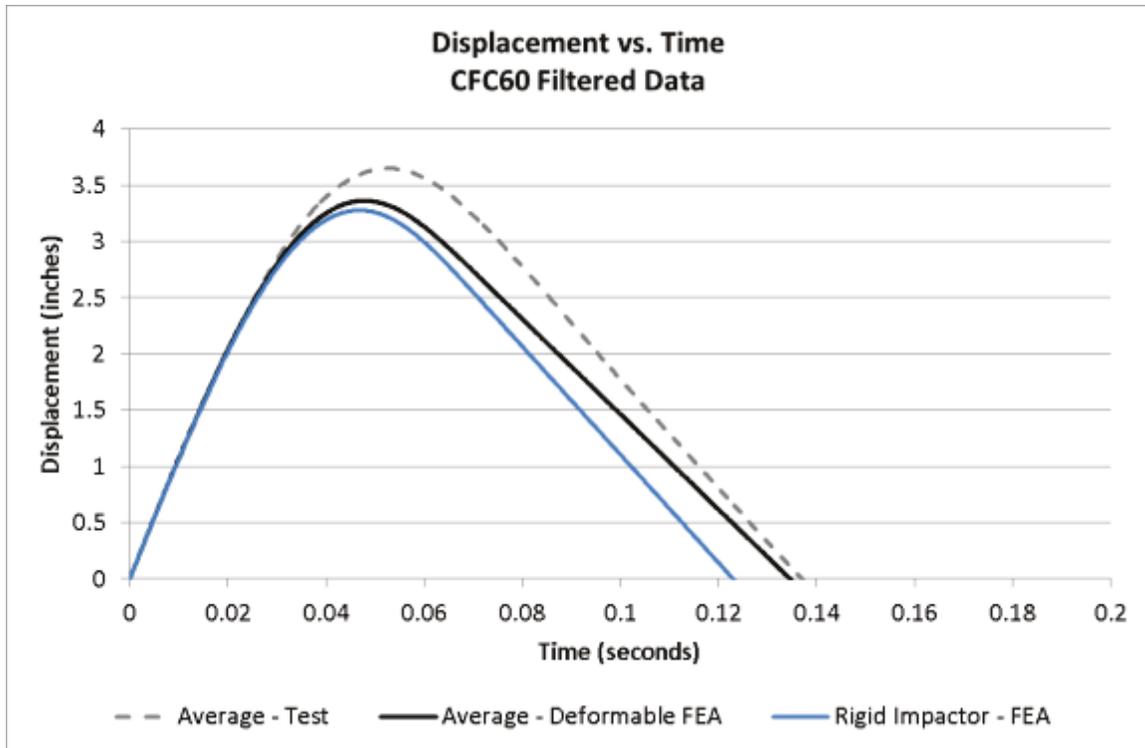
Figure 47. Tank 202 Displacement-time History from Test and Post-test FEA

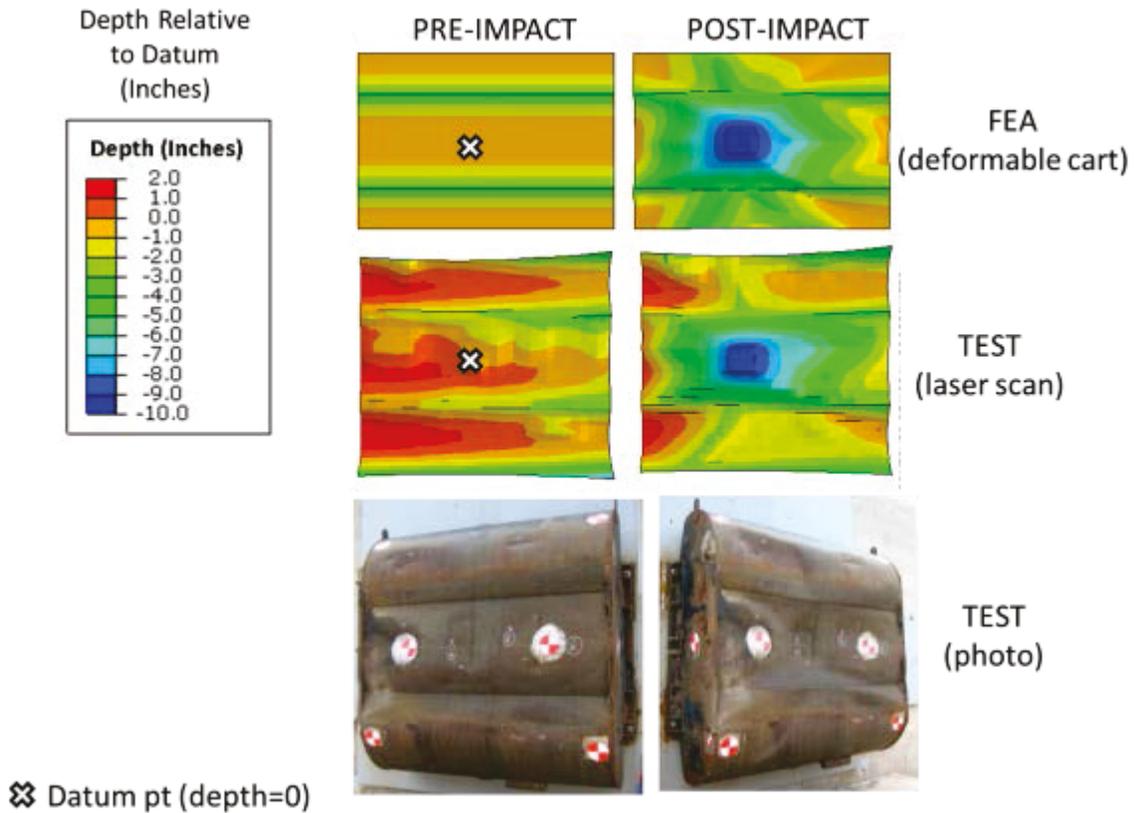
Figure 48. Tank 234 Deformed Shape Comparison between FEA and Test

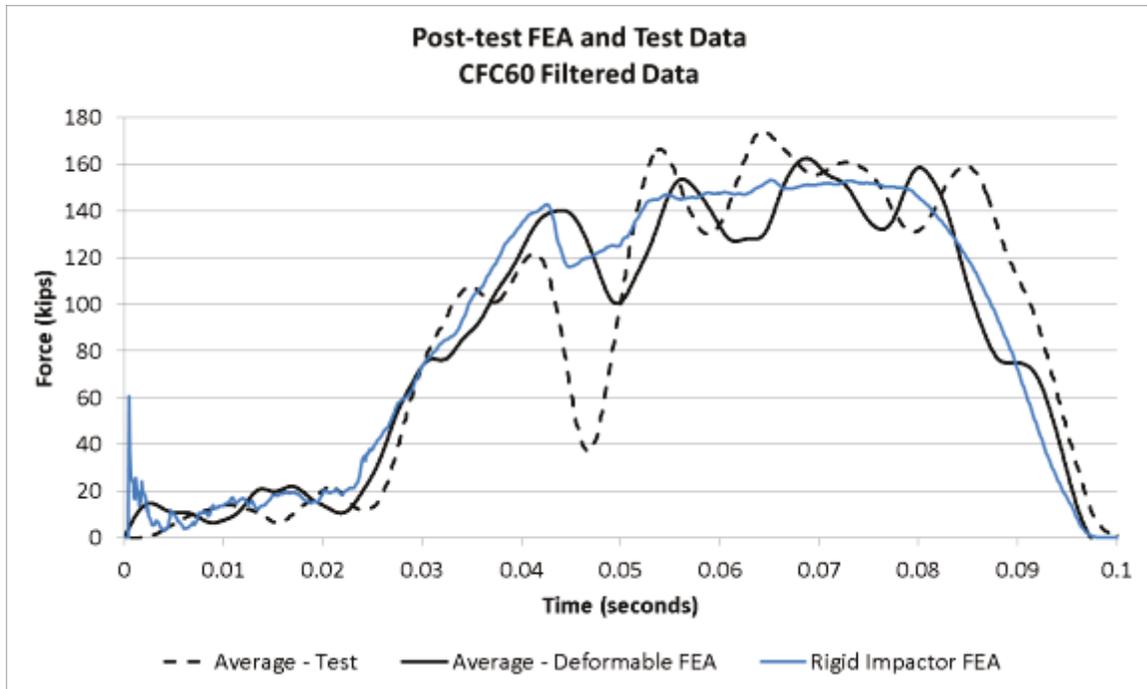
Figure 50. Tank 234 Force-time History from Test and Post-test FEA

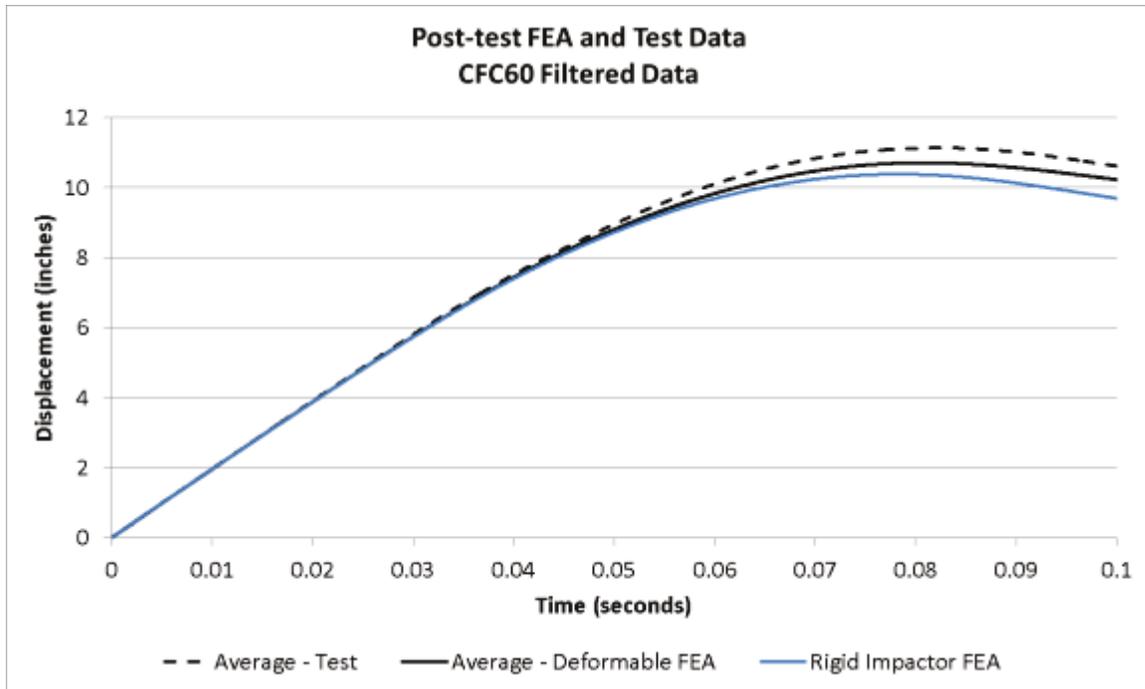
Figure 51. Tank 234 Displacement-time History from Test and Post-test FEA

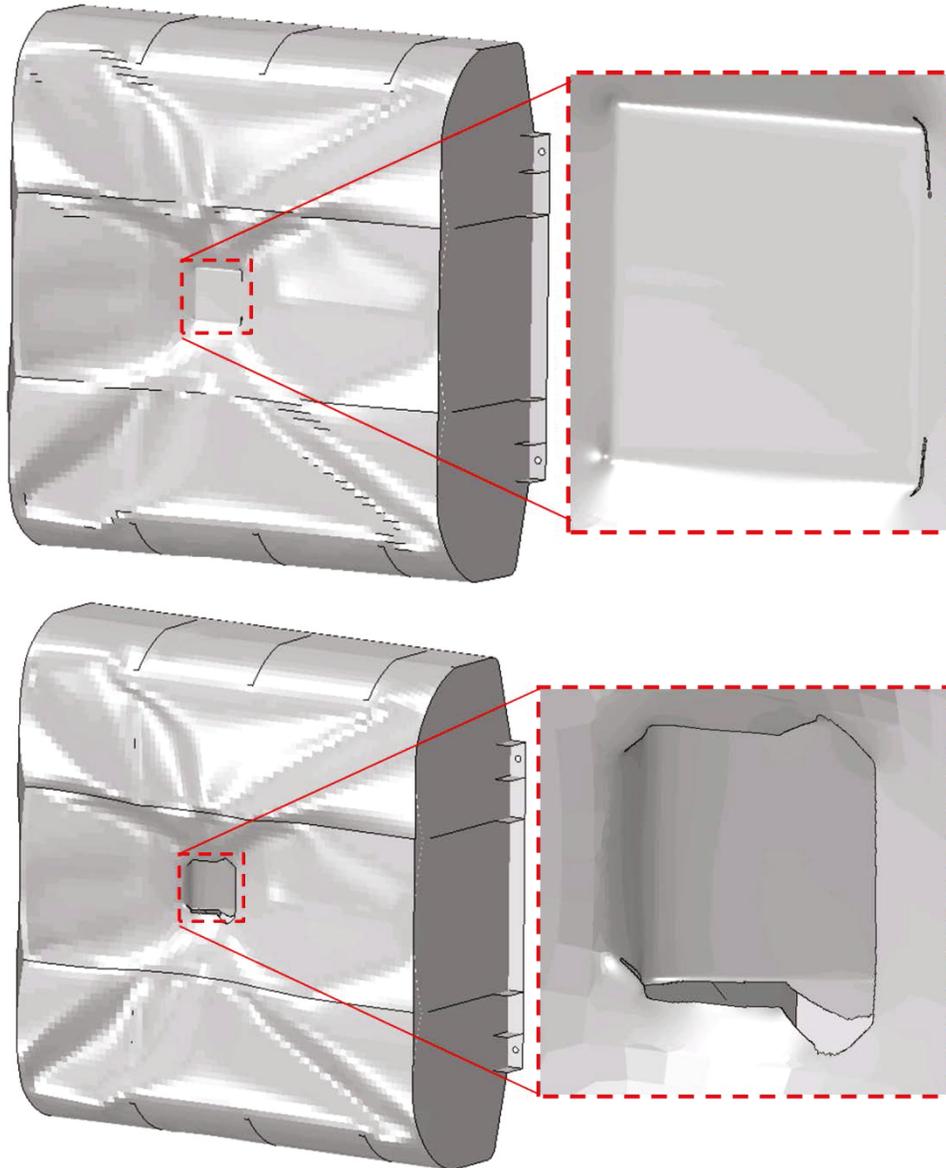
Figure 52. Deformed Shape of Tank 234 and Puncture Detail after 14.5 mph Impact Simulation (top) and 16 mph Impact Simulation (bottom)

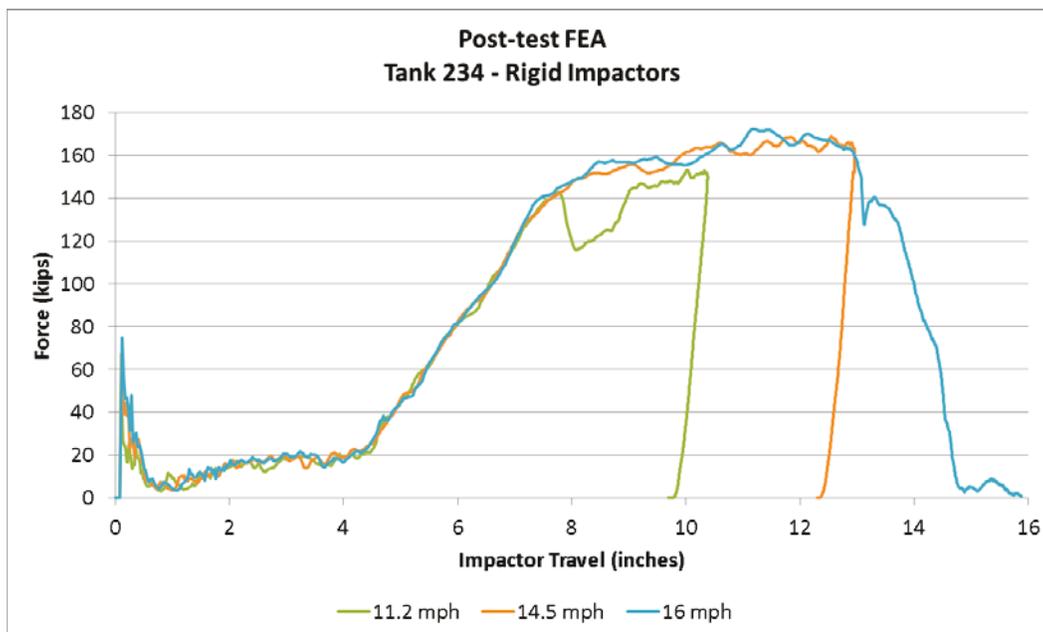
Figure 53. Force-displacement Responses for 11.2, 14.5 and 16 mph FEA of Tank 234

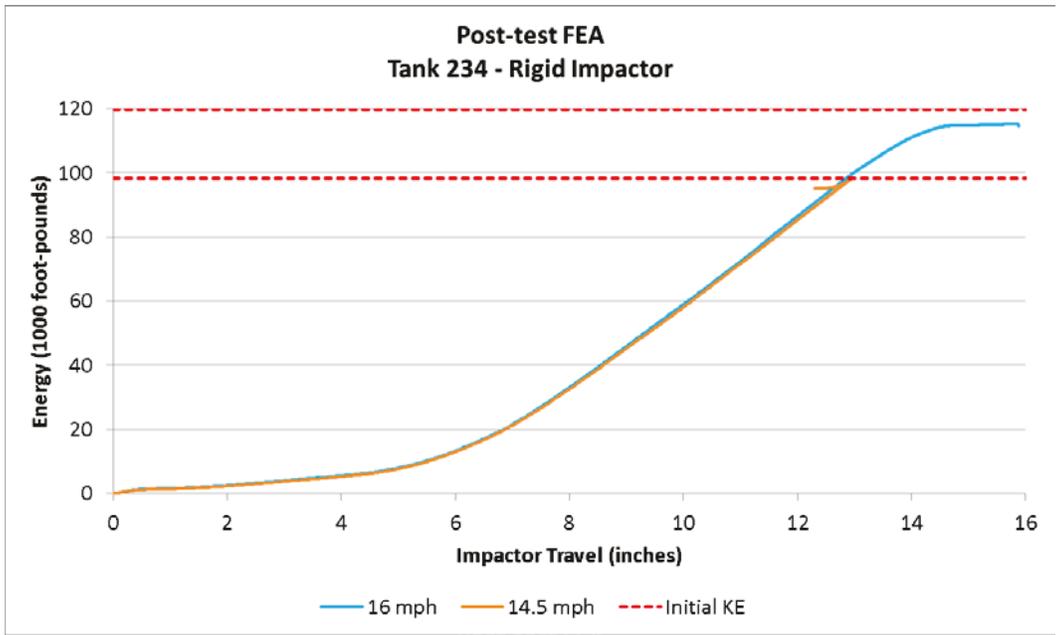
Figure 54. Energy Dissipated During 14.5 and 16 mph Impact Simulations

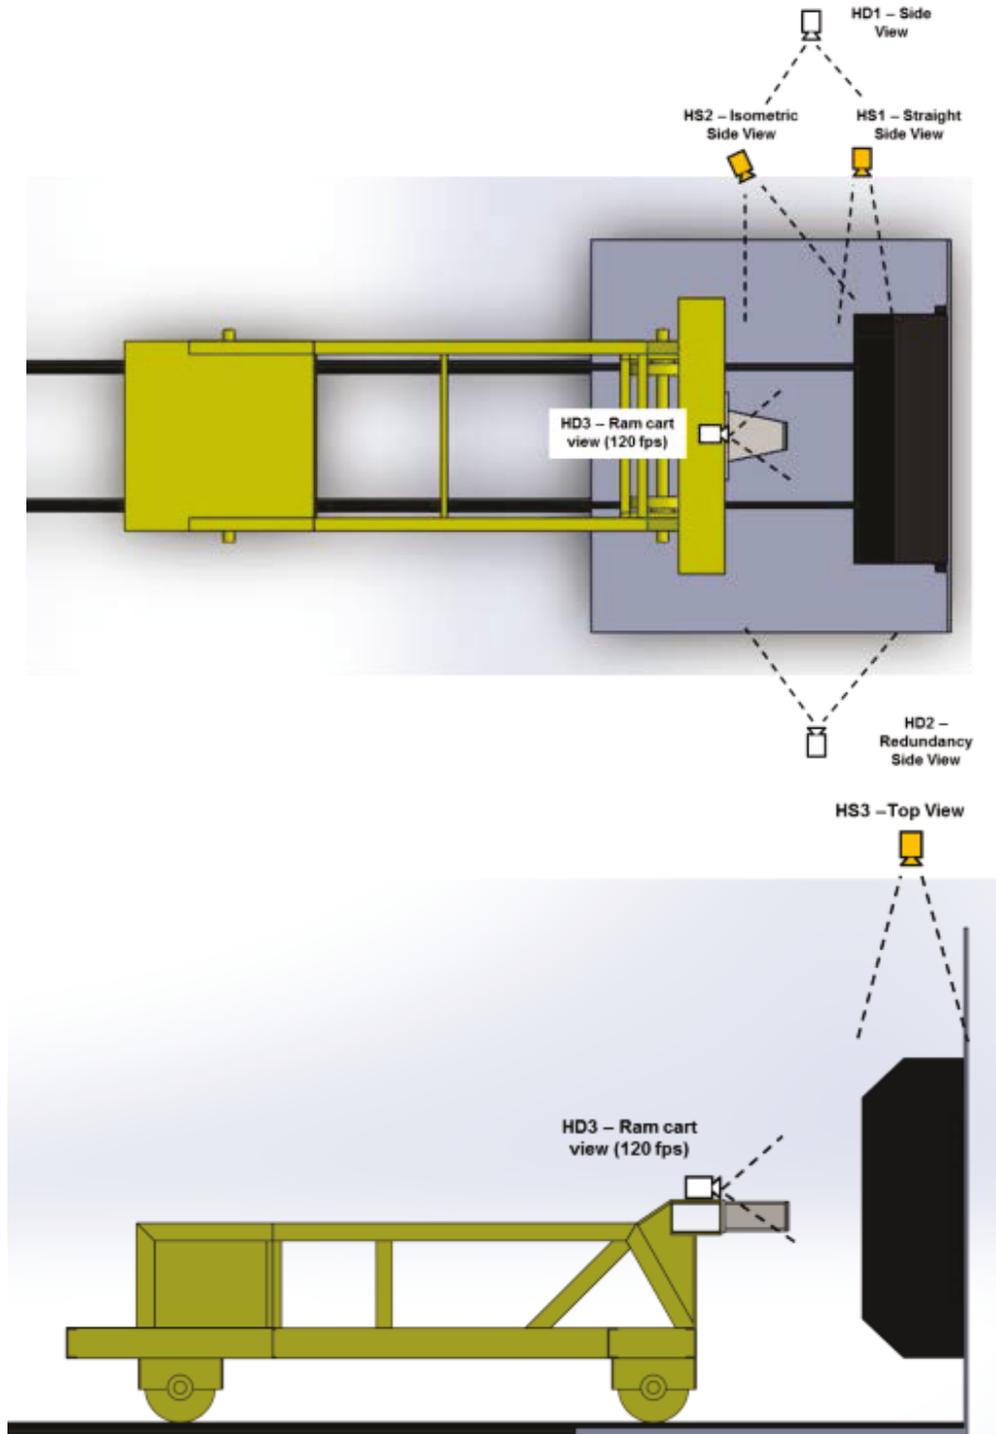
Figure A1. Camera Views

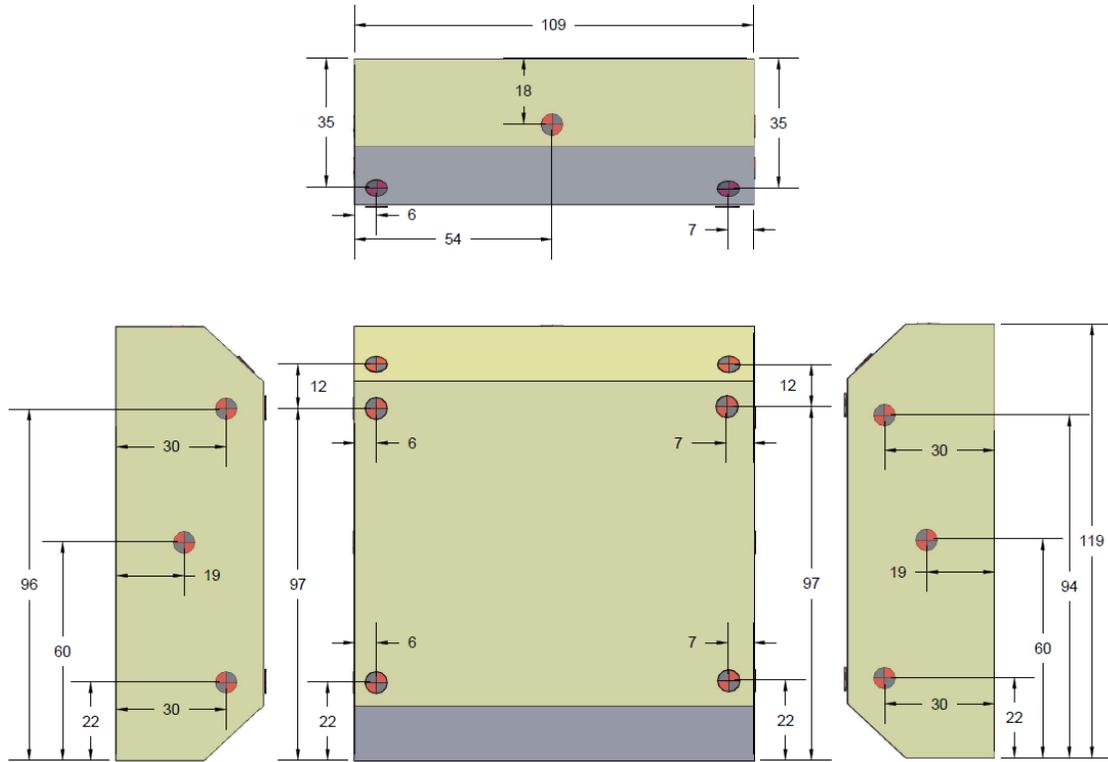
Figure A3. Target Locations (Tank 202)

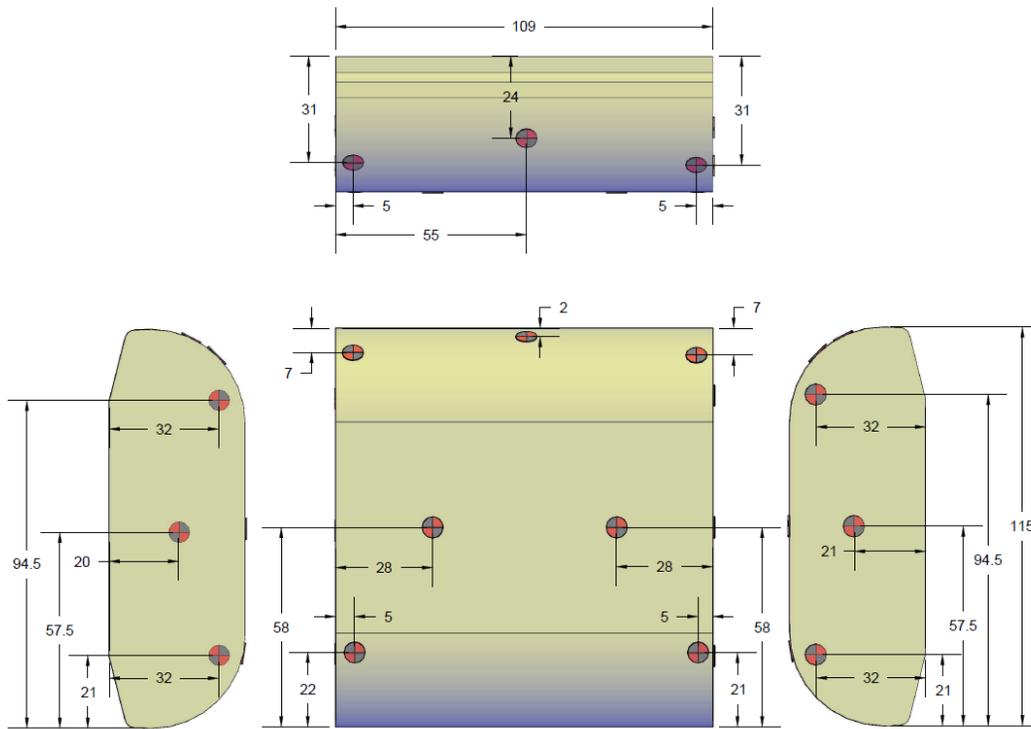
Figure A4. Target Locations (Tank 232)

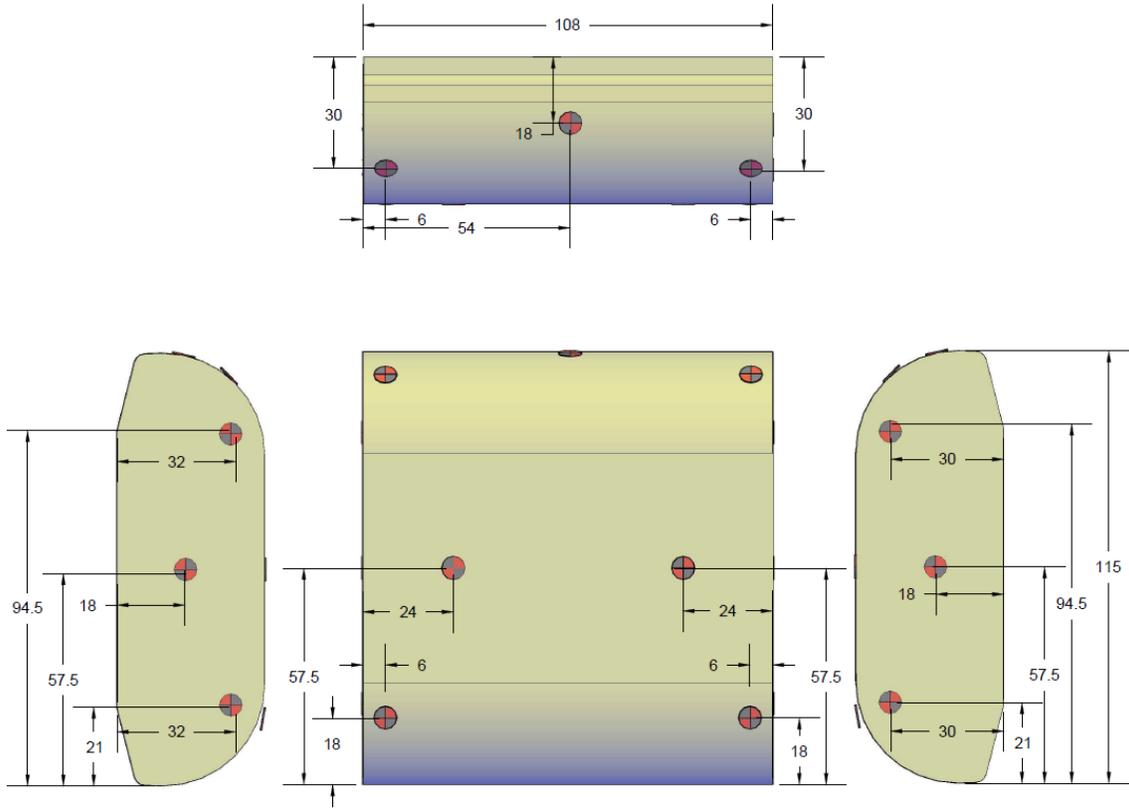
Figure A5. Target Locations (Tank 234)

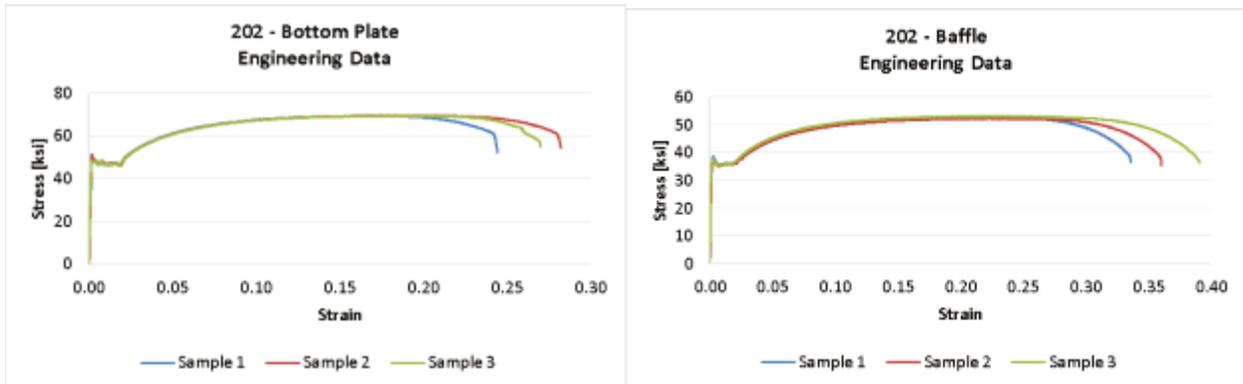
Figure B1. Engineering Stress-strain Responses from Tank 202 Members

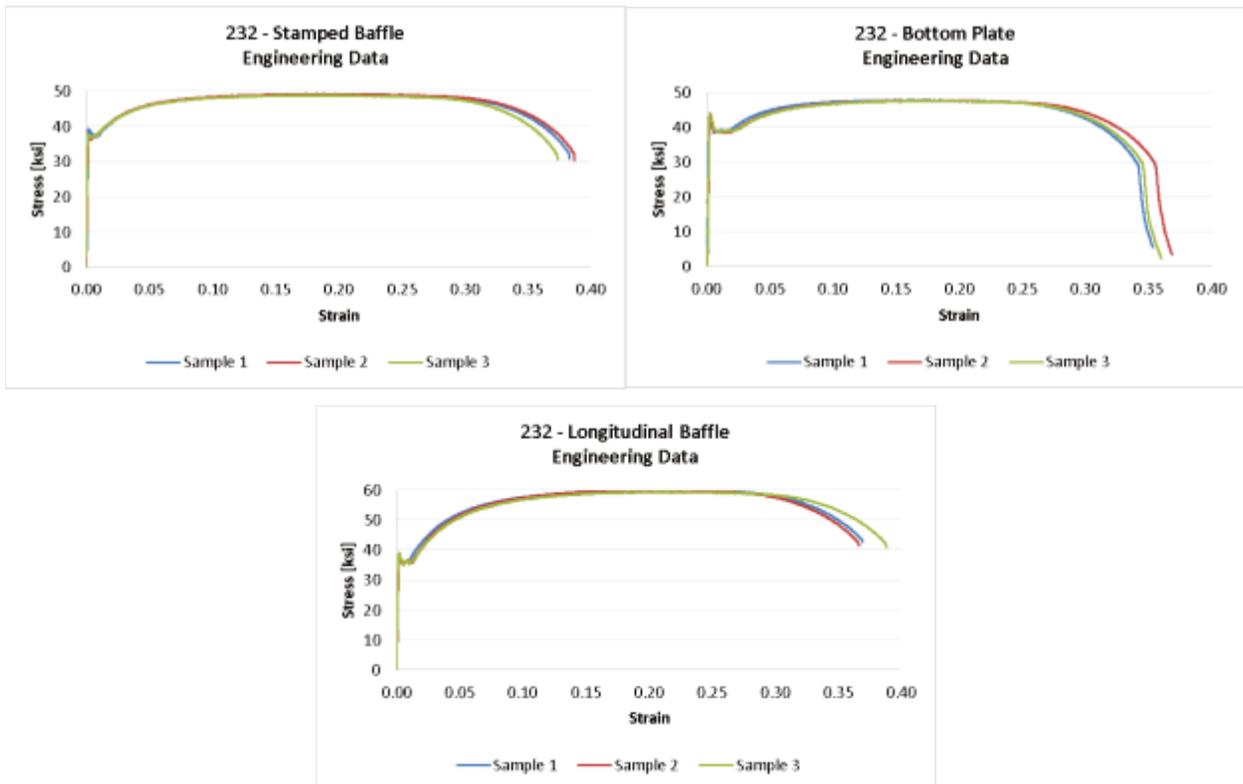
Figure B2. Engineering Stress-strain Responses from Tank 232 Members
