**Federal Railroad
Administration**

Blunt Impact Tests of Retired Passenger Locomotive Fuel Tanks

1. AGENCY USE ONLY (Leave blank)		2. REPORT DATE August 2017	3. REPORT TYPE AND DATES COVERED Technical Report	
4. TITLE AND SUBTITLE Blunt Impact Tests of Retired Passenger Locomotive Fuel Tanks			5. FUNDING NUMBERS DTFR53-10-X-00061, RR28A3/NLL72

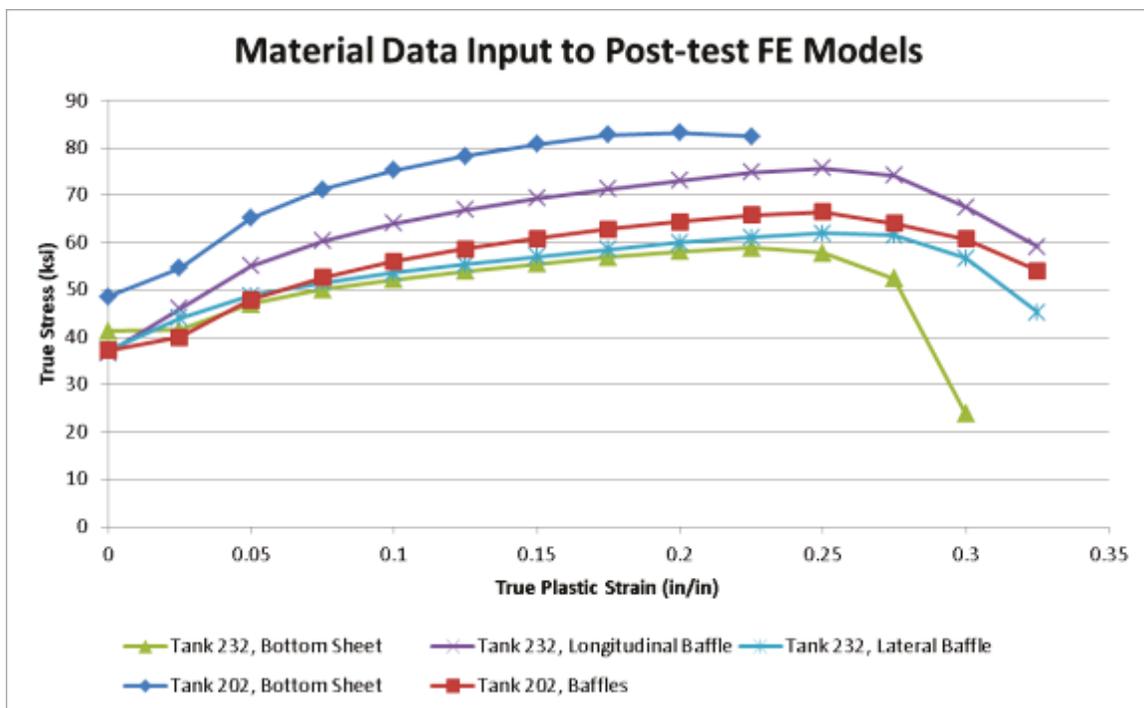
Figure B3. Stress-strain Data Defined in Post-test FE Models of Tanks 202 and 232

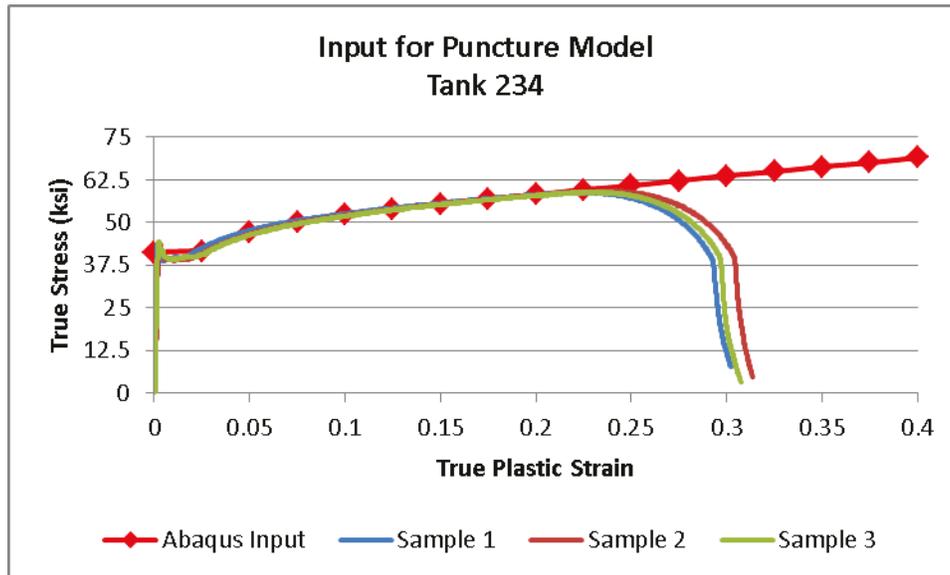
Figure B4. True Stress-strain Behavior for Tank 234 Puncture Model

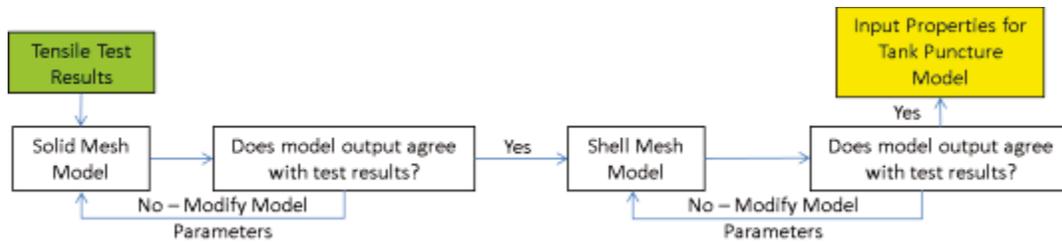
Figure B5. Process for Simulating Tensile Tests of Bottom Sheet Material

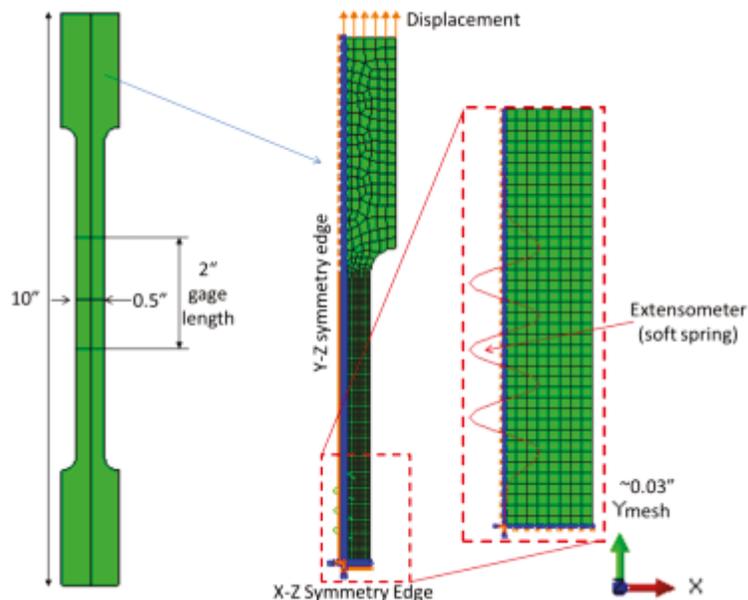
Figure B6. Uniaxial Tension FE Model (shell model shown)

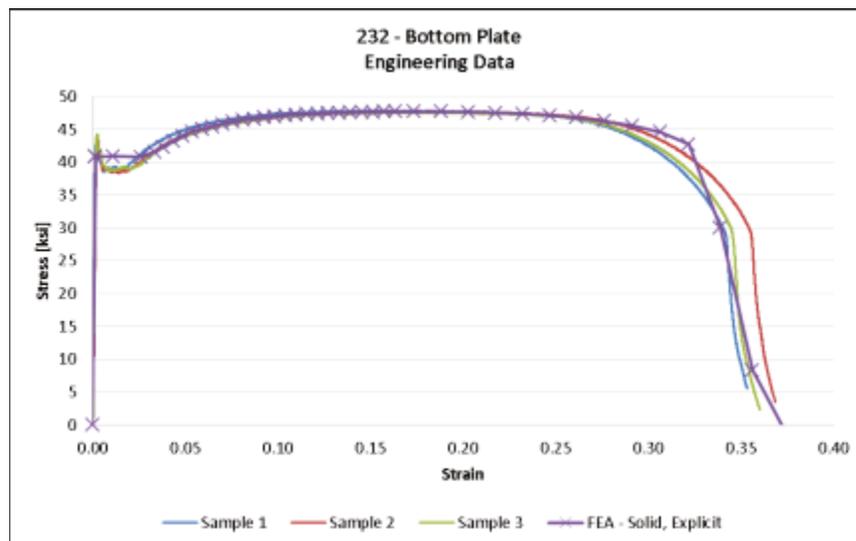
Figure B7. Stress-strain Comparison between Tensile Tests and Solid FE Model Tank 232

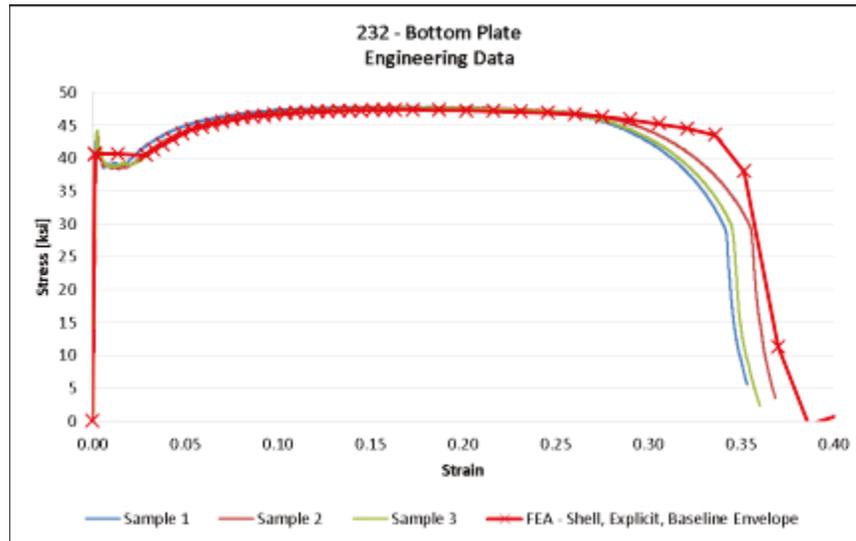
Figure B8. Stress-strain Comparison between Tests and Shell FE Model Tank 232 (Baseline Envelope)

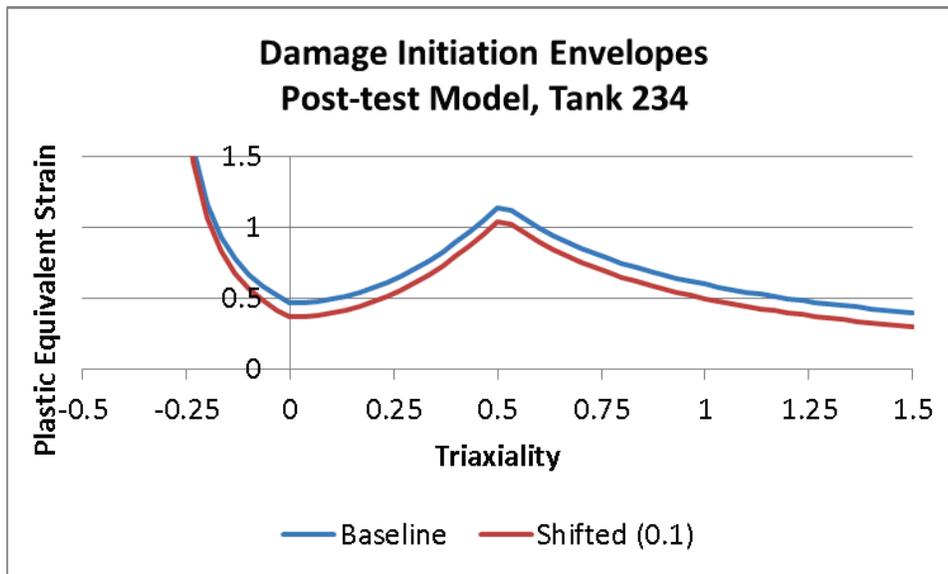
Figure B9. Baseline and Shifted Failure Initiation Envelopes

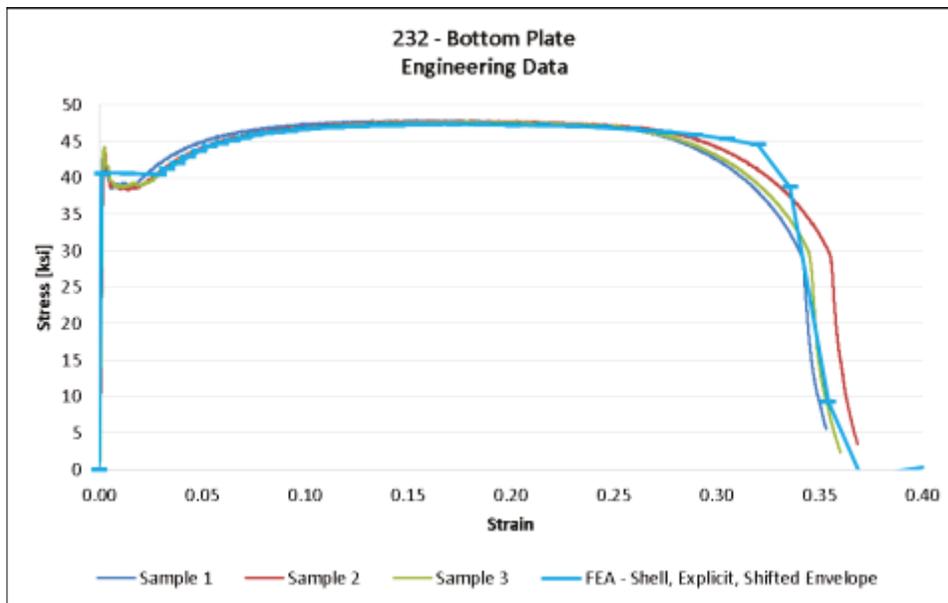
Figure B10. Stress-strain Comparison between Tests and Shell FE Model Tank 232 (Shifted Envelope)

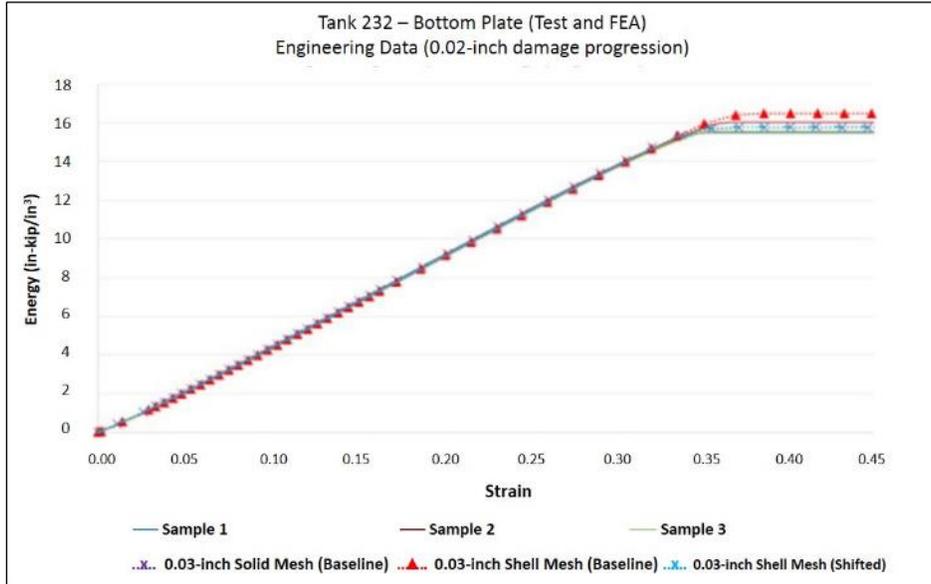
Figure B11. Tank 232 Toughness vs Strain for Each Tensile Test or Simulation

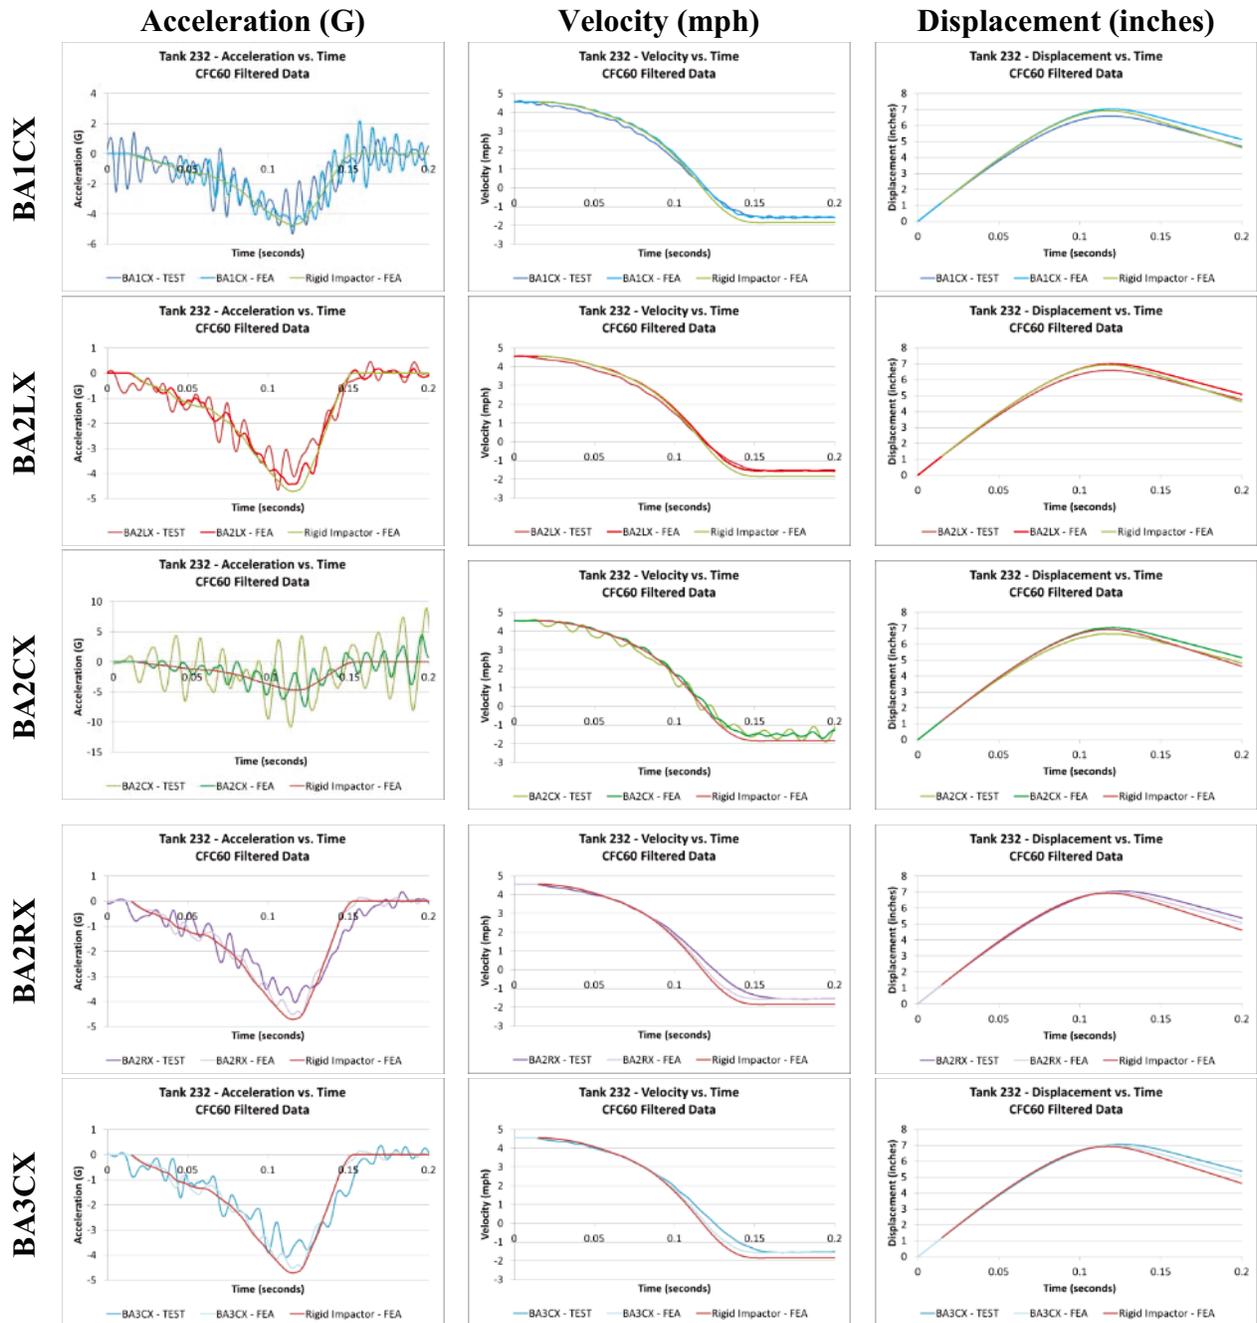
Impact Speed: 4.5 mph

* For the FE model of tank 232, the impactor was initially offset from the tank at t=0 seconds. This was done to attempt to compensate for the uncertainty between the triggering of the instrumentation and the actual contact with of the impactor with the tank, as discussed in Section 3.4.4. In the FE model, this corresponded to a time offset of 0.015 second, or approximately 1 inch.

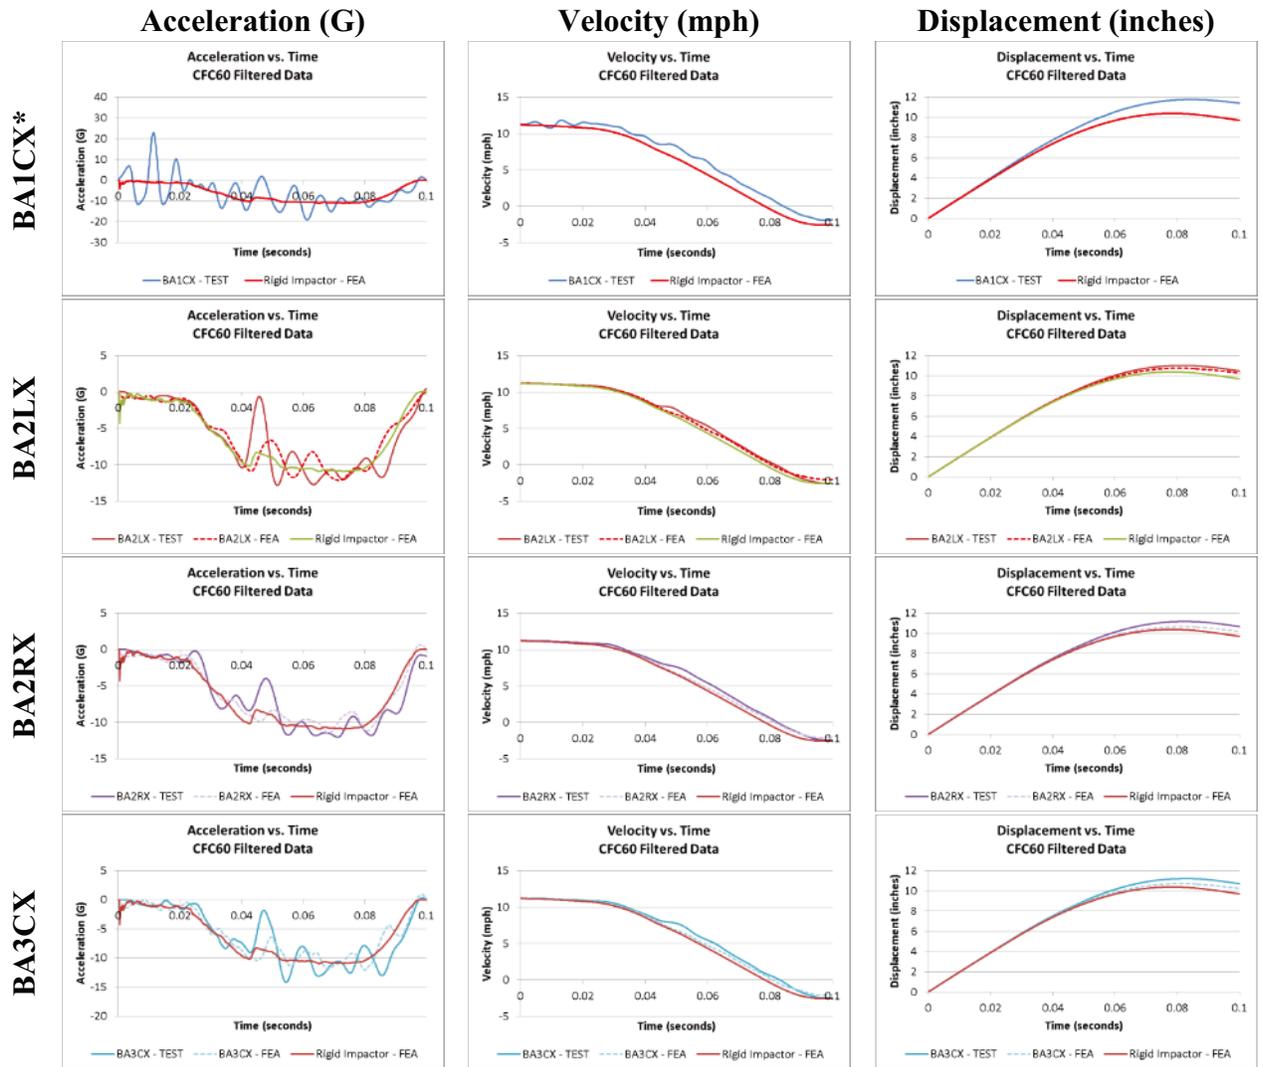
Tank 234 – Post-test Model

*Deformable FEA results not requested at BA1CX location due to high-frequency noise.
