Effect of Anti-Trespass Guard Panels on Pedestrian Behavior

1. AGENCY USE ONLY (Leave blank)		2. REPORT DATE July 2019	3. REPORT TYPE AND DATES COVERED Technical Report September 2014 – January 2016	
4. TITLE AND SUBTITLE Effect of Anti-Trespass Guard Panels on Pedestrian Behavior			5. FUNDING NUMBERS RR97A7-PJ1K3

6. AUTHOR(S) Tashi Ngamdung and Marco daSilva			8. PERFORMING ORGANIZATION REPORT NUMBER DOT-VNTSC-FRA-17-01	
7. PERFORMING ORGANIZATION NAME(S) AND ADDRESS(ES) U.S. Department of Transportation Office of the Assistant Secretary for Research and Technology John A. Volpe National Transportation Systems Center 55 Broadway Cambridge, MA 02142			9. SPONSORING/MONITORING AGENCY NAME(S) AND ADDRESS(ES) U.S. Department of Transportation Federal Railroad Administration Office of Railroad Policy and Development Office of Research, Development and Technology Washington, DC 20590

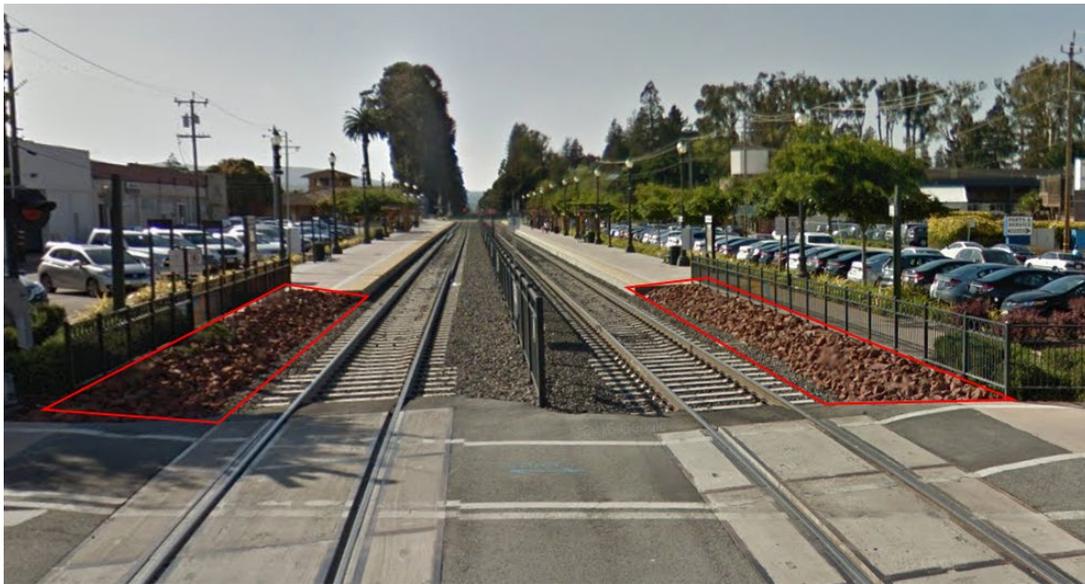
This type of safety treatment is widely used in Europe as an additional safety measure to prevent pedestrians and livestock from trespassing onto ROWs. In the U.K., the Office of Rail Regulation provides guidance on the installation of cattle-cum-trespass guards on “all types of crossings on third rail electrified railways, and where there is movement of animals over the crossing, or where there is a significant risk of trespass by pedestrians” [2]. In United States, this type of safety treatment has been used exclusively at crossings on third rail electrified territory. But recently, similar treatment involving jagged-edge rocks has been used at several crossings adjacent to a station to prevent pedestrians from using the ROW as a shortcut to a station. Figure 1 shows the installation of a rock treatment at the Howard Avenue grade crossing in Burlingame, CA on a Caltrans rail line and Figure 2 shows the installation of triangular section timbers installed at the North Sacramento Avenue grade crossing in Chicago, IL on the electrified CTA Brown Line.

Figure 1. Howard Avenue Grade Crossing, Burlingame, CA

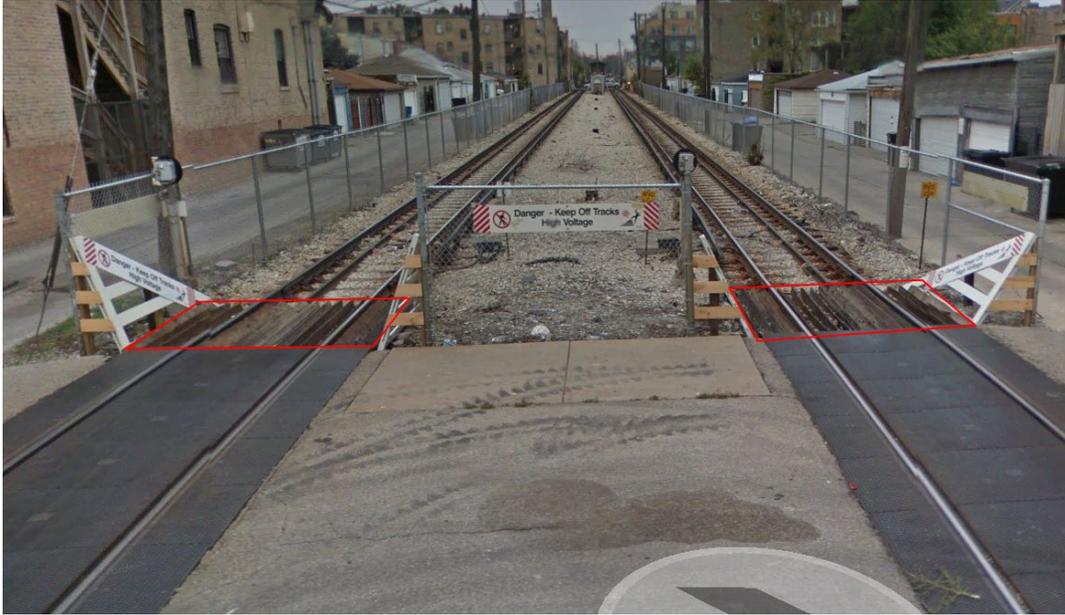
Figure 2. North Sacramento Avenue Grade Crossing, Chicago, IL

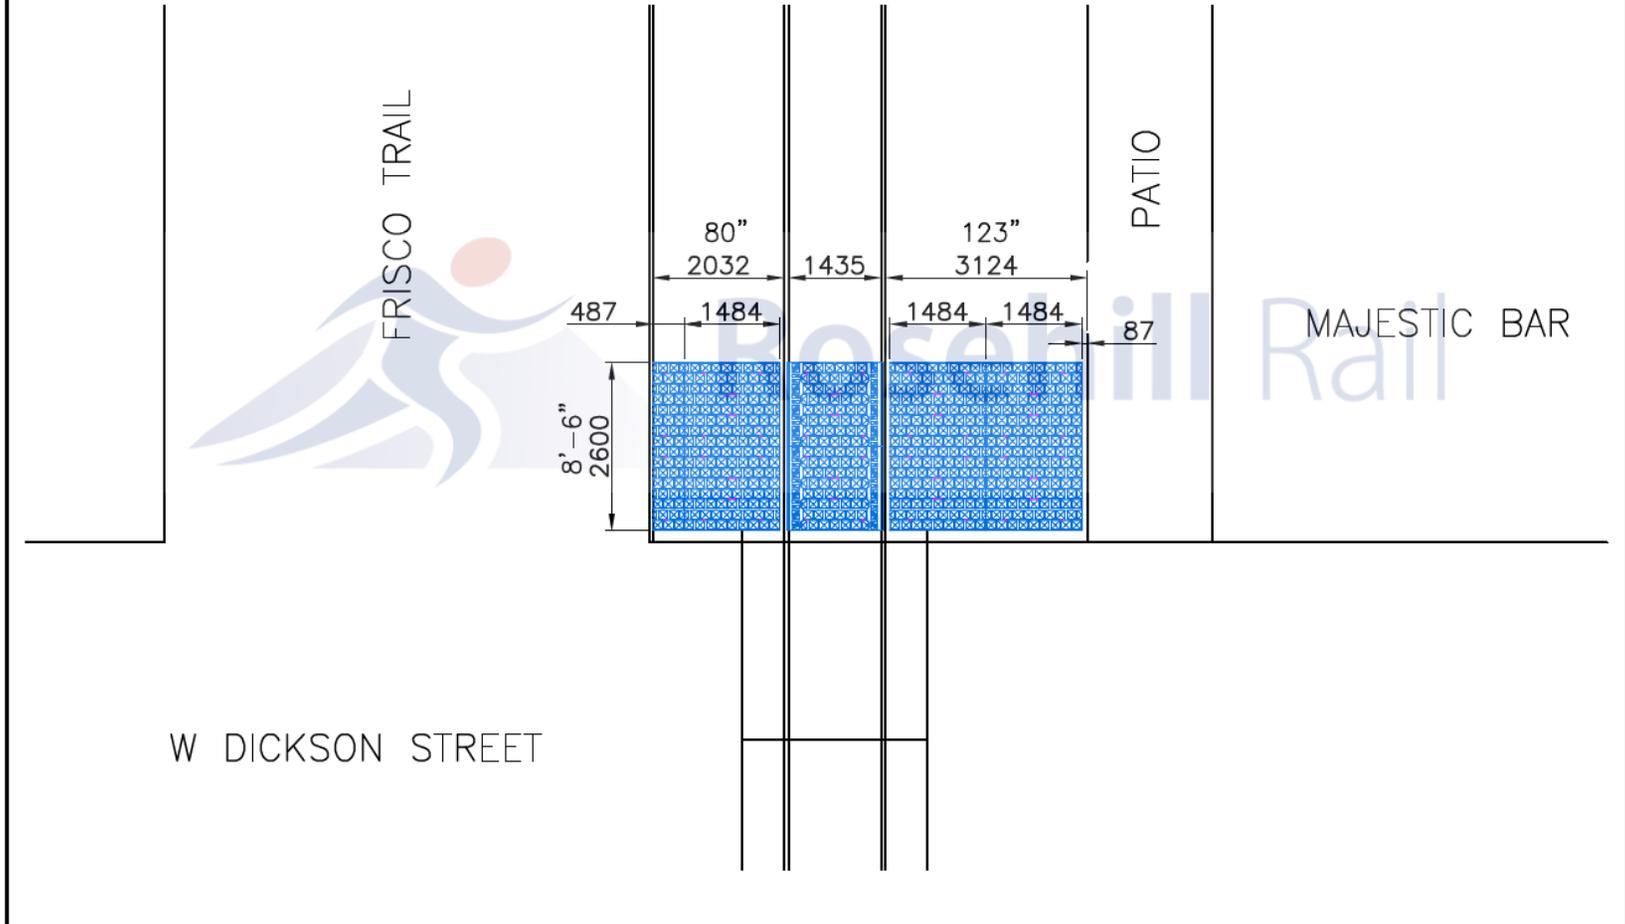
For this implementation, the entire ROW width between the Frisco Trail fence and Majestic Bar patio on the south side of the West Dickson Street crossing were fitted with anti-trespass guard panels. The panels were approximately 8.5 feet deep and consisted of two double-flange standard panels and seven flangeless flat panels. The double-flange standard panels were used between the rails and the flangeless Flat panel were used to cover the area outside the rails. The schematic in [Figure 3](#) shows the installation drawing of the panels at the crossing.

Figure 3. Schematic of Anti-Trespass Guard at West Dickson Street Grade Crossing

The anti-trespass guard panels chosen by A&M for this study were manufactured by Rosehill Rail in the U.K. The treatment consists of panels with a raised pyramidal design installed adjacent to and between the rails at a highway-rail grade crossing. The panels are manufactured from 100 percent recycled rubber and come in three different types: the double-flange standard panel, single-flange panel, and flangeless flat panel. The double-flange standard panel is approximately 1,435 mm by 1,300 mm in size and intended for use between the rails with four foot gauge, the single flange panel is approximately 1,490 mm by 1,300 mm in size and typically used outside the rail, and the flangeless flat panel is approximately 1,490 mm by 1,300 mm in size and used at wider-area highway-rail grade crossings. They are installed using the supplied fixing kits, consisting of two plastic planks and eight screw fixings. The planks are placed under the edge of the panels and secured in place using the washers and screws.

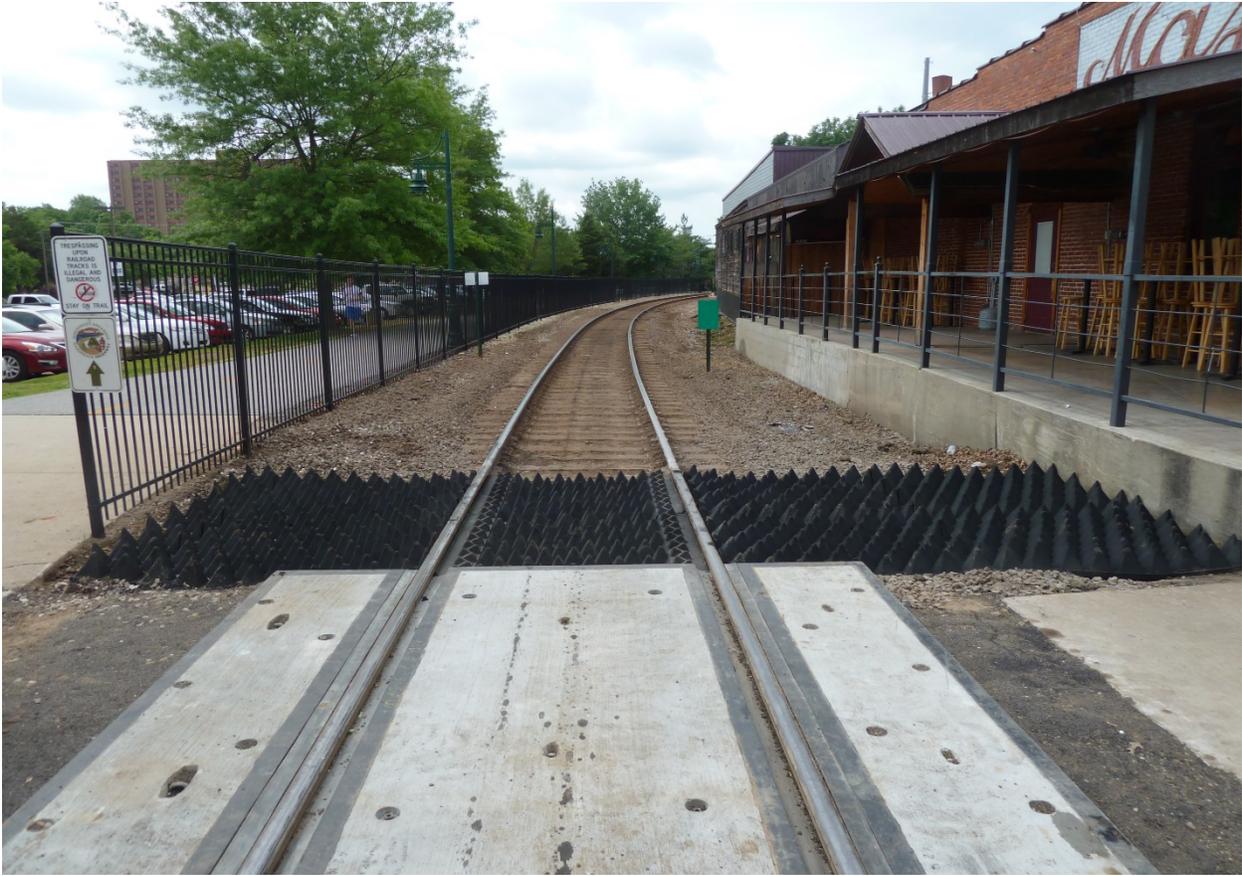
The anti-trespass guard panels were installed on June 2, 2015 by A&M personnel. [Figure 4](#) shows an image of the anti-trespass guard after installation.

Figure 4. Anti-Trespass Guard at West Dickson Street Grade Crossing

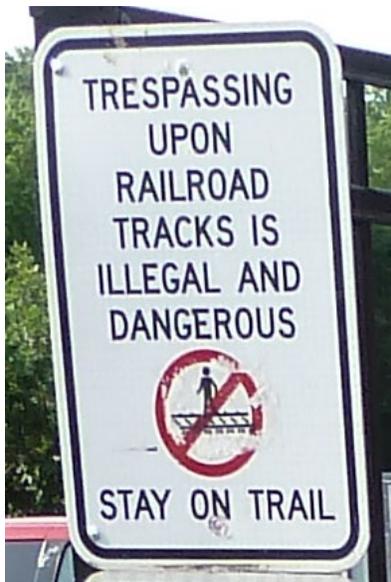
In addition to the panels, there was an existing sign mounted to the fence adjacent to the crossing. The sign, which can be seen in the [Figure 5](#), reads “TRESPASSING UPON RAILROAD TRACKS IS ILLEGAL AND DANGEROUS. STAY ON TRAIL.”

Figure 5. No Trespassing Signage at West Dickson Street Grade Crossing

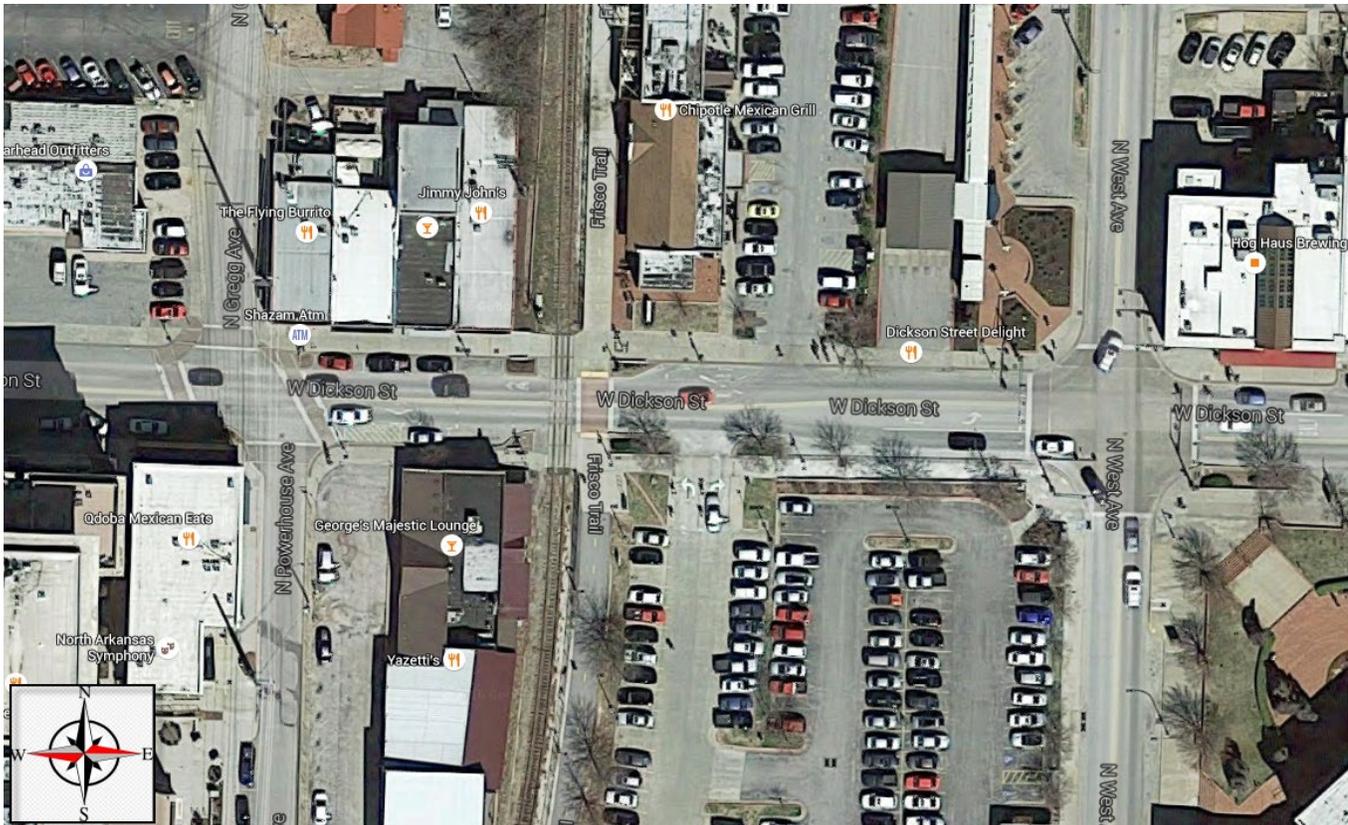
active railroad track that intersects West Dickson Street, and it runs north-south. According to the DOT Highway-Rail Grade Crossing Inventory database, approximately four trains move through the crossing per day at speeds ranging from 5 to 10 mph. The estimated annual average daily traffic (AADT) at this crossing in 1987 was 12,800. Although no pedestrian traffic count was available, the crossing does have heavy pedestrian traffic volume. The crossing was equipped with crossbucks and flashing lights, but during study period in September 11, 2015, the warning devices were upgraded and subsequently equipped with four pedestrian gates (one per quadrant) and two vehicular gates. [Figure 7](#) shows a close-up satellite image of the crossing.

Figure 7. West Dickson Street Grade Crossing Satellite Image

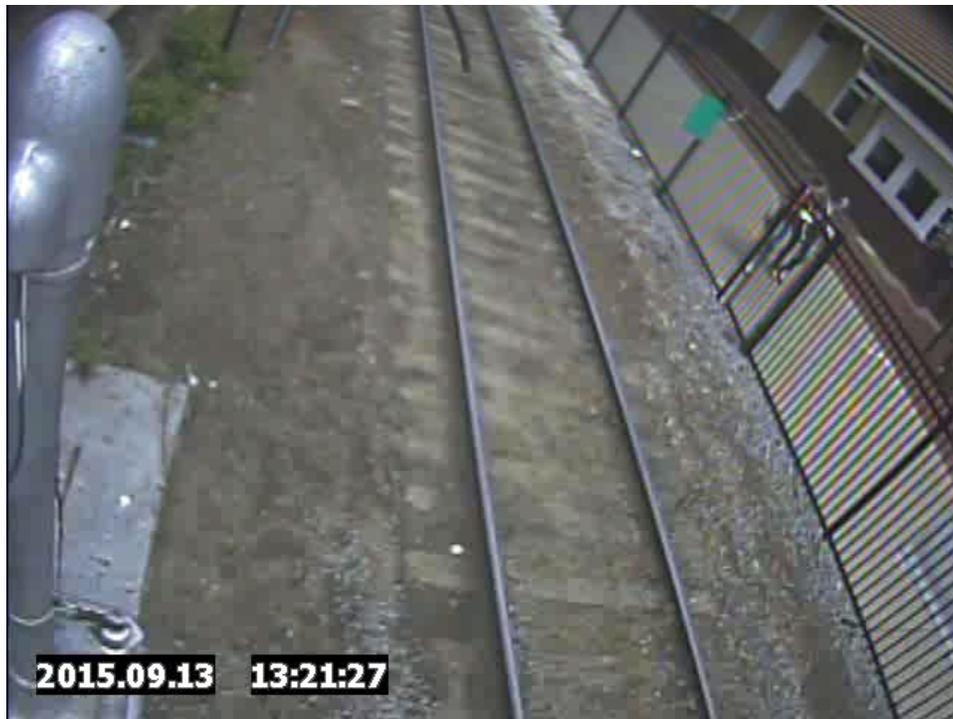
The east side of the track on the north side of the crossing is fenced off and is bordered by Frisco Trail, which runs parallel to the track in this area. It is a paved rail-with-trail, accessible to pedestrians, bicyclists, and wheelchair users. There are a few restaurants adjacent to the trail near the crossing. The west side of the track on the north side of the crossing is bordered by a restaurant building and is fenced-off immediately after the restaurant building. [Figure 8](#) shows a northbound view from the crossing.

Figure 8. View of the Northbound Railroad ROW

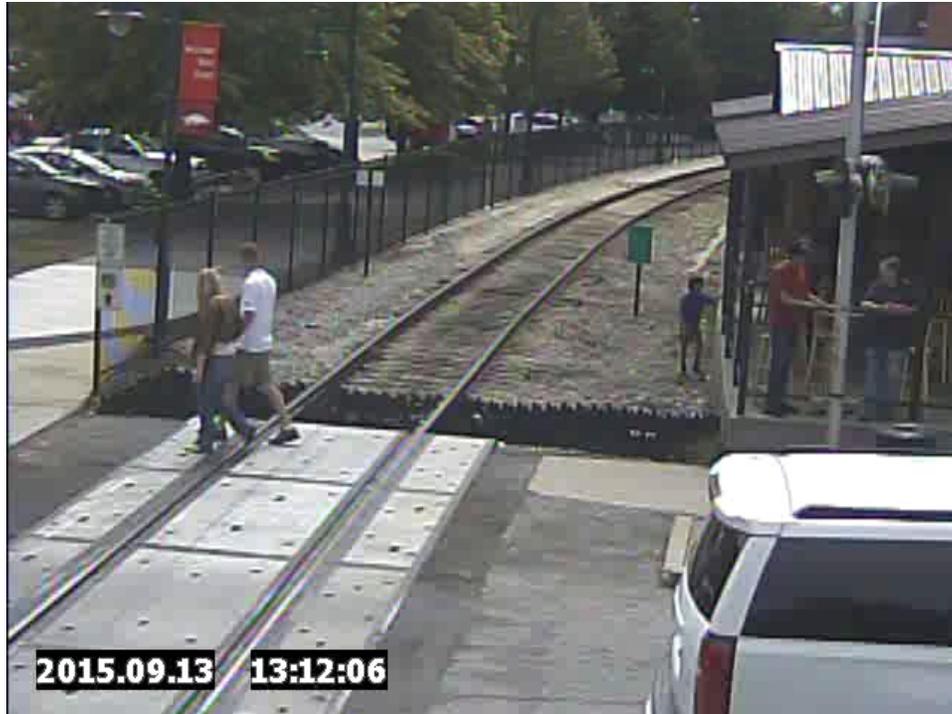
There is one lane of traffic and a sidewalk that intersect with the crossing. The east side of the track on the south side of the crossing is fenced off and is bordered by the Frisco Trail, which runs parallel to the track in this area. There is also a large parking lot adjacent to the trail. On the west side of the track on the south side of the crossing, the ROW is bordered by the Majestic Lounge (a music venue and lounge) followed by a couple of restaurants. The lounge is a popular destination in the area for live music and nightlife. The lounge has open patio facing the track. Although the patio is fenced off, the research team noticed many instances where patrons would access the venue by walking onto the ROW and climbing over the patio fence. There is also a parking garage and many restaurants approximately 400 feet away on the south side of the crossing. [Figure 9](#) shows a pedestrian trespassing on the railroad ROW in the south side of the crossing.

Figure 9. Example of Pedestrian Trespassing on Southbound Railroad ROW

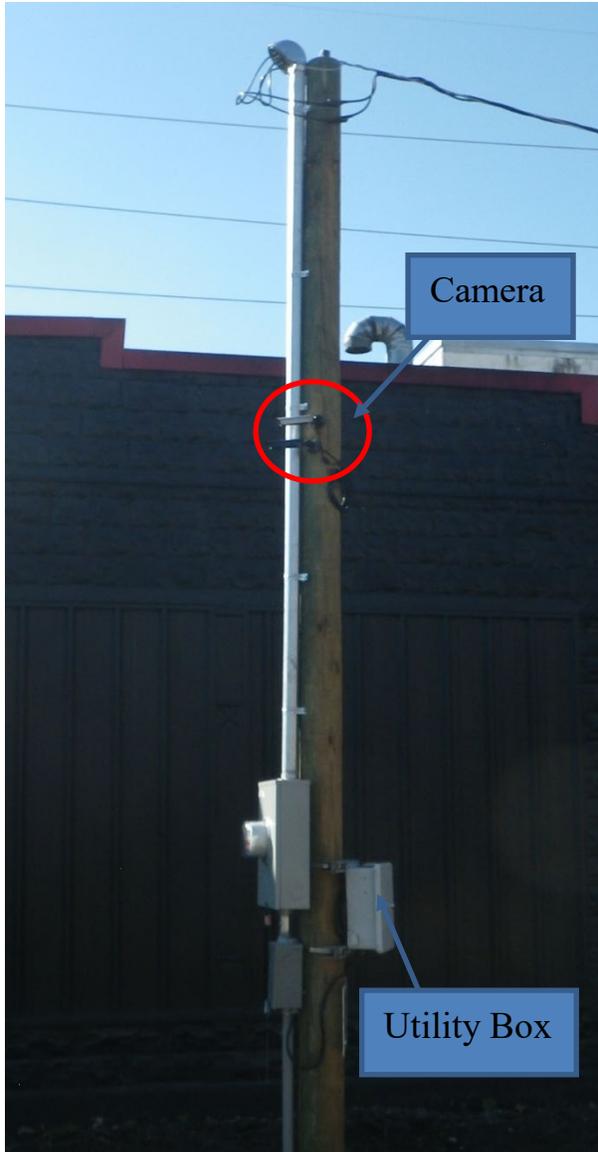
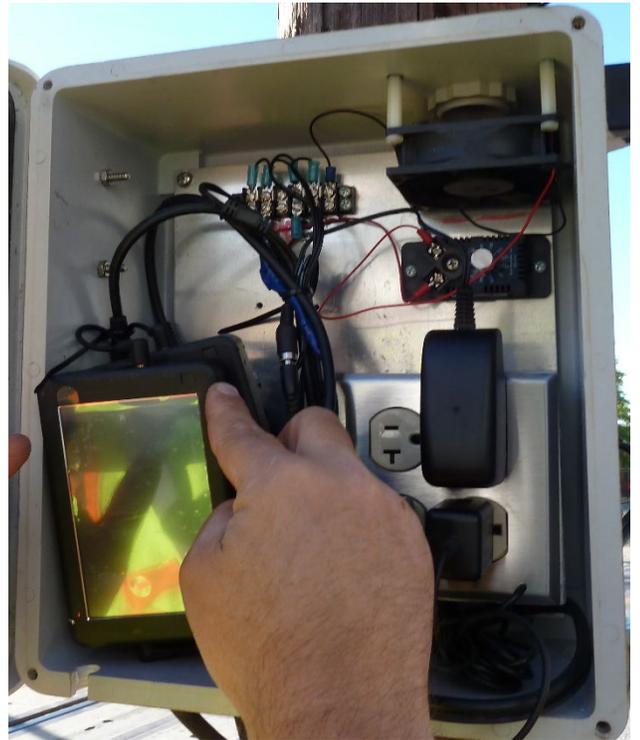
Pedestrian movements around the crossing were collected using a video camera mounted high up on a railroad pole located on north side of the crossing. The video-based data collection system was installed on September 23, 2014 and remained operational through December 30, 2015. The system consisted of a camera mounted on the pole and a utility box at the bottom of the pole that housed the digital video recorder, temperature switch, fan, and AC power outlet (AC power was obtained from railroad signal system power). [Figure 10](#) shows the video data collection system as installed at the crossing.

Figure 10. Video Data Collection System

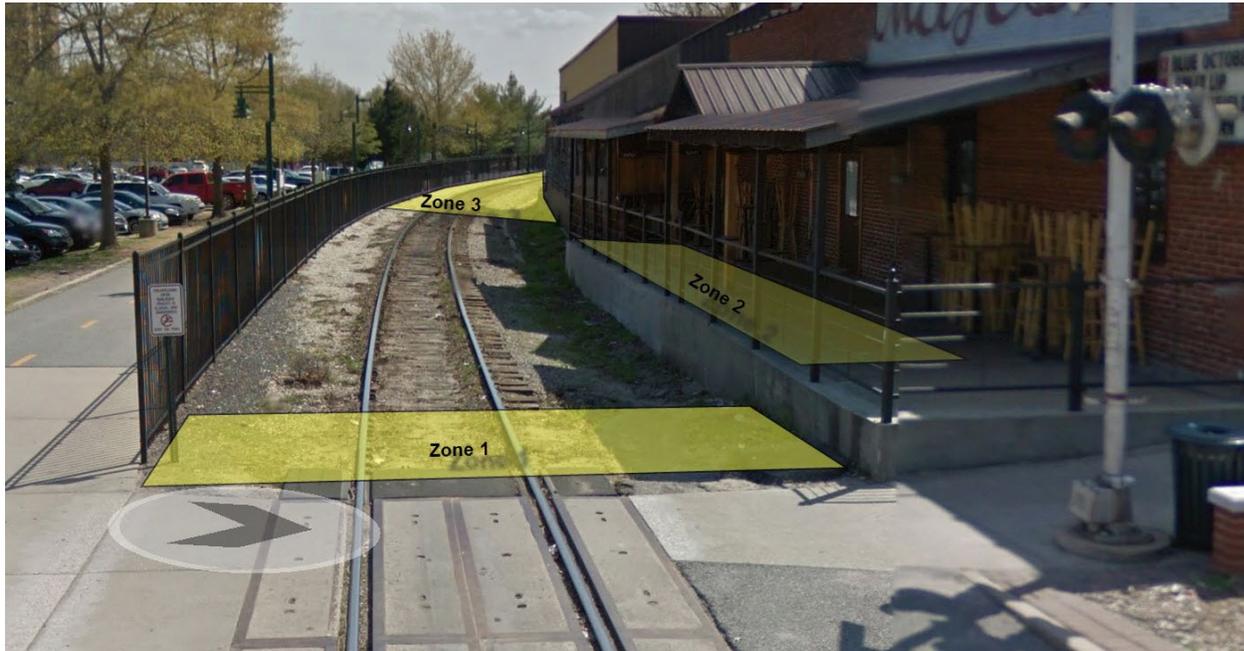
Trespassers were coded based on three possible zones in which a trespasser could enter and exit the railroad ROW. The ROW study area and the location of these three zones are shown in [Figure 11](#). A pedestrian was considered a trespasser if they stepped with both feet anywhere on ROW in the study area. However, for this study, pedestrians stepping onto the trespass guard panels without completely crossing the zone covered by the panels were not included in the analysis. To account for this during pre-installation, pedestrians who stepped on the ROW that was covered by the trespass guard panel post-installation were also not included in the study. The three zones where trespassers could enter and exit the railroad ROW were as follows:

- Zone 1: A pedestrian who trespassed in Zone 1 was accessing the ROW from the West Dickson Street crossing. The trespass guard panels were installed at this location.
- Zone 2: A pedestrian who trespassed in Zone 2 was accessing the ROW by climbing over Majestic Lounge patio railing.
- Zone 3: A pedestrian who trespassed in Zone 3 was entering the ROW from a pedestrian-only crossing located approximately 370 feet south of the West Dickson Street crossing.

Figure 11. Zone Assignments for West Dickson Street Grade Crossing

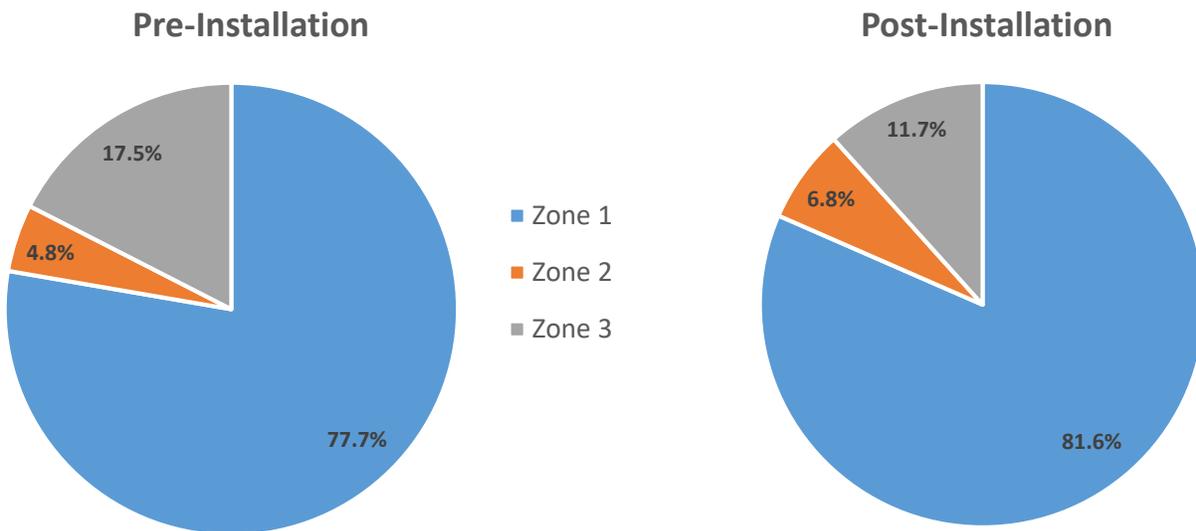
Figure 12 illustrates the distribution of pedestrians who trespassed onto the ROW by location where they entered the ROW. As can be seen, the majority of the pedestrian trespass occurred from Zone 1, with 129 of 166 pre-installation observations and 84 of 103 after installation, followed by Zone 3, with 29 of 166 pre-installation and 12 of 103 after installation. The fewest pedestrian trespass observations originated from Zone 2, with 8 of 166 pre-installation and 7 of 103 after installation.

Figure 12. Where the Pedestrian Trespassed onto Railroad ROW

No significant changes in where trespassers entered the ROW were found from before to after the installation of the anti-trespass guard panels locations ($\chi^2 = 1.98$, $df = 2$, $P > 0.05$).

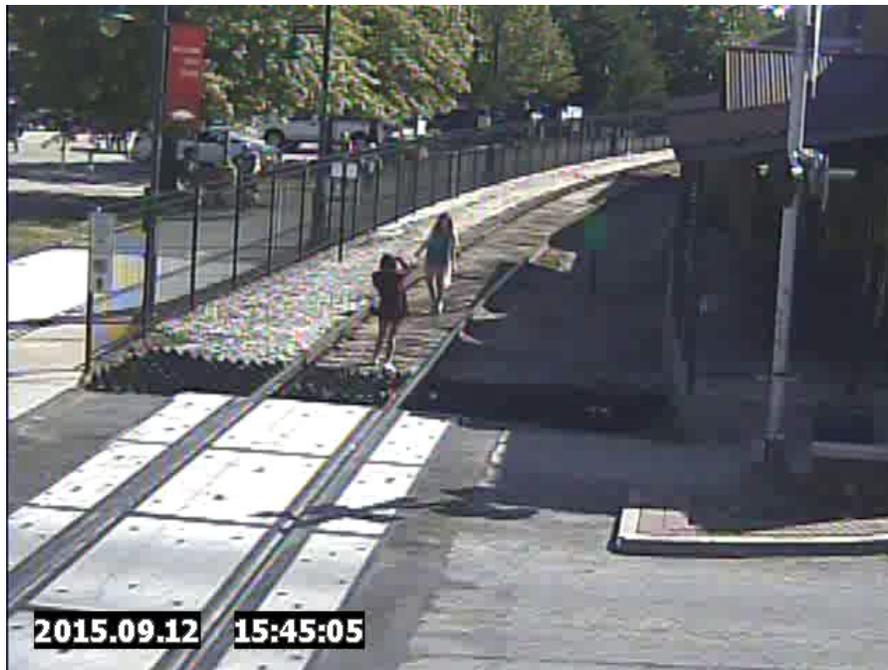
Examples of pedestrians trespassing from Zone 1, Zone 2, and Zone 3 are shown in Figure 13 through Figure 15, respectively. In Figure 13, two female trespassing pedestrians entered the railroad ROW from the crossing (Zone 1) by walking on the rails, then remained for approximately 90 seconds taking pictures before exiting via the crossing (Zone 1) by walking on the rails.

Figure 13. Example of Pedestrians Trespassing upon Railroad ROW from the Crossing (Zone 1)

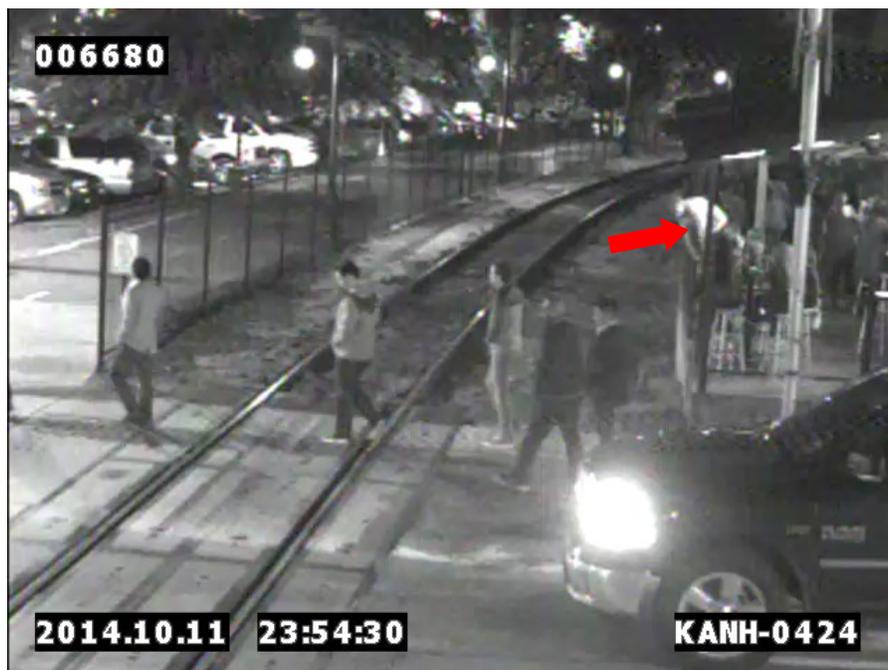
In [Figure 14](#), a male trespassing pedestrian entered the railroad ROW from the Majestic Lounge patio by climbing over the railing (Zone 2). The pedestrian picked up something he dropped and exited the ROW by climbing over the railing (Zone 2).

Figure 14. Example of a Pedestrian Trespassing from the Majestic Lounge Patio (Zone 2)

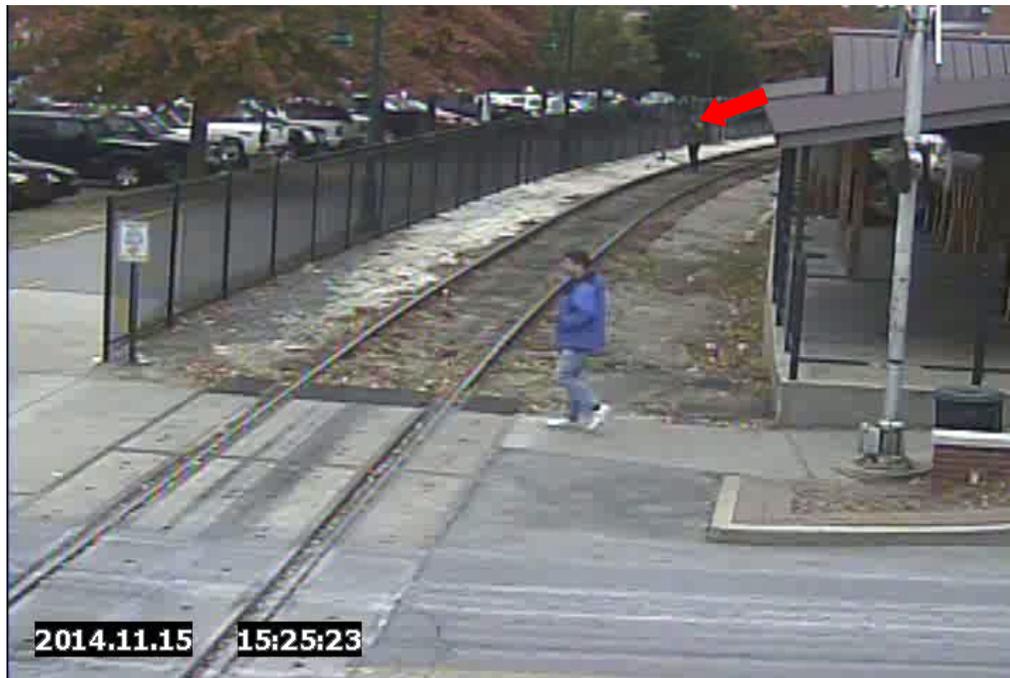
In [Figure 15](#), a male trespassing pedestrian walking a dog entered the railroad ROW from the area south of the crossing (Zone 3) and exited via the crossing (Zone 1).

Figure 15. Example of a Pedestrian Trespassing from the Area South of the Crossing (Zone 3)

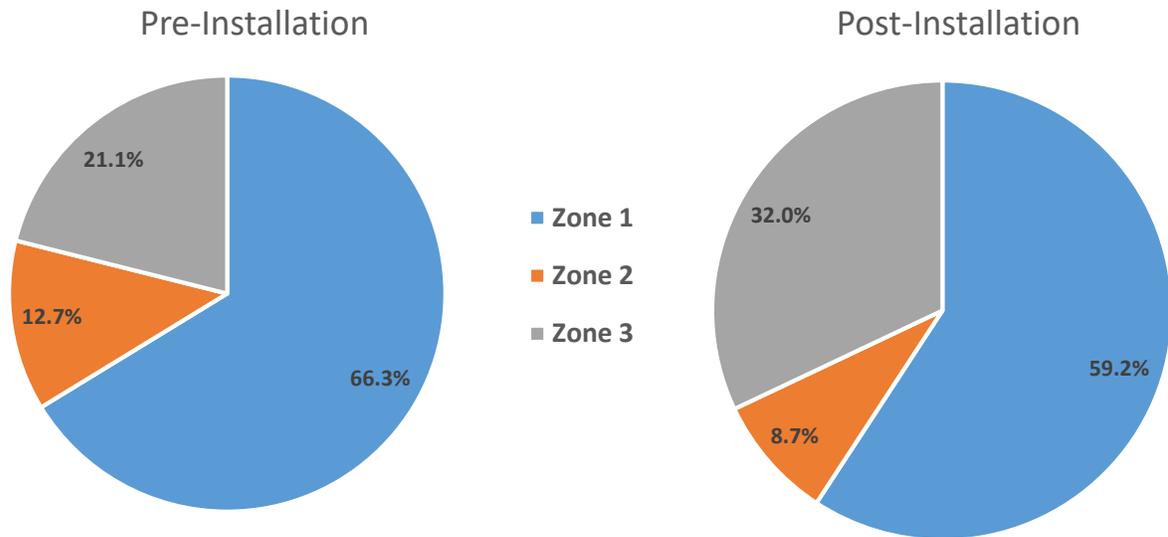
Pedestrians who trespassed onto the ROW had three possible choices for where they could exit the ROW. Findings showed the majority of the pedestrians who trespassed exited the ROW from Zone 1, with 110 of 166 pre-installation and 61 of 103 after installation, followed by Zone 3, with 35 of 166 pre-installation and 33 of 103 after installation, and the fewest pedestrians exited from Zone 2, with 21 of 166 pre-installation and 9 of 103 after installation. [Figure 16](#) illustrates the distribution of trespass events by exit location.

Figure 16. Where the Pedestrian Exited the Railroad ROW

Similar to the trespassing entrance path, there was no significant change in where trespassers exited the ROW after the installation of the anti-trespass guard panels ($\chi^2 = 4.39$, $df = 2$, $P > 0.05$). This indicates that although pedestrians may have changed their decision-making process prior to trespassing on railroad ROW, there was little change in where they exited the ROW once they decided to trespass.

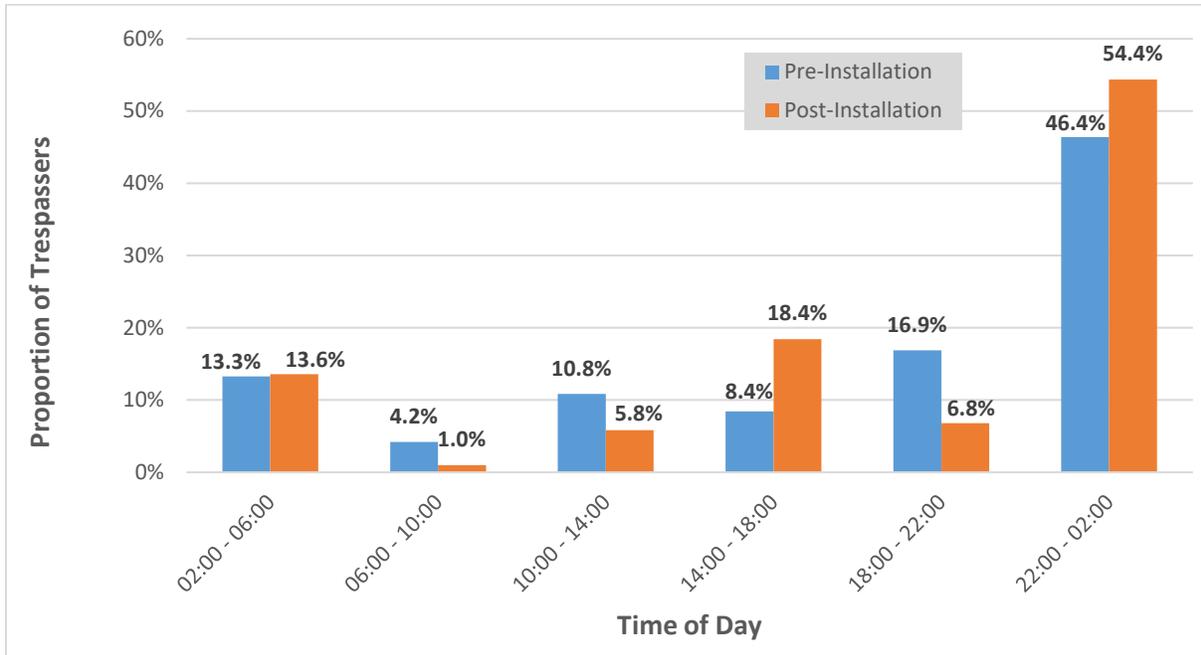
Pedestrians trespassed at all hours of the day. The majority of trespassing occurred at late night-early morning between 10:00 p.m. and 2:00 a.m. for both the pre- (46.4 percent) and post-installation (54.4 percent) periods. Figure 17 shows the distribution of trespass activity by the time of day for both pre- and post-installation periods.

Figure 17. Proportion of Trespass Activity by Time of Day (Pre-Install n = 166 and Post-Install n = 103)

There was significant change in the time of day when pedestrians committed trespassing after the installation of the anti-trespass guard panels ($\chi^2 = 15.02$, $df = 5$, $P < 0.05$). This change was primarily due to an increase in the proportion of trespass occurrences from 2:00 p.m. to 6:00 p.m. and 10:00 p.m. to 2:00 a.m. and a decrease in the proportion of trespass occurrences from 6:00 a.m. to 10:00 a.m., 10:00 a.m. to 2:00 p.m., and 6:00 p.m. to 10:00 p.m.. The increase in proportion of trespassing during late night hours between 10:00 p.m. to 2:00 a.m. could be related to fact that the majority of the trespassers during this time were patrons of the Majestic Lounge, next to the ROW.
